ILLINOIS DEPARTMENT OF TRANSPORTATION	
SHEET TITLE	
BEAM REPAIR DETAILS	
PROJECT	PROJECT NO.
I-55 NB OVER KANKAKEE RIVER	03095-16
FAI ROUTE 55, SECTION 88(B&B-1)BR	SCALE
WILL COUNTY	06/25/09
SN 099-0001	DRAWN BY
	CFC
	CHECKED BY
	MCB/KPS
DRAWING NO.	
COOMBE-BLOXDORF P.C.	
Engineers / Land Surveyors	
Springfield, Illinois	
Design Firm License No. 184-002703	
10	OF 19 SHTS

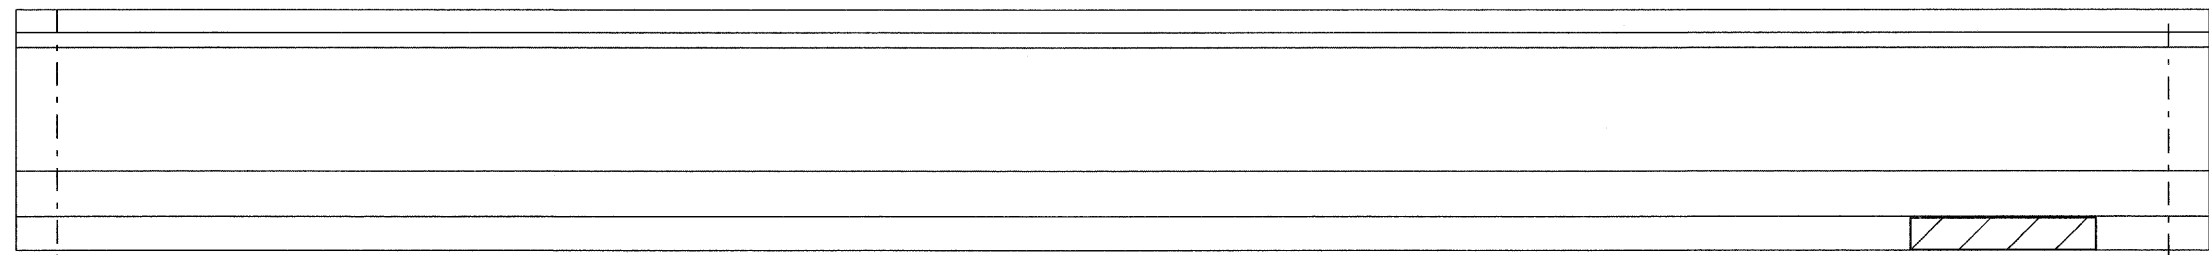
**BOTTOM FLANGE
PLAN VIEW
BEAM 1, SPAN 8**

ELEVATION
(Looking West)

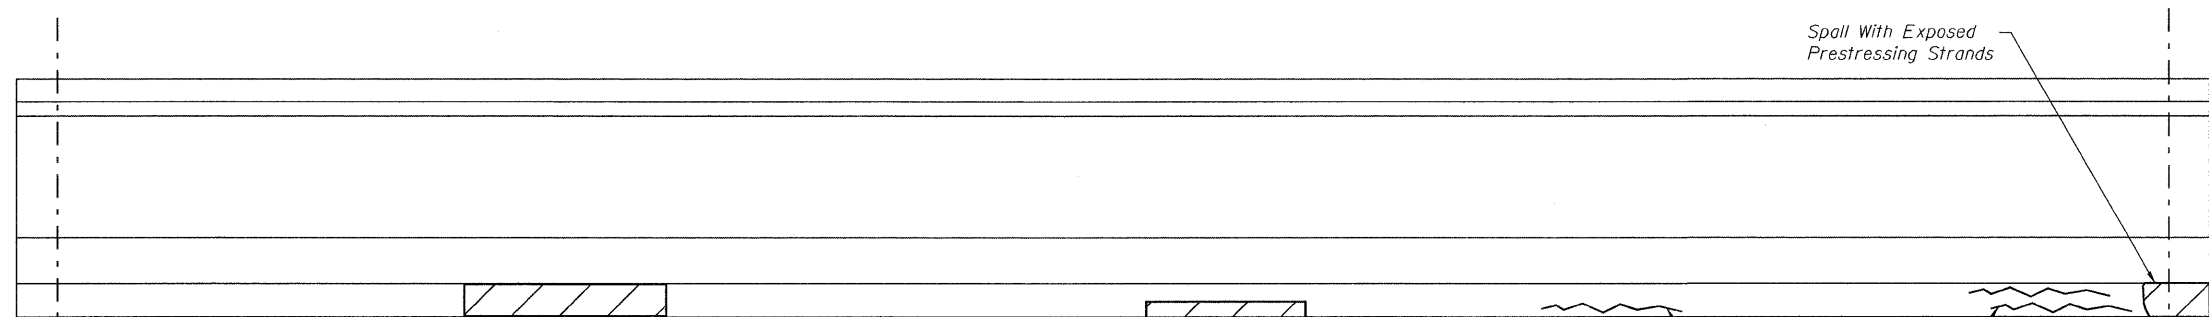
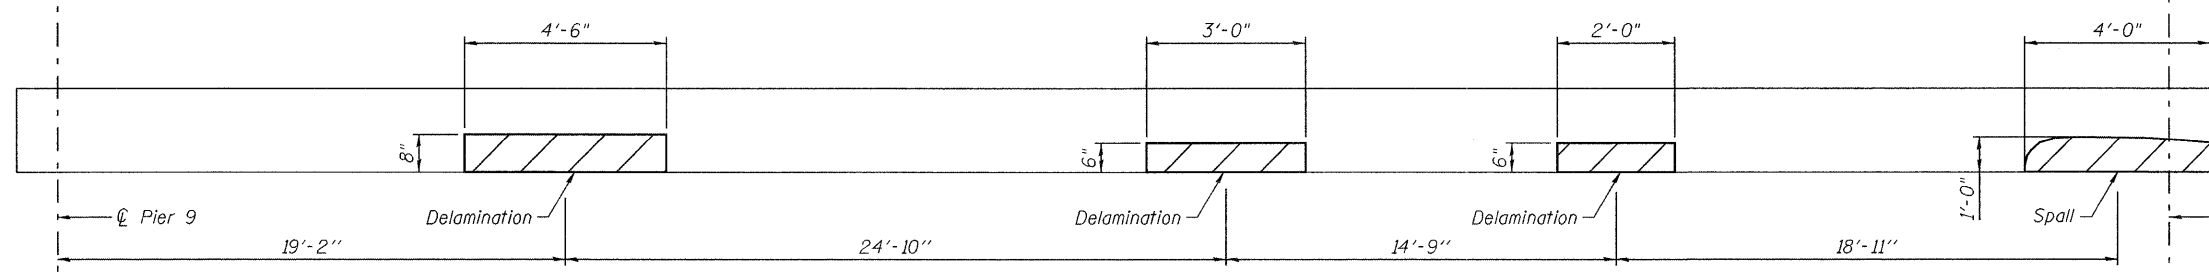
**BOTTOM FLANGE
PLAN VIEW
BEAM 1, SPAN 9**

ELEVATION
(Looking West)
