DECK PLAN

FILE NAME = deck_repairs.dgn	USER NAME = ID01	DESIGNED - B.N.S.	REVISED -	STATE OF ILLINOIS DEPARTMENT OF TRANSPORTATION	DECK PLAN U.S. 30 OVER WEST BRANCH BIG ROCK CREEK S.N. 045-2005	SCALE:	SHEET NO. 52 OF 518 SHEETS	STA. TO STA.	FED. ROAD DIST. NO. 1 ILLINOIS FED. AID PROJECT
PLOT SCALE = 50.0000' / IN.	PLOT DATE = 1/26/2009	CHECKED - B.N.S./J.C.N.	REVISED -		CONTRACT NO. 60E63

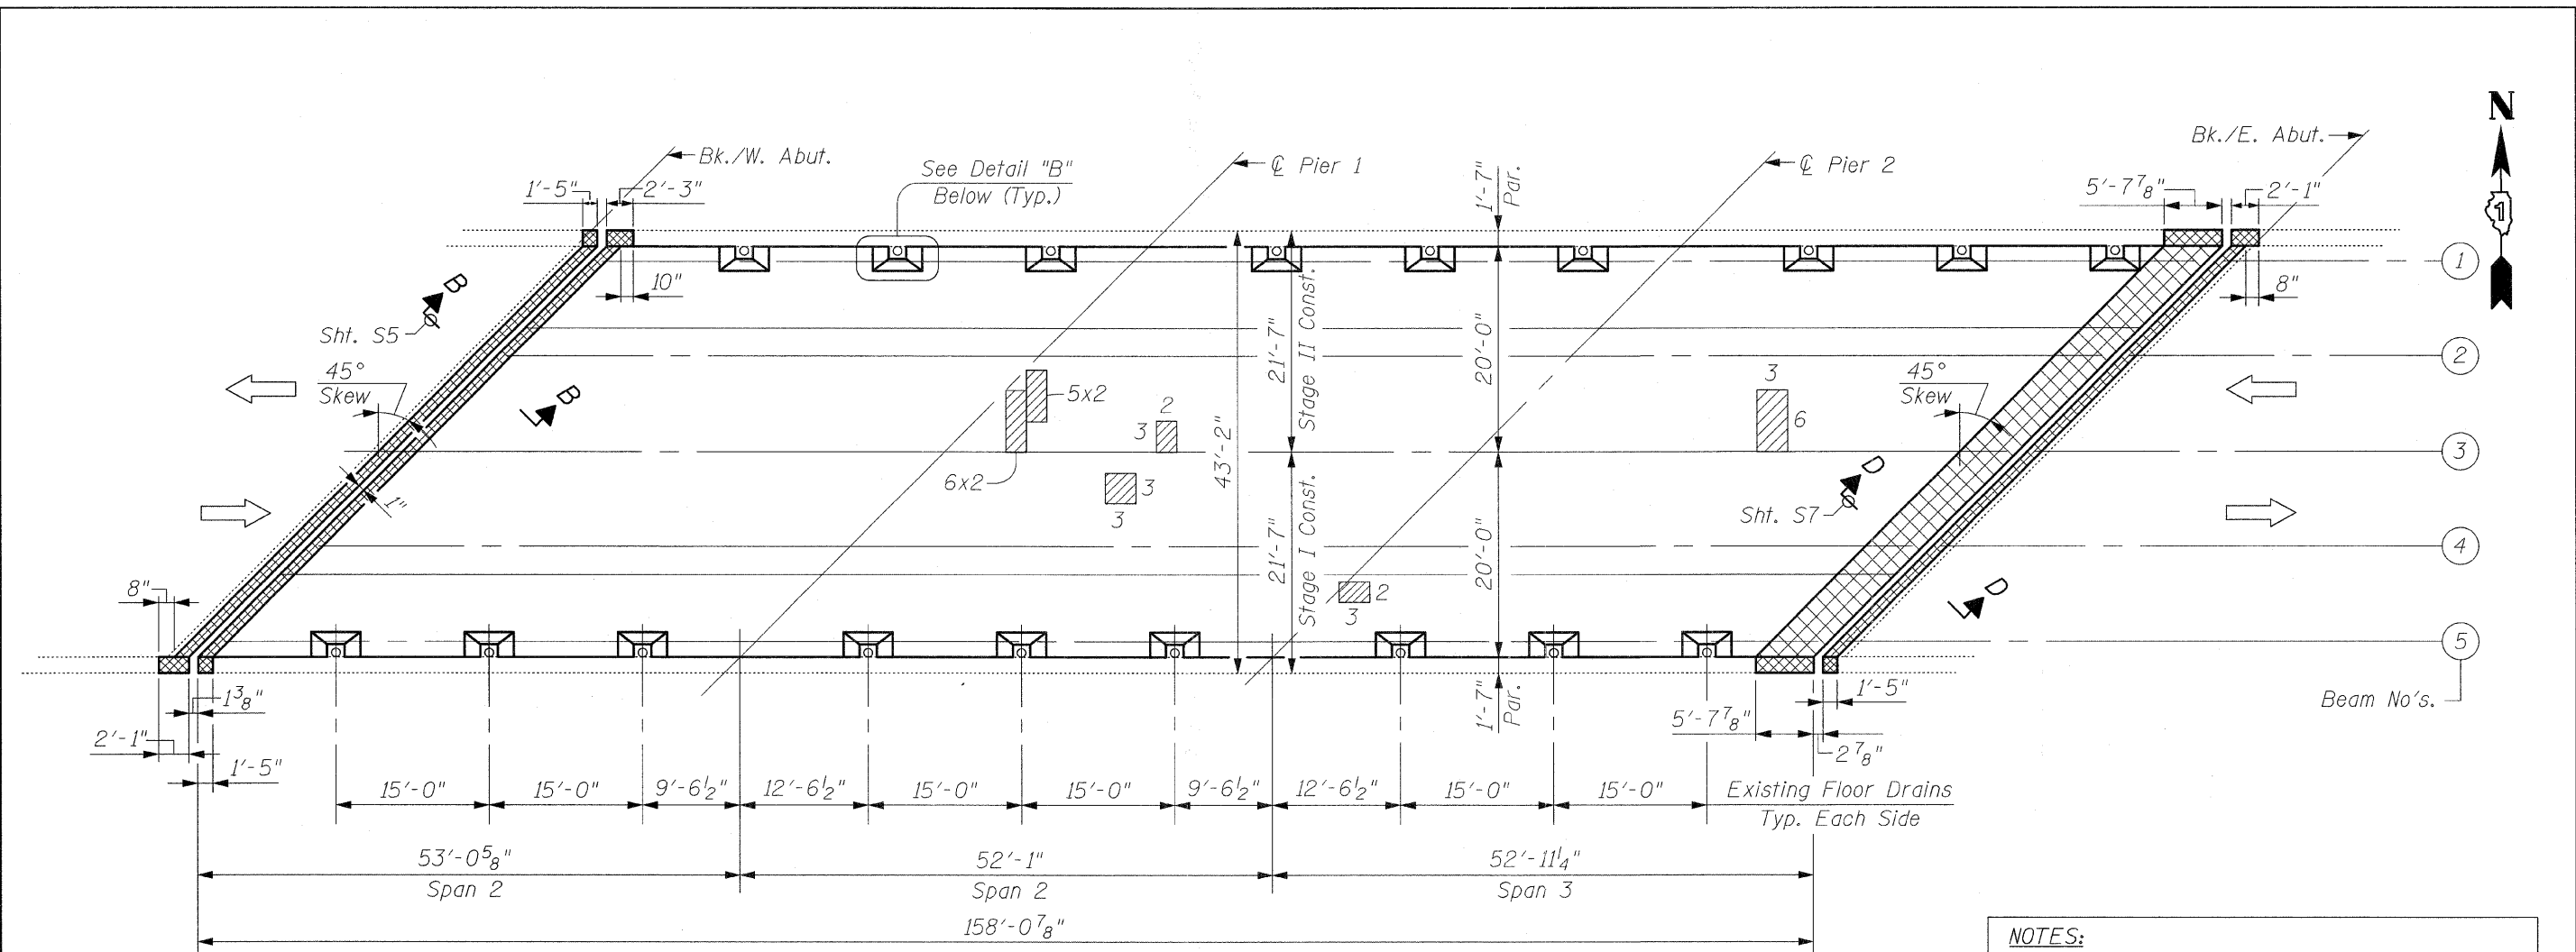
NOTES:
 For Joint Reconstruction Details, See Sht's. S4 thru S7.
 Deck Slab Repair (Partial) is Shown for Information Only.
 Locations & Areas of Repairs are Approximate and are Based on Inspections Performed by I.D.O.T. and Earth Tech/AECOM.
 Proposed Overlay to be Tapered at Existing Floor Drains, See Detail "B".
 All Patch Dimensions are in Feet.
