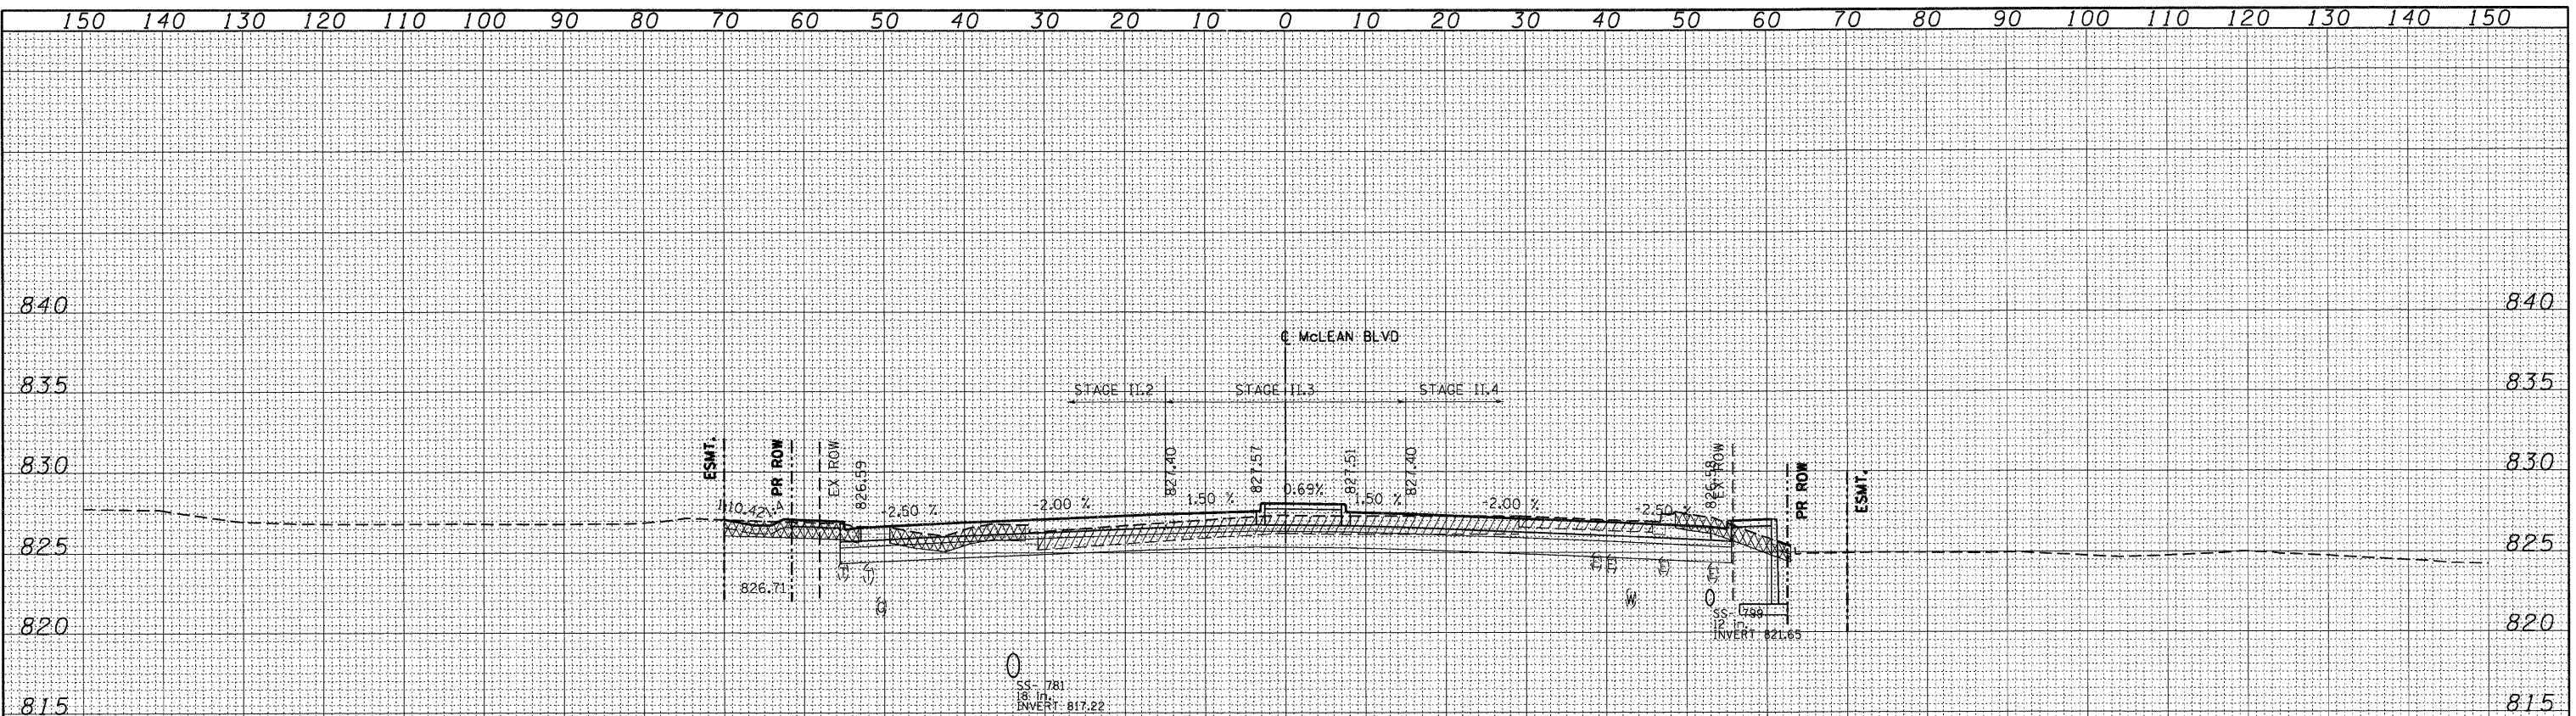
**68 + 50.00**

END AREAS (SQ FT)	STAGE II.2	STAGE II.3	STAGE II.4
EARTH EXCAVATION =	32.06	23.95	62.25
EMBANKMENT =	7.48	0.00	8.13
UNS MATL (TOPSOIL EXCAVATION) =	33.66	0.00	14.40
PGE SUBGRADE =	0.00	0.00	0.00

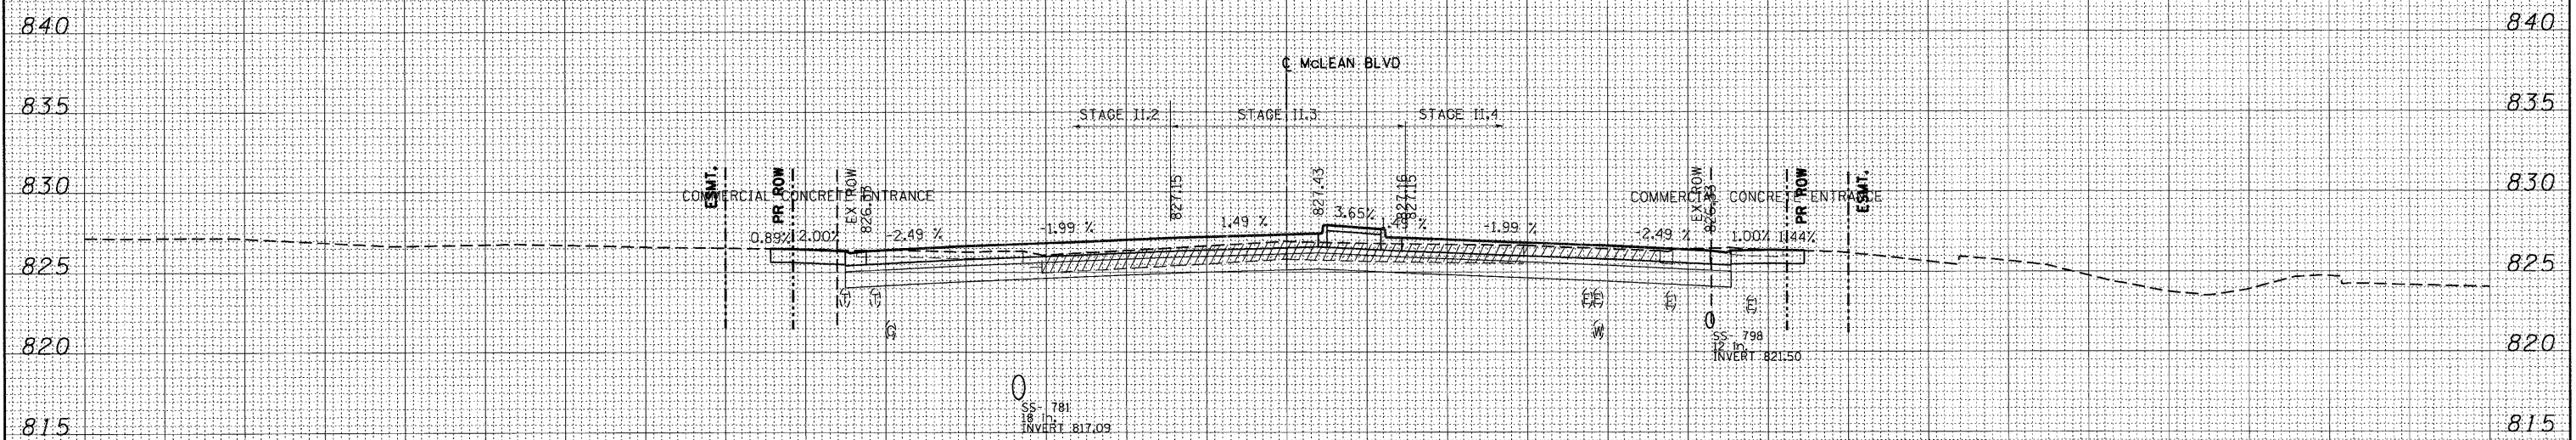
**68 + 00.00**

END AREAS (SQ FT)	STAGE II.2	STAGE II.3	STAGE II.4
EARTH EXCAVATION =	52.51	17.49	59.00
EMBANKMENT =	0.00	0.00	0.00
UNS MATL (TOPSOIL EXCAVATION) =	0.00	0.00	0.00
PGE SUBGRADE =	0.00	0.00	0.00
