BORING LOG SB 02-12 Page 1 of 1

WEI Job No.: 414-07-01
 Client: T. Y. LIN International
 Project: Dan Ryan Improvements; IDOT No. D-91-421-01
 Location: From 95th Street to South of 69th Street

BORING LOG SB 02-14 Page 1 of 1

ILLINOIS DEPARTMENT OF TRANSPORTATION
 F.A.I. 94 (DAN RYAN EXPRESSWAY)
 SOIL BORINGS SB 02-12 & SB 02-14

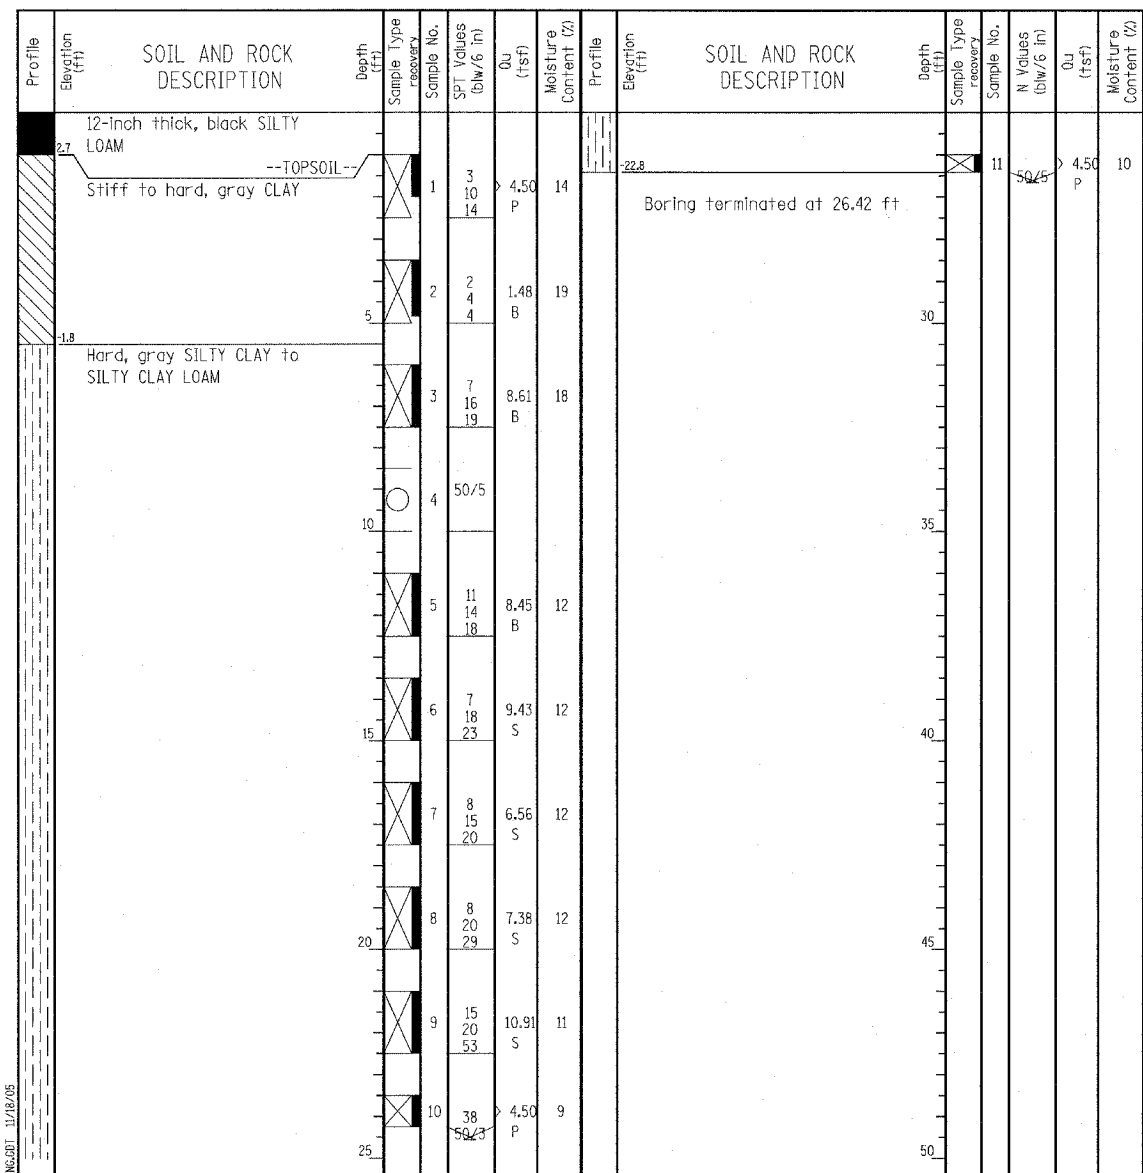
Datum: CCD
 Elevation: 3.65 ft
 North: 1843753.79 ft
 East: 1177841.57 ft
 Station: 2223+85.3
 Offset: 70.454' RT

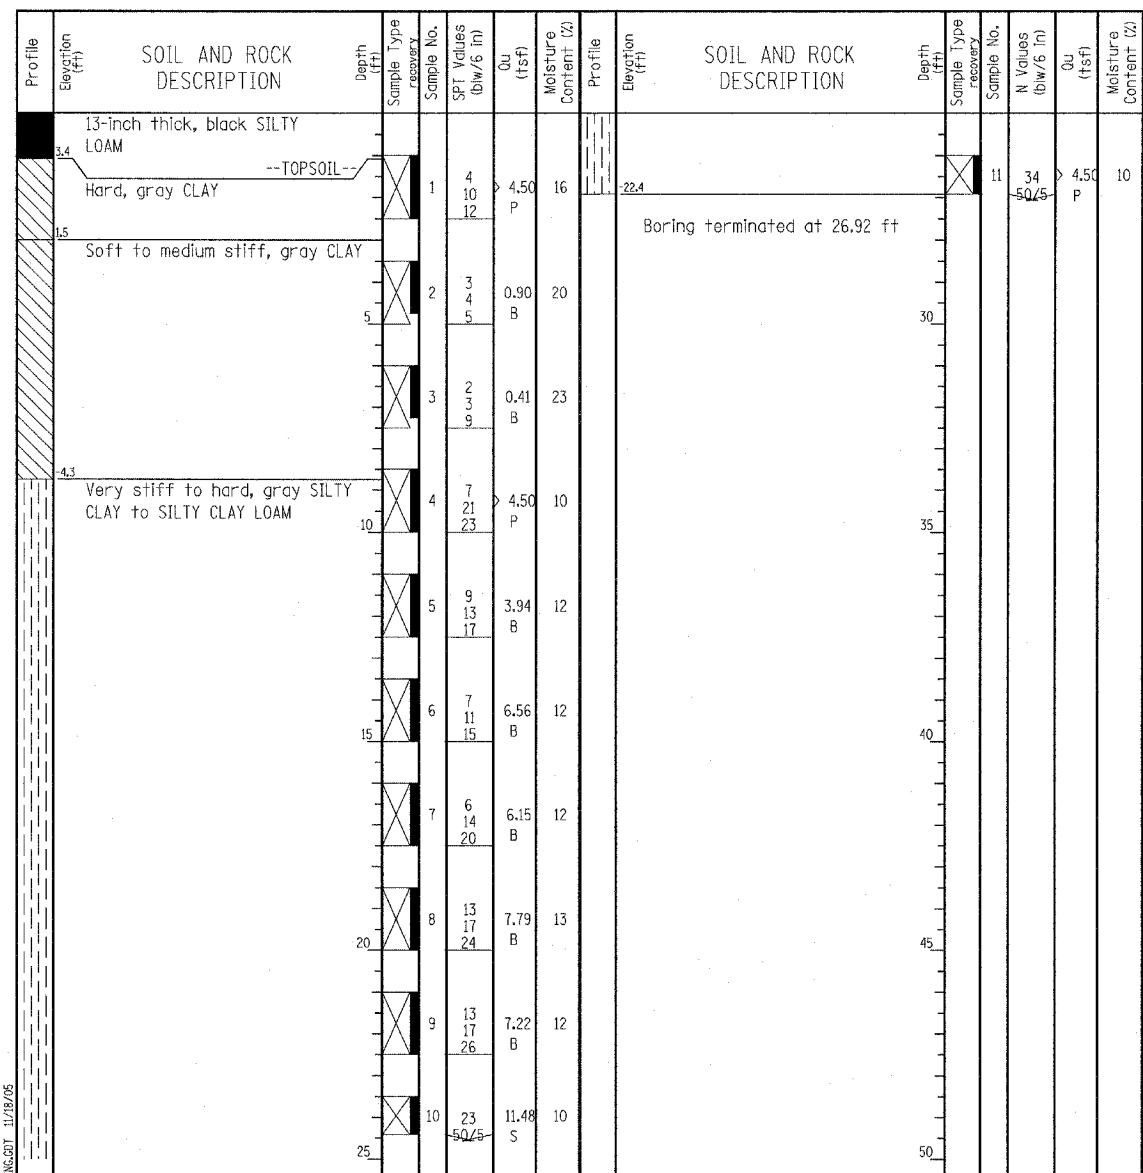
Datum: CCD
 Elevation: 4.48 ft
 North: 1843601.05 ft
 East: 1177847.45 ft
 Station: 2222+32.5
 Offset: 71.965' RT
