DESIGNED - IJL	EXAMINED - <i>Joanne F. Jelliffe</i>	DATE - MARCH 11, 2011	STATE OF ILLINOIS DEPARTMENT OF TRANSPORTATION	ABUTMENT BACKWALL REPAIR DETAILS SN 101-0032 (N.B.)	F.A.P. RTE. 738	SECTION (5HB)M1	COUNTY WINNEBAGO	TOTAL SHEETS 9	SHEET NO. 8
CHECKED - GGE	PASSED - <i>Carl King</i>				SHEET NO. 4 OF 5 SHEETS	CONTRACT NO. 64G89 ILLINOIS FED. AID PROJECT			
DRAWN - Kyle M. Steffen	ACTING ENGINEER OF STRUCTURAL SERVICES								
CHECKED - IJL GGE	ACTING ENGINEER OF BRIDGES AND STRUCTURES

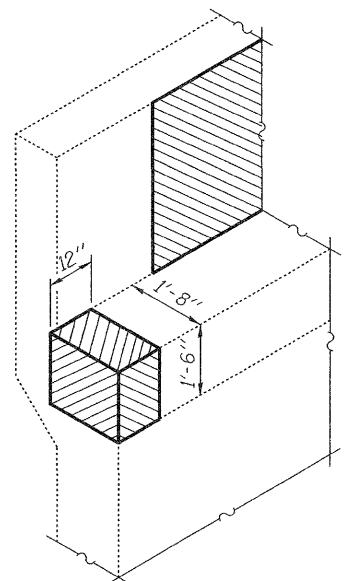
ISOMETRIC VIEW
 P.P.C. I-Beam & Bearing
 not shown for clarity.
