DECK REPAIR PLAN
(Spans 14 thru 16)

DECK REPAIR DETAILS
SPANS 14-16
VACHEL LINDSAY BRIDGE REHABILITATION
LONG BAY DRIVE OVER LAKE SPRINGFIELD
SPRINGFIELD, ILLINOIS

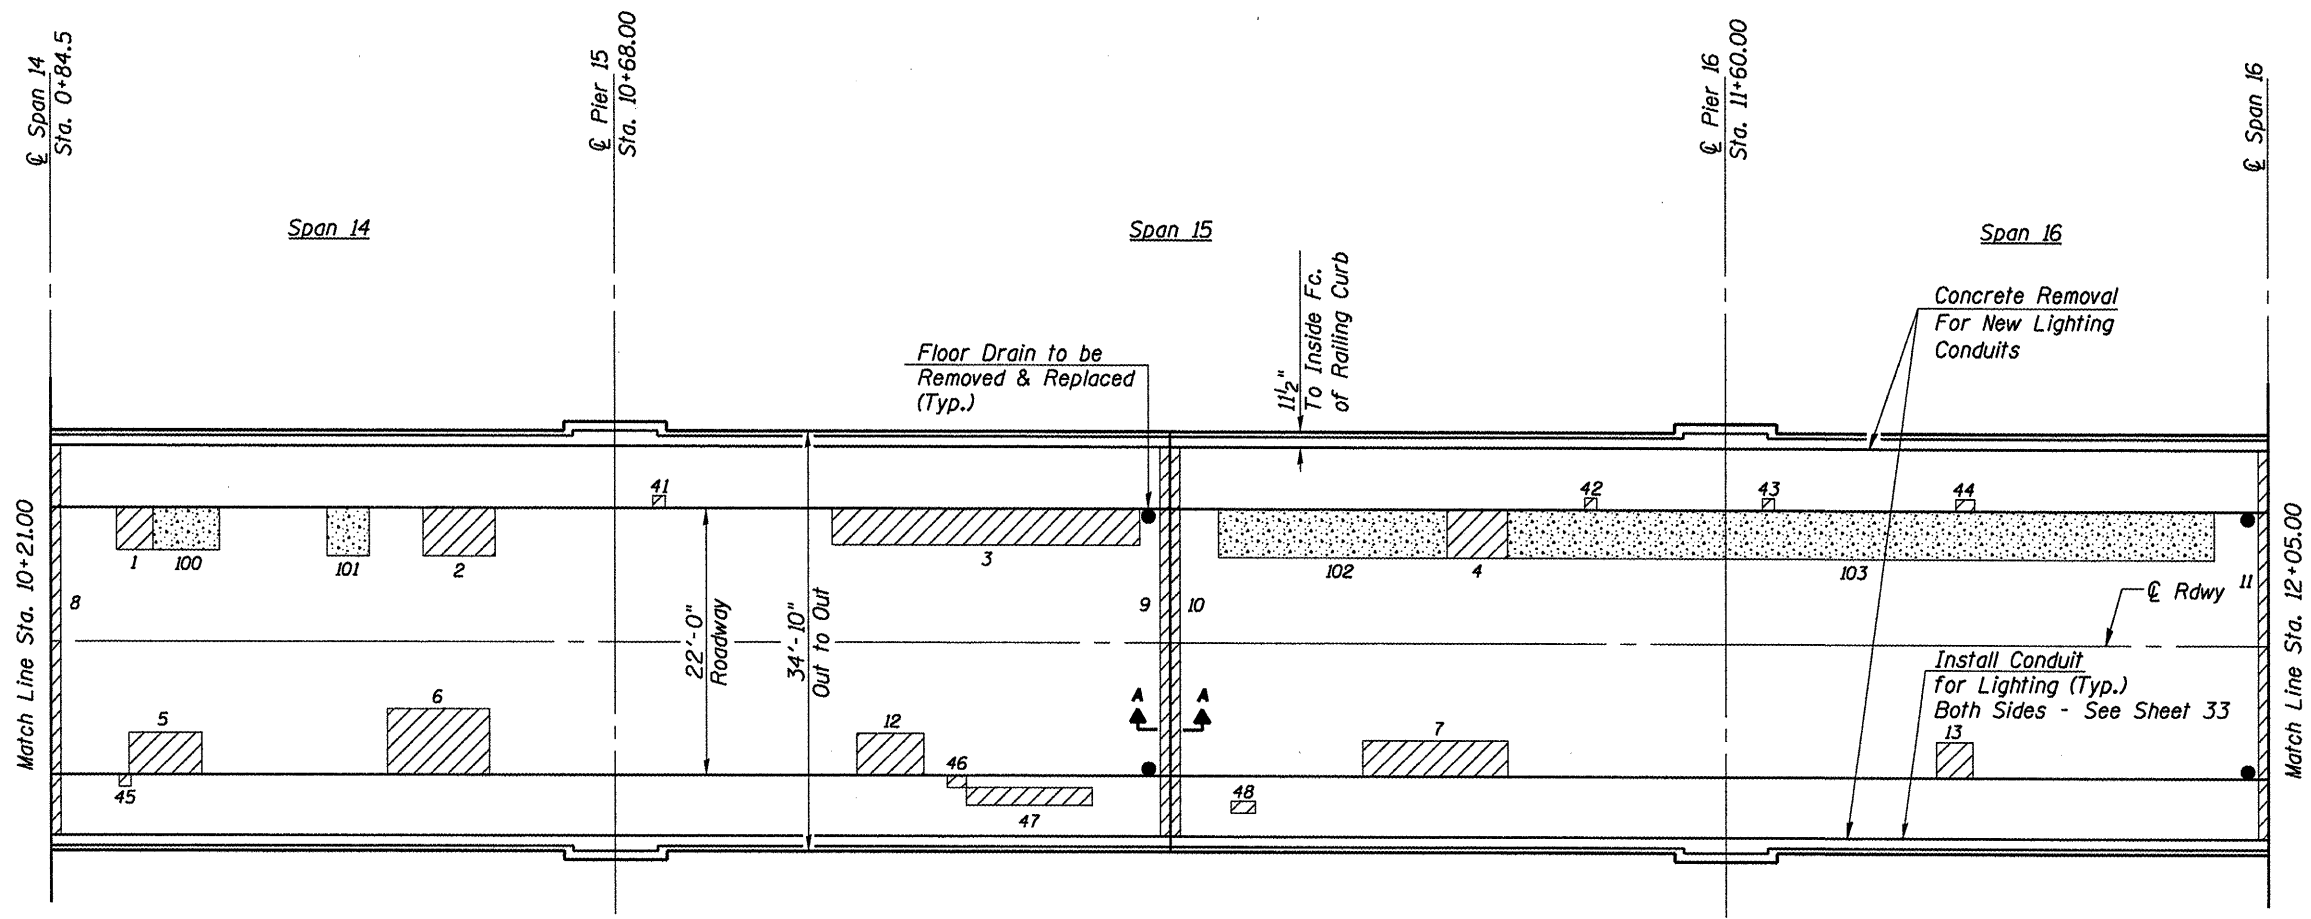
DECK SLAB RESTORATION-ROADWAY SPANS 14-16
DECK SLAB REPAIR (PARTIAL)

DECK SLAB RESTORATION-SIDEWALK SPANS 14-16
DECK SLAB REPAIR (PARTIAL)

POLYMER OVERLAY PRETREATMENT
SPANS 14-16

Date of Deck patching survey = May 27, 2010
The Engineer shall record the actual areas of repair and location on this sheet in order to document as-built conditions for future reference.

EXPANSION JOINT REPAIRS-SPANS 14-16
DECK SLAB REPAIR (PARTIAL)
