STRUCTURAL REPAIR OF CONCRETE
SPAN 8

STRUCTURE REPAIR DETAILS
SPAN 8
VACHEL LINDSAY BRIDGE REHABILITATION
LONG BAY DRIVE OVER LAKE SPRINGFIELD
SPRINGFIELD, ILLINOIS

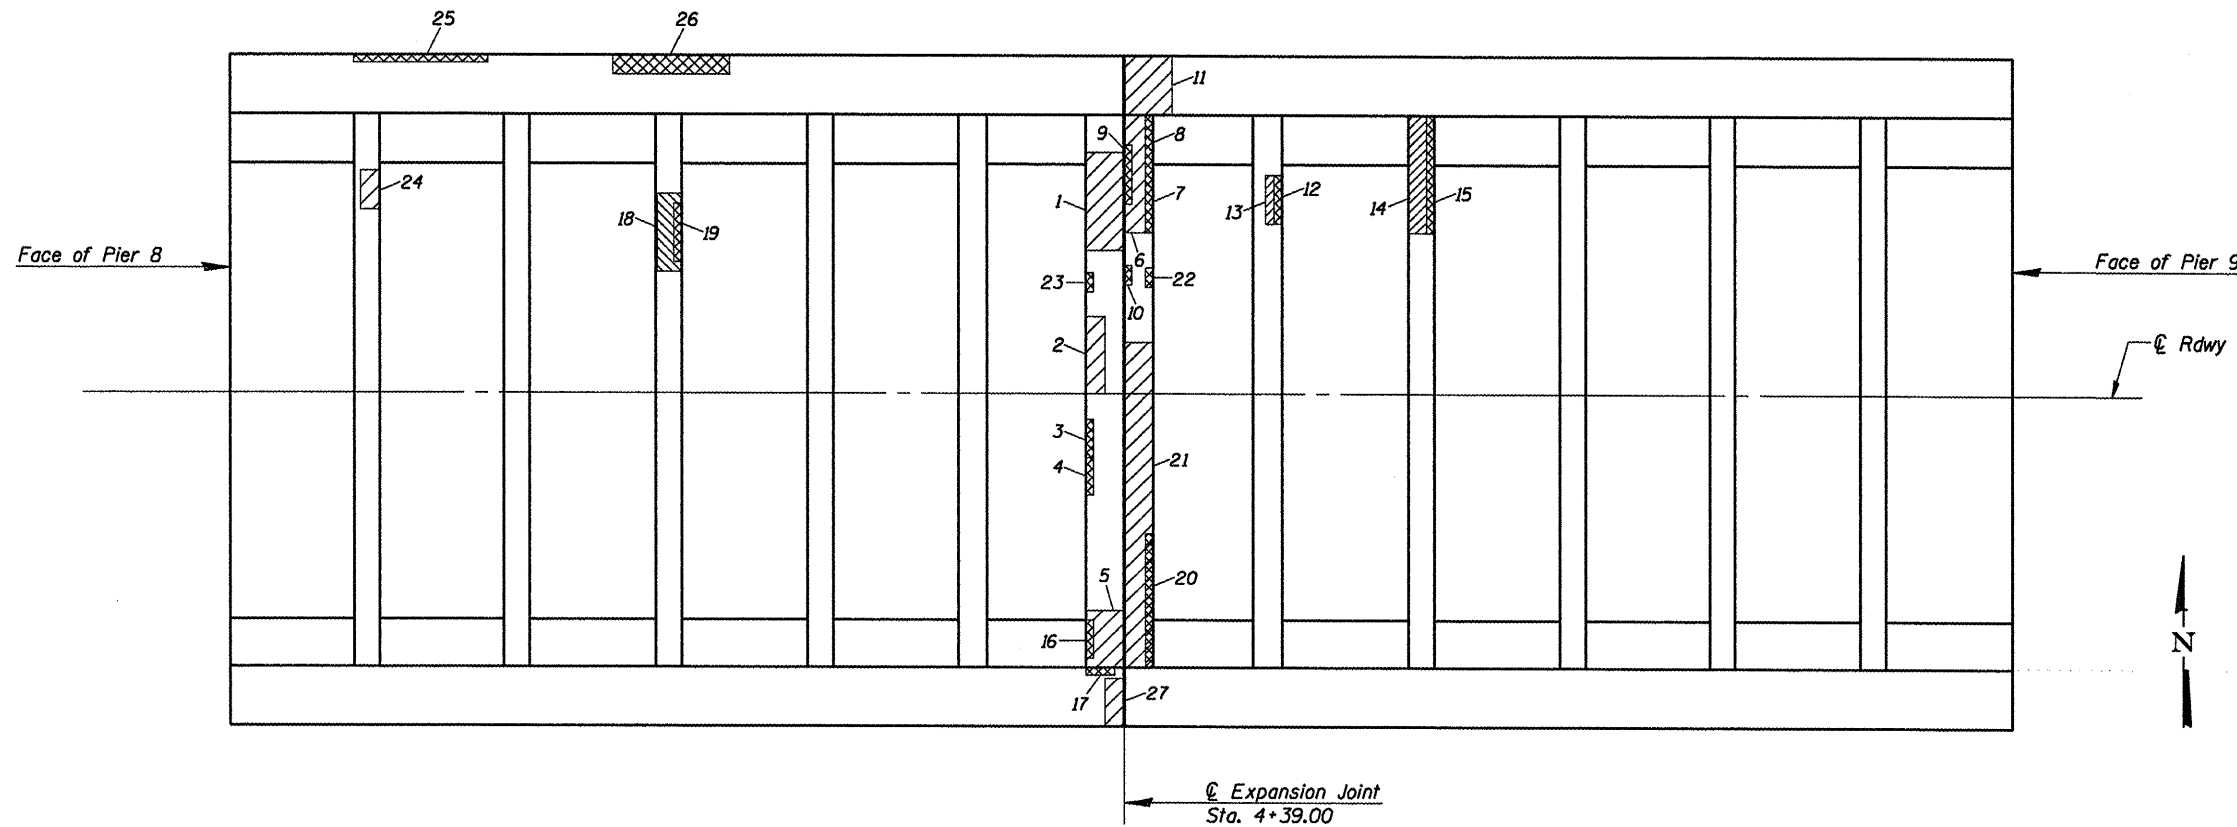
STRUCTURE REPAIR PLAN AT FLOOR BEAMS
(Span 8)

Patch No.	Vert. or Horiz.	Dimensions	Area (SQ. FT.)
1	H	5.00x2.00'	10.00
2	H	4.00x1.00'	4.00
3	V	2.00x1.00'	2.00
4	V	2.00x1.00'	2.00
5	H	3.00x2.00'	6.00
6	H	6.00x1.25'	7.50
7	V	6.00x1.25'	7.50
8	V	3.00x1.00'	3.00
9	V	3.00x1.00'	3.00
10	V	1.00x1.00'	1.00
11	H	2.50x3.50'	8.75
12	V	2.50x0.67'	1.68
13	H	2.50x0.83'	2.08
14	H	6.00x1.25'	7.50
15	V	6.00x1.00'	6.00
16	V	2.00x1.00'	2.00
17	V	1.50x1.50'	2.25
18	H	4.00x1.25'	5.00
19	V	3.00x0.75'	2.25
20	V	7.00x1.25'	8.75
21	H	17.00x1.25'	21.25
22	V	1.00x1.00'	1.00
23	V	1.00x1.00'	1.00
24	H	2.00x1.00'	2.00
25	V	7.00x1.00'	7.00
26	V	6.00x1.00'	6.00
27	H	2.50x1.00'	2.50
Subtotal of Vertical Repair Areas			56.43
Subtotal of Horizontal Repair Areas			76.58
Subtotal			133.01
