STATE OF ILLINOIS
 DEPARTMENT OF TRANSPORTATION

REPAIRS TO - SOUTH ABUTMENT
 STRUCTURE NO. 060-0255

SHEET NO. 16 OF 48 SHEETS

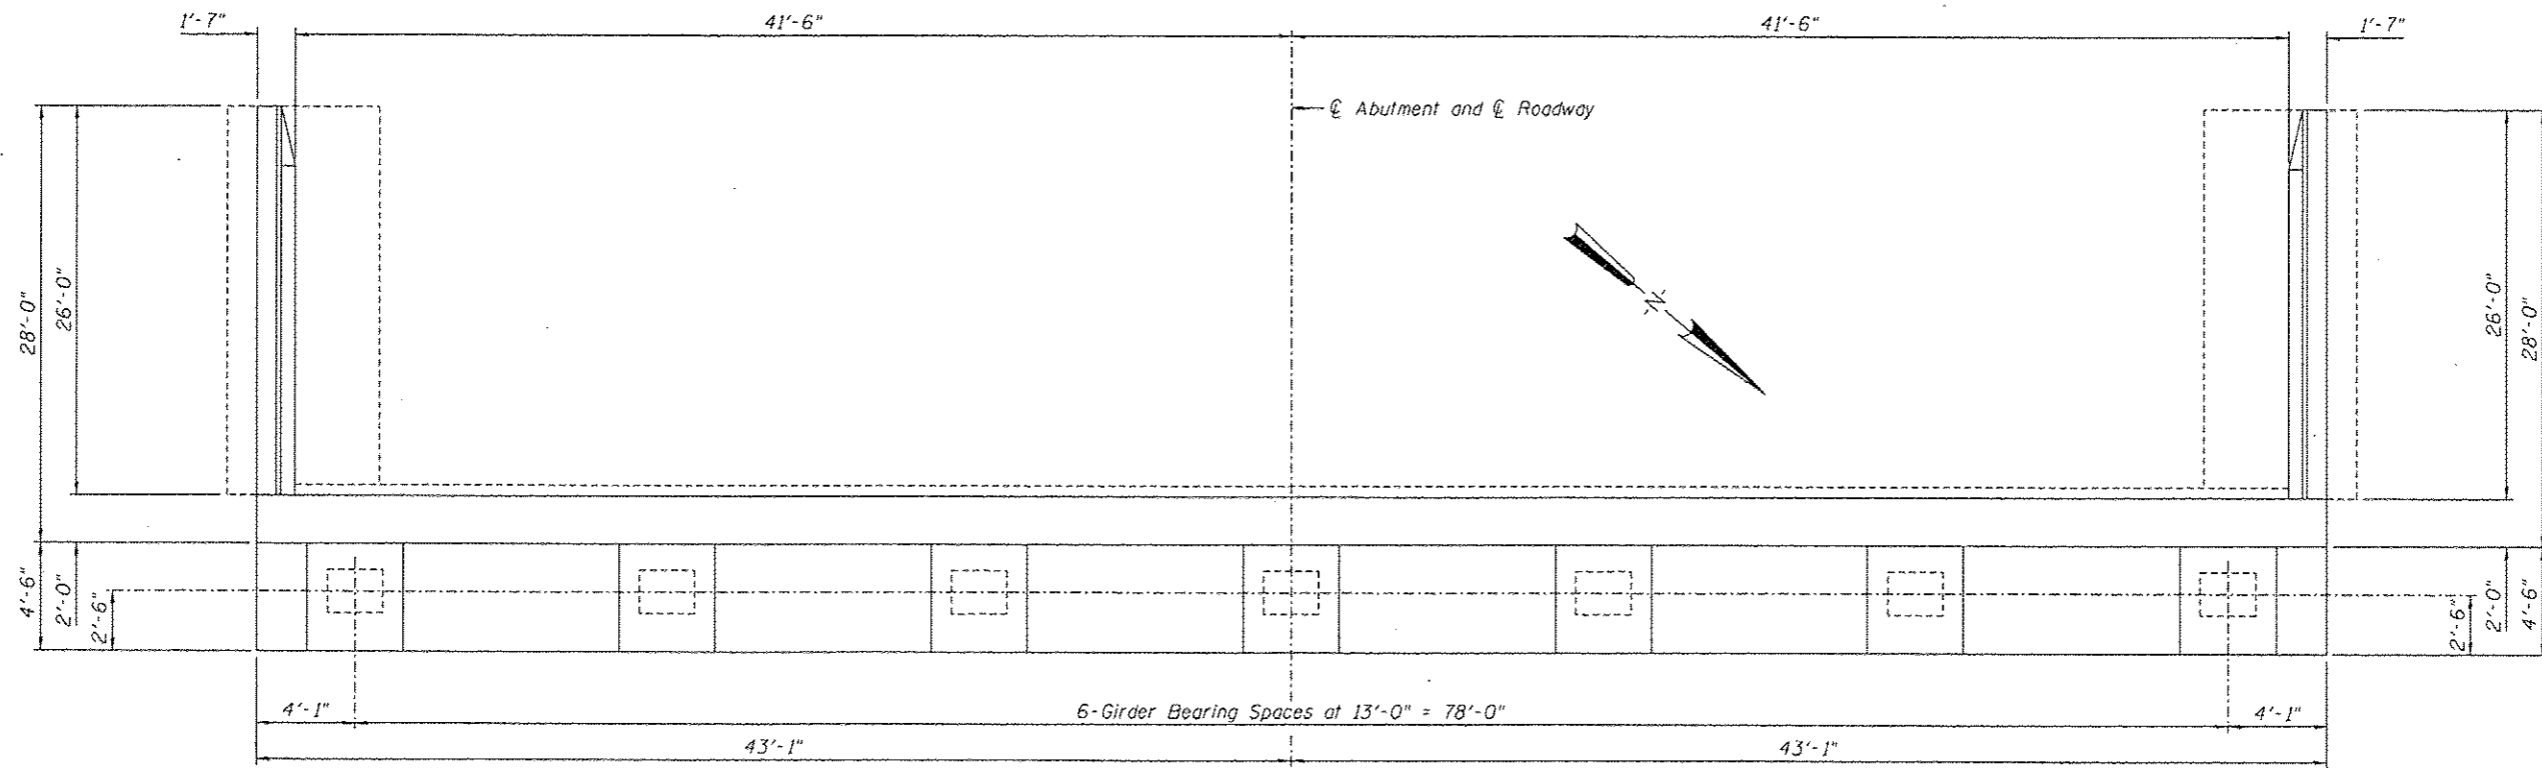
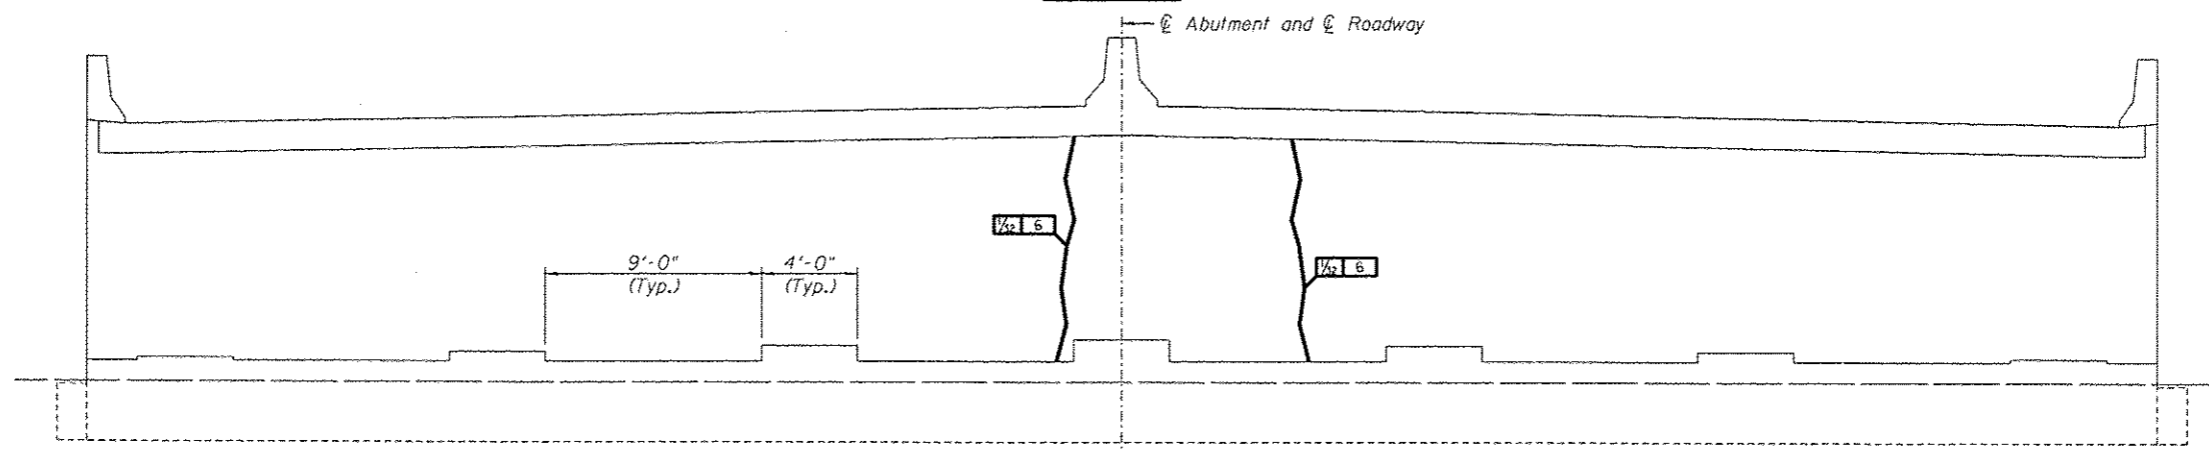
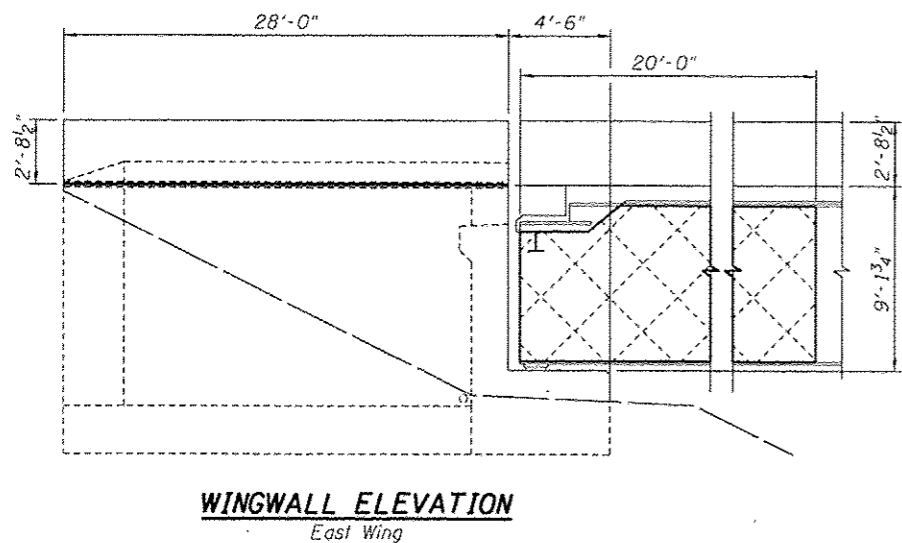
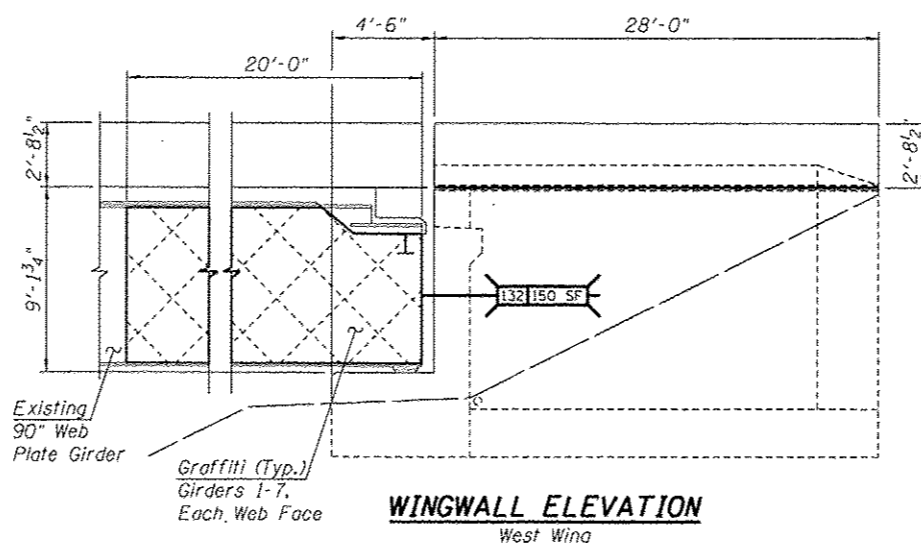
REPAIRS LIST - SOUTH ABUTMENT

Graffiti Removal
 Repair, I.D.
 132 22 SF
 Repair Area Sq. Ft.
GRAFFITI REMOVAL

HL 12 Crack Length (Feet)
 Crack Width (Inches)
CRACKS < 1/16"
 Hairline Cracks (HL) or
 Cracks < 1/16" not to be Sealed.

I.D.	Description	Pay Item	Units	Quantity
132	Beams 1-7, Each Web Face	Graffiti Removal	SQ. YD.	233.3
