F.A.S. RTE.	SECTION	COUNTY	TOTAL SHEETS	SHEET NO.
1279	1(D,E,F,P)I-3	LASALLE	19	14
STA. 23+51		TO STA. 35+09		
FED. ROAD DIST. NO. _		ILLINOIS	NON-FED. AID PROJECT

ILLINOIS DEPARTMENT OF TRANSPORTATION
DECK PATCHING SURVEY
APPROACH SPANS
 EXISTING S.N. 050-0088
 IL 178 OVER ILLINOIS RIVER
 STATION 29+30
 SCALE: VERT. _____
 HORIZ. _____
 DATE 12/08/04
 DRAWN BY RLW
 CHECKED BY _____

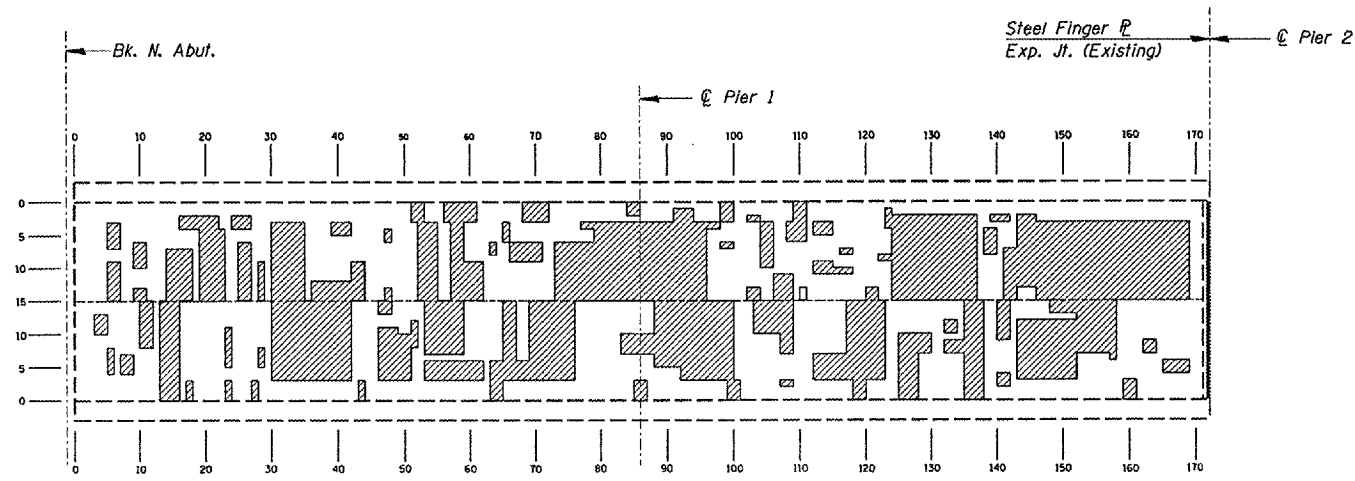
NORTH APPROACH PLAN

Hatched areas represent delaminated areas.

Deck Slab Repair (Partial) has been estimated at 19% of total deck area = 635 square yards.

Deck Slab Repair (Full Depth) has been estimated at 2% of total deck area = 70 square yards.

The Engineer shall sound the entire deck surface to determine exact locations and quantities of "Deck Slab Repair".
