F.A. RTE.	SECTION	COUNTY	TOTAL SHEETS	SHEET NO.
412	(50-6VB)I	LASALLE	25	13
FED. ROAD DIST. NO.		ILLINOIS	NON-FED. AID PROJECT

ILLINOIS DEPARTMENT OF TRANSPORTATION
FORMED CONCRETE REPAIR
PPC DECK BEAM
 S.N. 050-0167 (SB)
 F.A.I. 412 OVER C. & N.W. RAILROAD
 SECTION (50-6VB)I-1
 STA. 1429 + 12.74

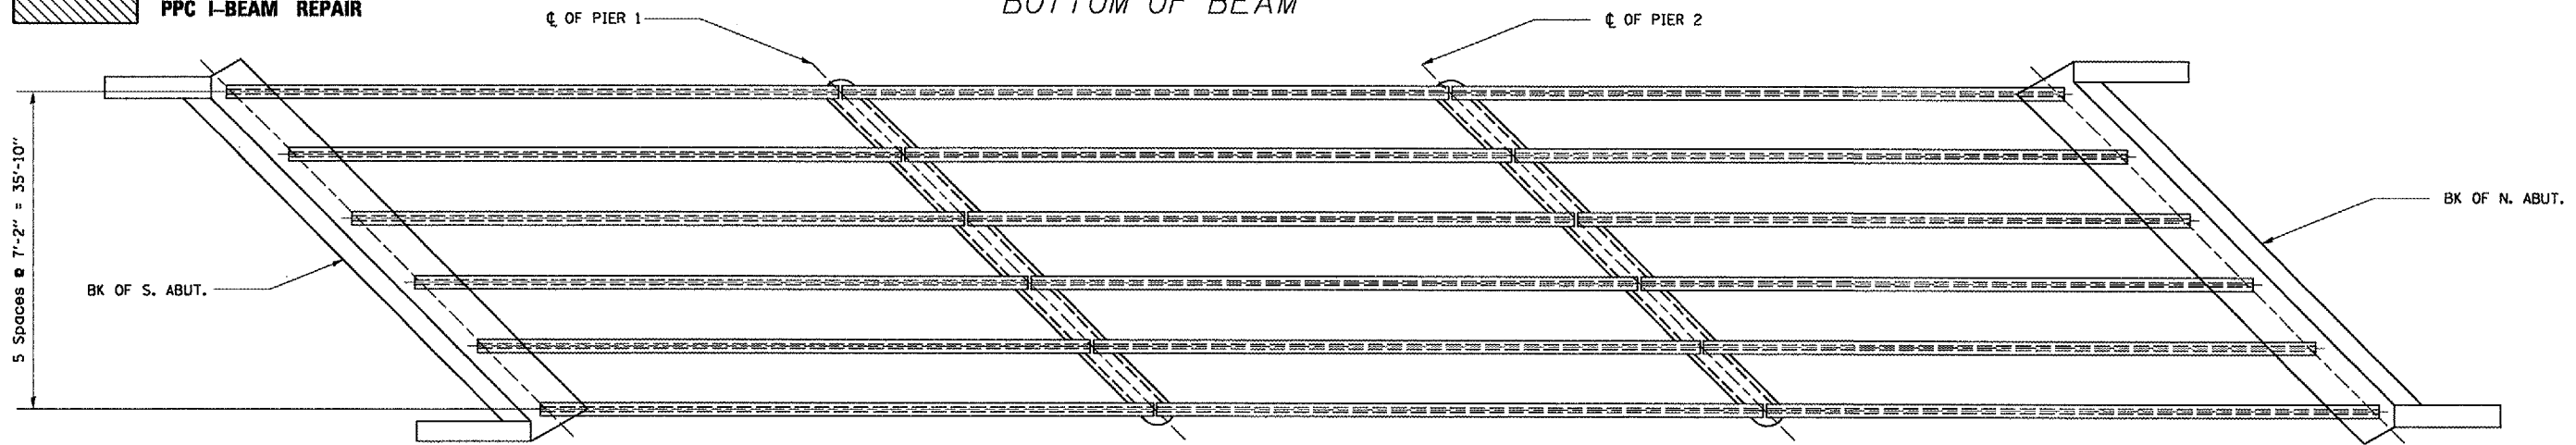
WEST FACIA BEAM
*BOTTOM OF BEAM

- POLYMER MODIFIED PORTLAND CEMENT MORTAR
- PPC I-BEAM REPAIR

*Although the damage is shown across the entire flange width, the actual area to be repaired may be limited to the corner of the flange at some locations.

Item	Unit	Total
PPC I-Beam Repairs	L.S.	1
Polymer Modified Portland Cement Mortar	Sq. Ft.	97
