**DECK PATCHING PLAN**  
**IL 106 OVER HADLEY CREEK**  
**SN 075-0004**

SHEET NO. 5	F.A.P. RTE.	SECTION	COUNTY	TOTAL SHEETS	SHEET NO.
	751	D6 BRIDGE REPAIR 2009	PIKE	22	22
5 SHEETS	CONTRACT NO. 72D44				
FED. ROAD DIST. NO.		ILLINOIS FED. AID PROJECT

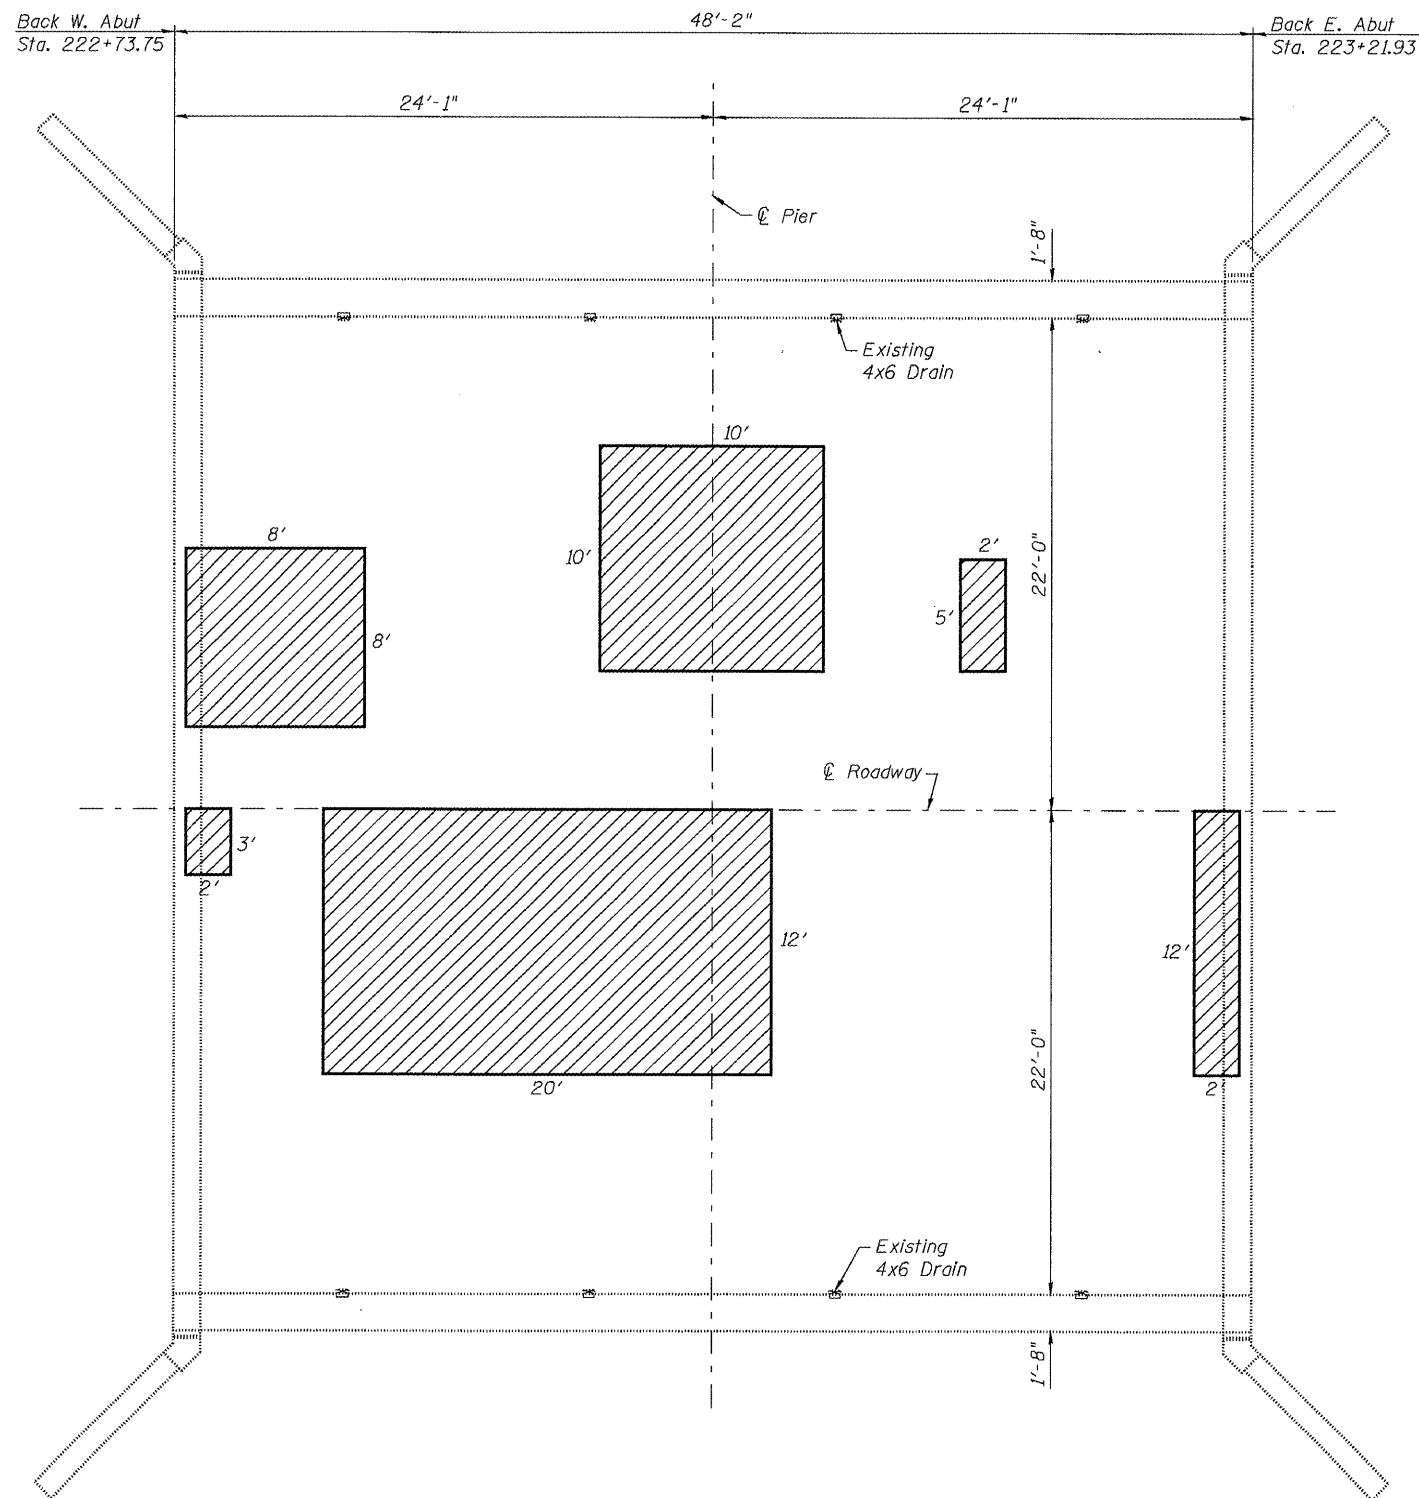
Deck Slab Repair (Partial Depth) - 50 SQ. YD.  
 Note: Partial Depth Repair shall be achieved by bridge deck hydro-scarification and filled with microsilica concrete overlay. Cast included in "BRIDGE DECK HYDRO-SCARIFICATION 2 1/2" " and "BRIDGE DECK MICROSILICA CONCRETE OVERLAY 2 1/4" "
