EXISTING CULVERT REPAIR DETAILS STRUCTURE NO. 025-2017

de la companya de la			
SHEET NO. 7		F.A.I. RTE.	SECTION	COUNTY	TOTAL SHEETS	SHEE NO.
		70	(25-3)BY	EFFINGHAM	1416	465
8	SHEETS	-	SN 025-2017	CONTRACT	NO. 74	296
		FED. RO	DAD DIST. NO. 7 ILLINOIS FED. A	ID PROJECT

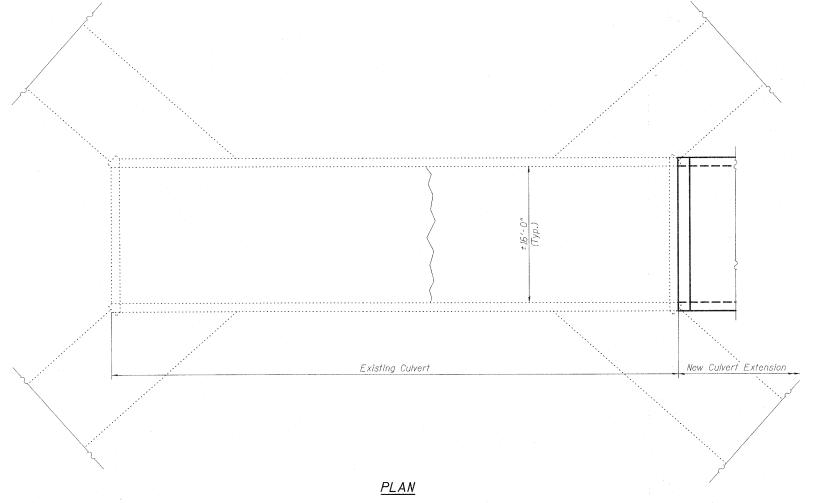
(Bottom of Top Slab)

Indicates Epoxy Crack Injection Required.

Note:
The limits of Epoxy Crack Injection shown are approximate. The limits of Crack Injection may vary in the field. Changes in the quantity of Epoxy Crack Injection shall be approved by the Engineer.
