**NORTH ABUTMENT & RETAINING WALL  
FORM LINER DETAILS  
ALTON PEDESTRIAN WALKWAY OVER  
UNION PACIFIC RAILROAD, NORFOLK  
SOUTHERN RAILROAD AND US ROUTE 67  
SECTION 06-00224-00-BR  
MADISON COUNTY  
STA. 2+42.54  
STRUCTURE NO. 060-6111**

ALTON, ILLINOIS  
PEDESTRIAN OVERPASS AT LANGDON ST.

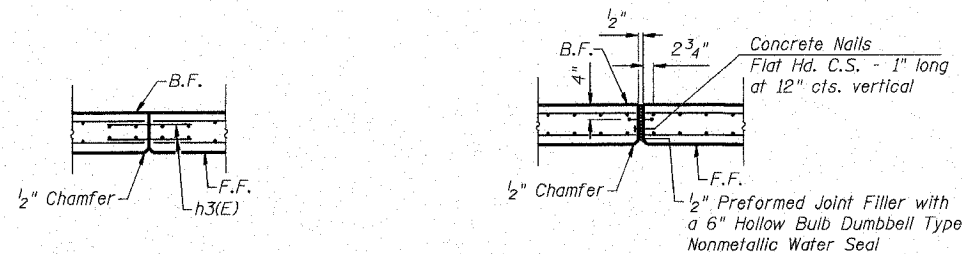
**CONTROL JOINT**

**EXPANSION JOINT**
