EXISTING TYPICAL SECTION

PROPOSED TYPICAL SECTION

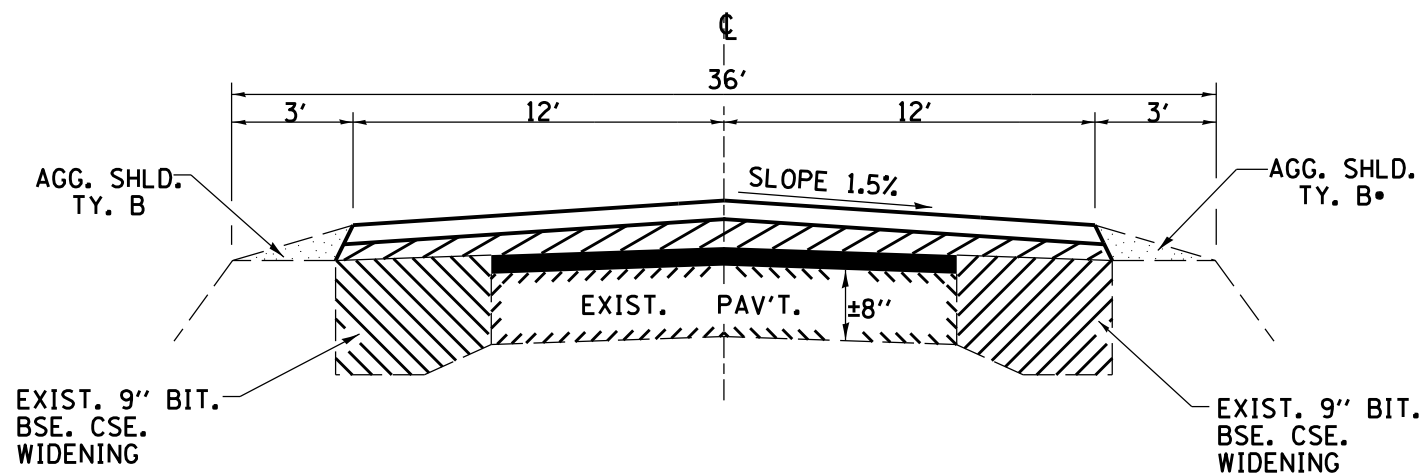
•PORTIONS OF THIS SHOULDER ARE DETERIORATED HMA SHOULDER

STA. 174+24 TO STA. 333+00
