**STATE OF ILLINOIS  
DEPARTMENT OF TRANSPORTATION**

**PIER 2 REPAIRS  
STRUCTURE NO. 016-0713**

SHEET NO. S17 OF S21 SHEETS

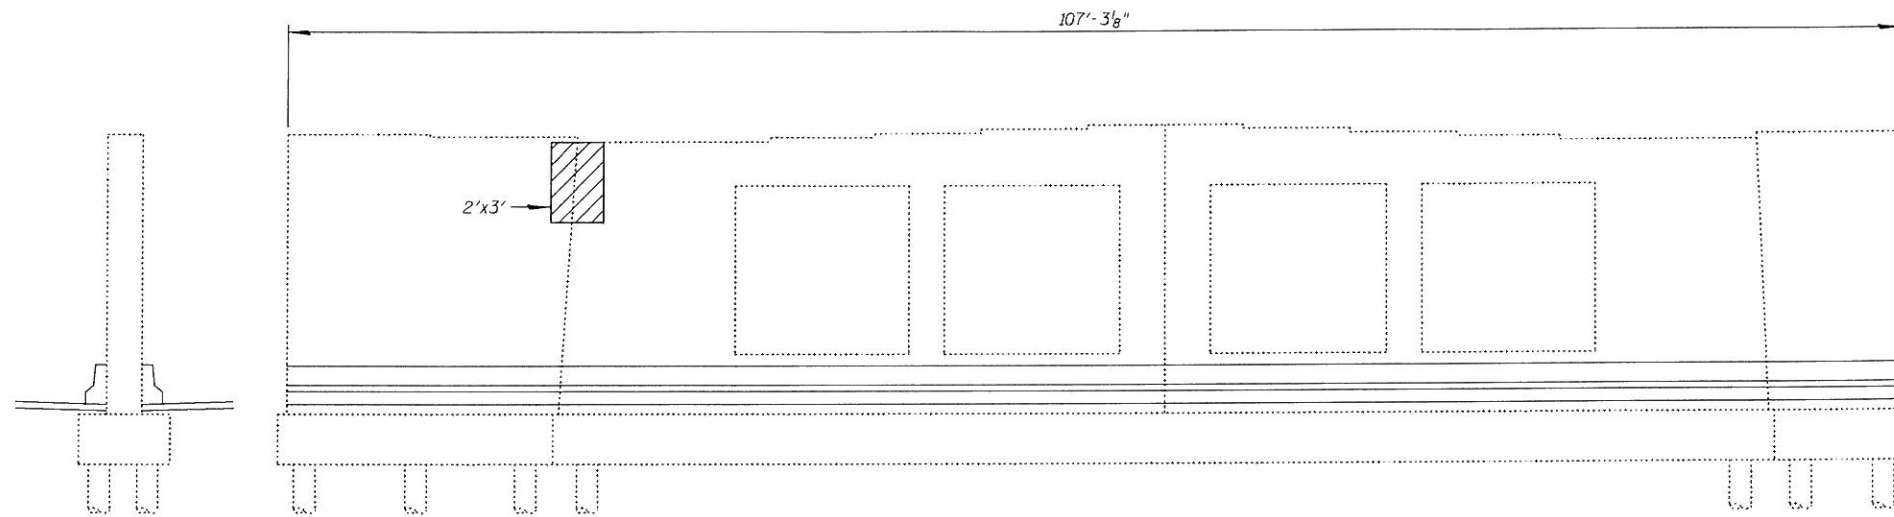
**PIER 2**  
(Looking West)

Structural Repair of Concrete  
 (Depth Equal To or Less Than 5 Inches)

Cracks (perform Epoxy Crack Injection)
