STATE OF ILLINOIS DEPARTMENT OF TRANSPORTATION

TRUSS REPAIRS (NORTHEAST) STRUCTURE NO. 016-2445

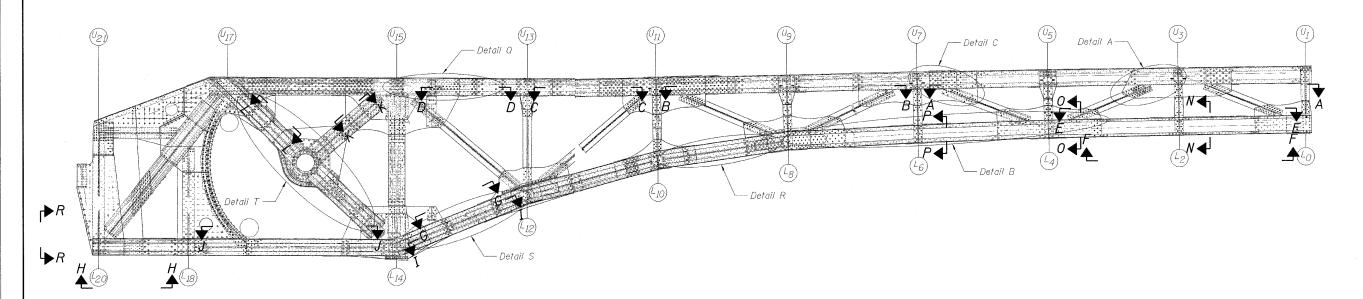
INSIDE TRUSS NORTHEAST LEAF

Looking South

Provide temporary bracing and supports to maintain structural integrity during rehabilitation.

Cost included in the cost of "Structural Steel Repair". For inside truss southwest leaf section and details

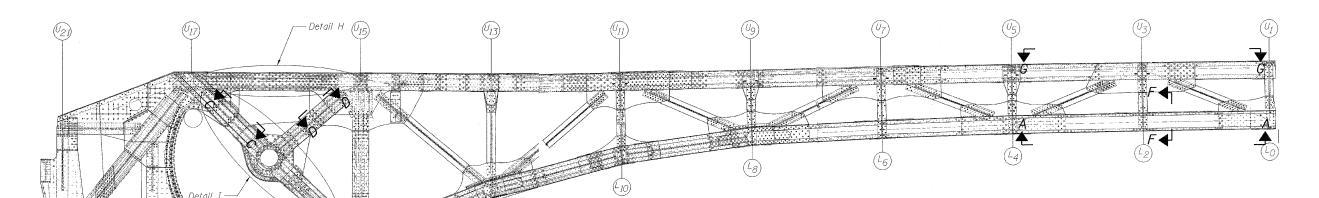
OUTSIDE TRUSS NORTHEAST LEAF

Looking South
