**STATE OF ILLINOIS**  
**DEPARTMENT OF TRANSPORTATION**

**PIERS 7 AND 8 REPAIR DETAILS**  
**STRUCTURE NO. 016-0486**

SHEET NO. SG71 OF SG100 SHEETS

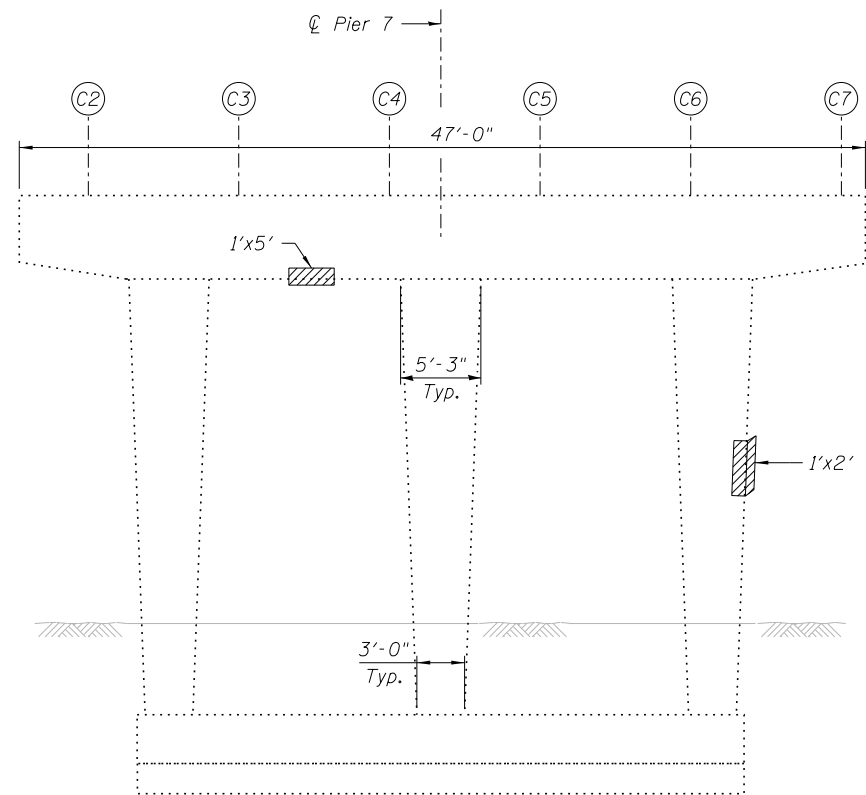
**PIER 7**  
Looking West

Structural Repair of Concrete  
(Depth equal to or less than 5 inches)
