**STATE OF ILLINOIS**  
**DEPARTMENT OF TRANSPORTATION**

**PIER 1 REPAIR DETAILS**  
**STRUCTURE NO. 016-0587**  
SHEET NO. 30 OF 42 SHEETS

F.A.I. RTE. = 55	SECTION = 22-1HB-R	COUNTY = COOK/DUPAGE	TOTAL SHEETS = 161	SHEET NO. = 118
CONTRACT NO. 60K77				
ILLINOIS FED. AID PROJECT

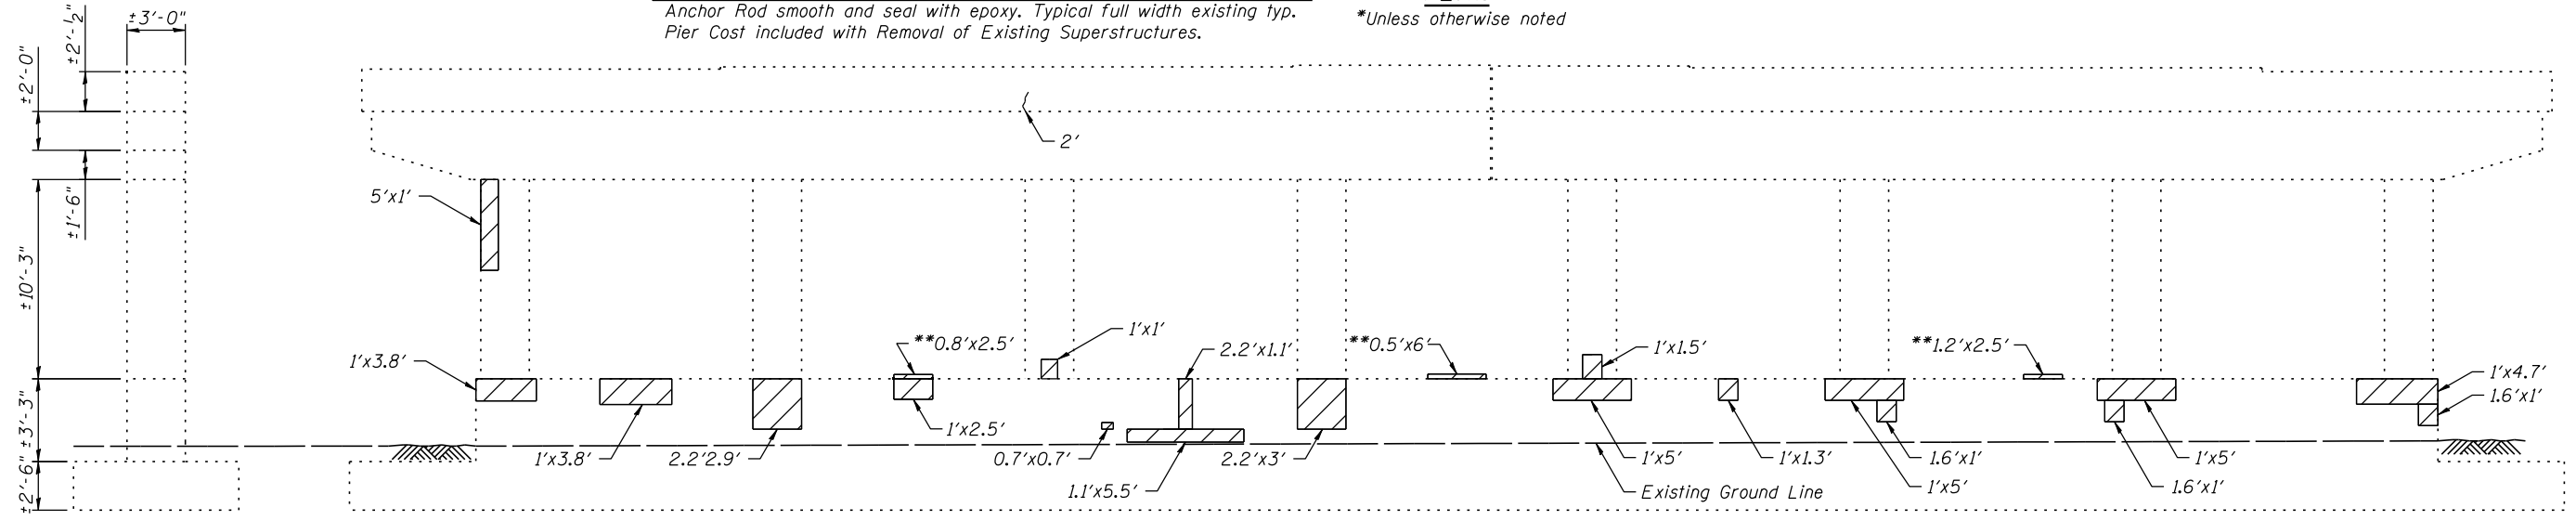
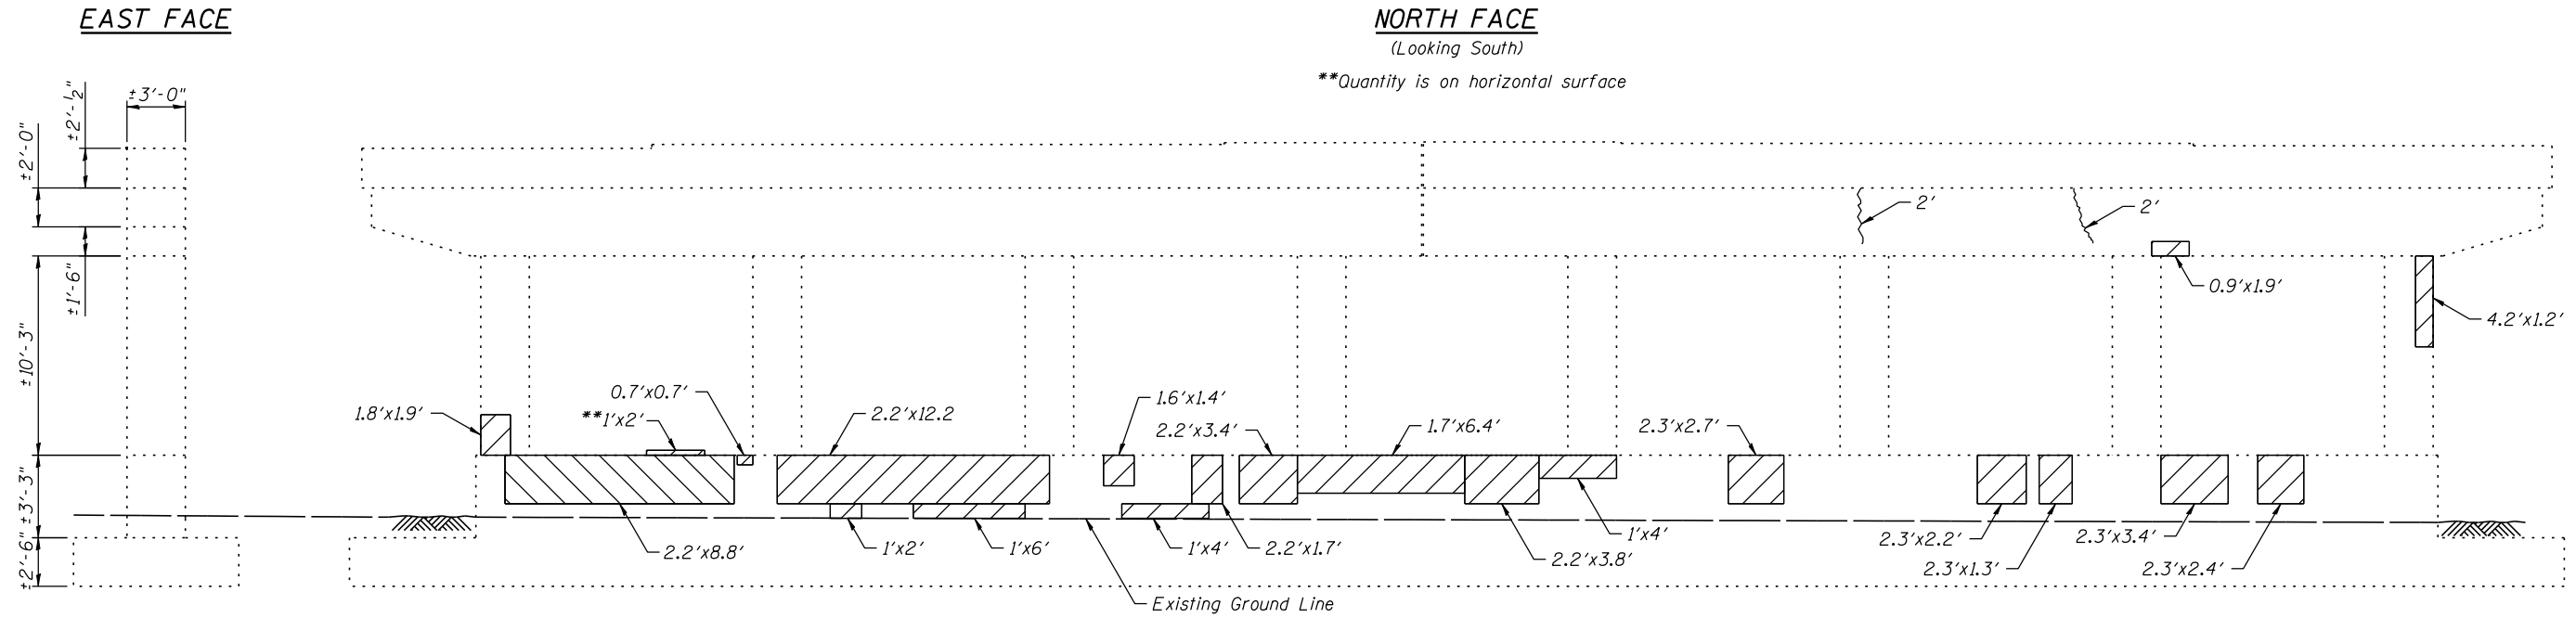
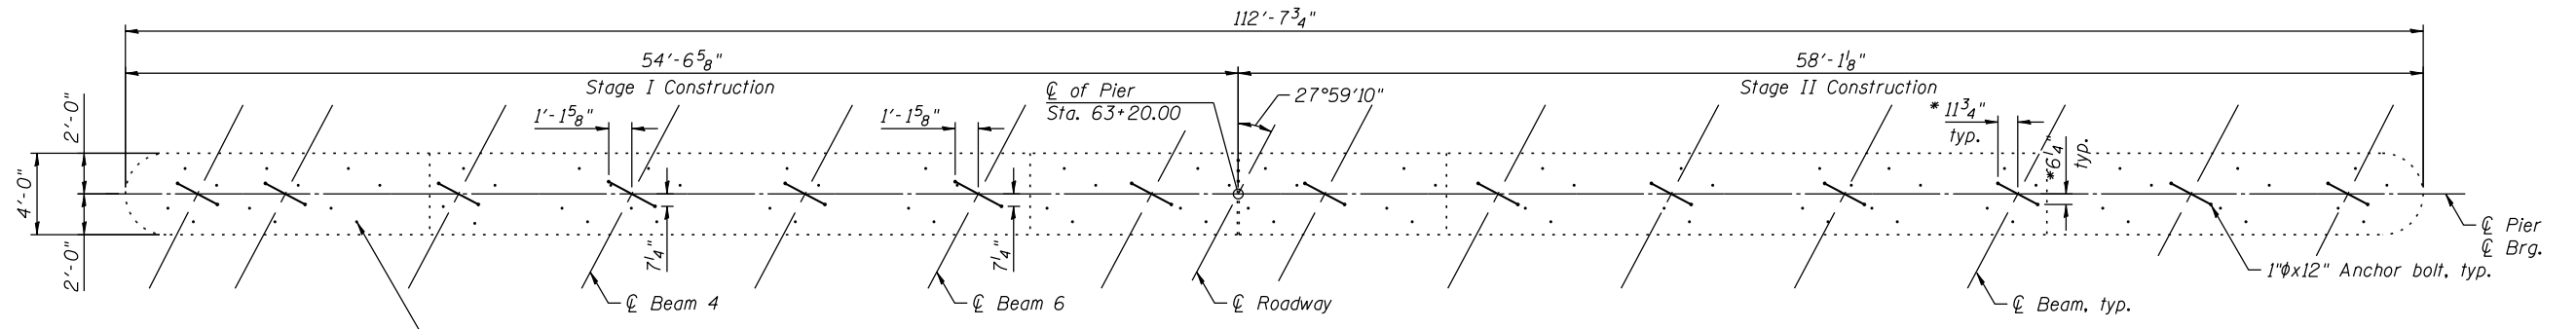
**Note:**  
Repairs shown are based upon observations performed in 2010 and are for bidding purposes only. Actual areas to be repaired shall be determined by the Engineer in the field at the time of construction. Quantities have been adjusted to account for the time difference.
