**STATE OF ILLINOIS  
DEPARTMENT OF TRANSPORTATION**

**ABUTMENT REPAIRS  
STRUCTURE NO. 082-0196**

SHEET NO. 11 OF 11 SHEETS

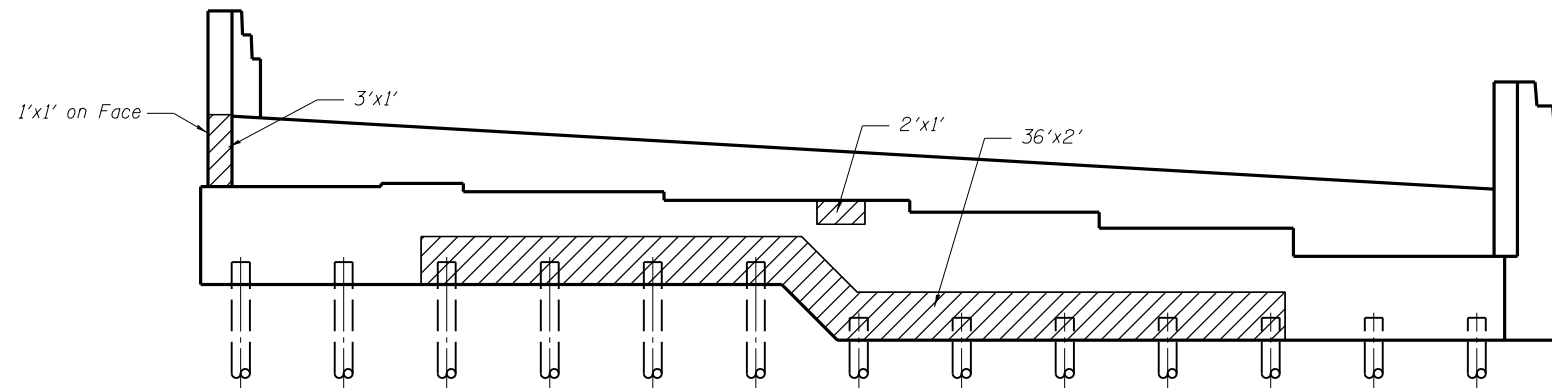
**SOUTH ABUTMENT**  
(Looking South)

Area of Structural Concrete Repair

Item	Unit	Total
Structural Repair of Concrete (Depth <= 5")	Sq. Ft.	128
