STRUCTURAL REPAIR OF CONCRETE AT PIERS
SN 071-0062 (S.B.) & 0063 (N.B.)

F.A.I. RTE.	SECTION	COUNTY	TOTAL SHEETS	SHEET NO.
39	D2 DECK REPAIR 2013-1	OGLE	32	26A
ILLINOIS FED. AID PROJECT			CONTRACT NO. 64HT3

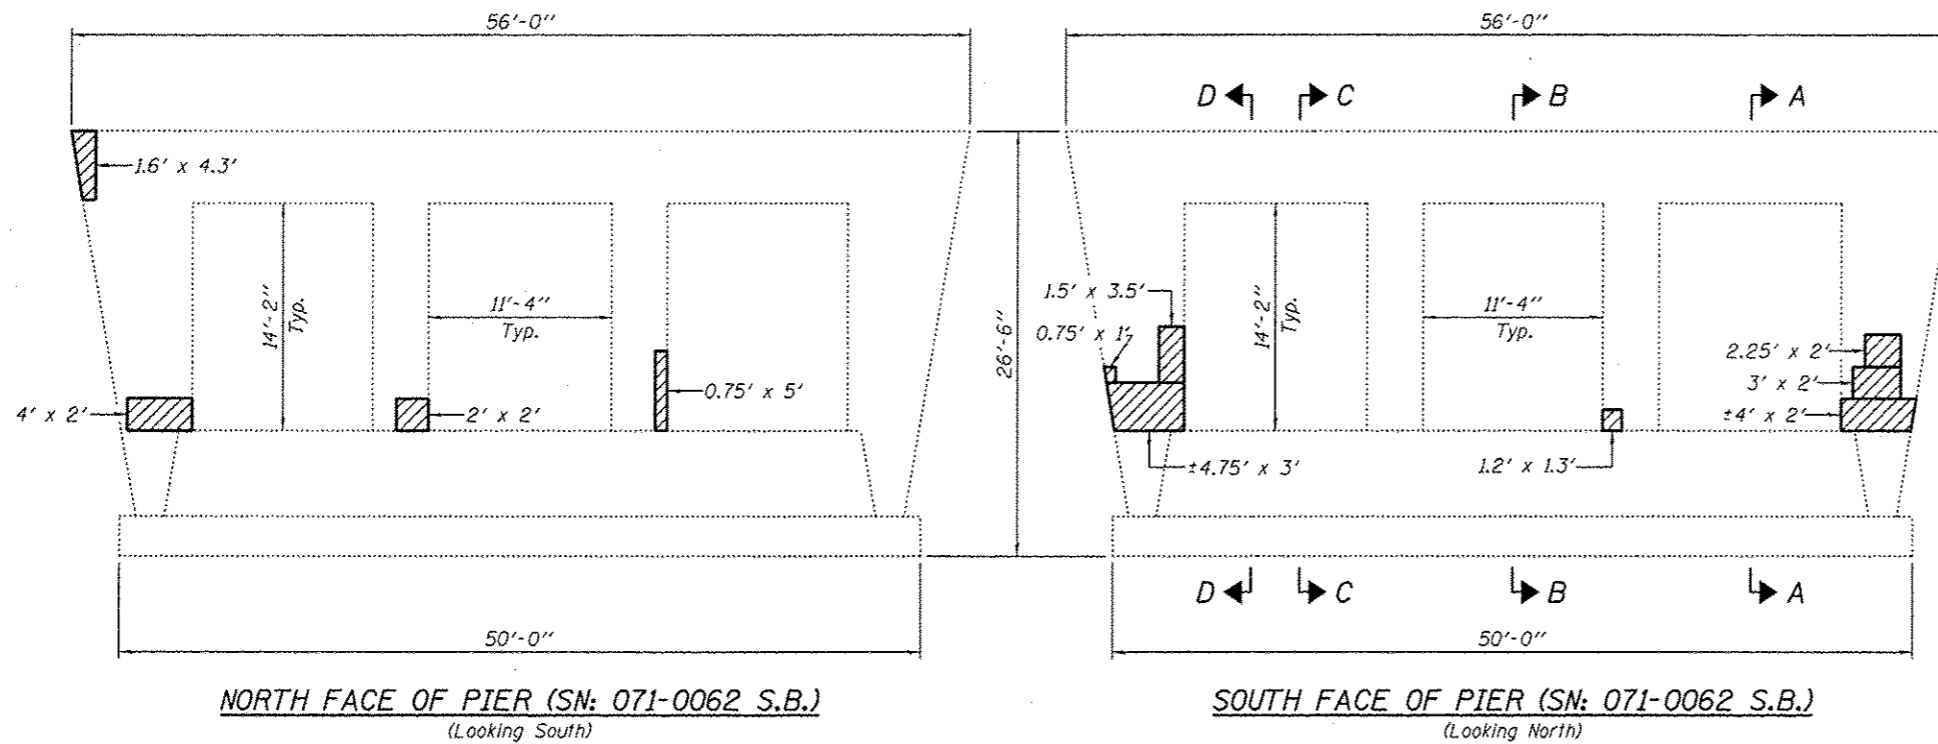
NORTH FACE OF PIER (SN: 071-0062 S.B.)
(Looking South)

SOUTH FACE OF PIER (SN: 071-0062 S.B.)
(Looking North)
