SUPERSTRUCTURE
WEST BOUND LANES
 STRUCTURE NO. 081-0019 (W.B.)
 FAI ROUTE 280 Section D2 Br Wear Surf I-280
 Rock Island County
 Sta. 232+86.50

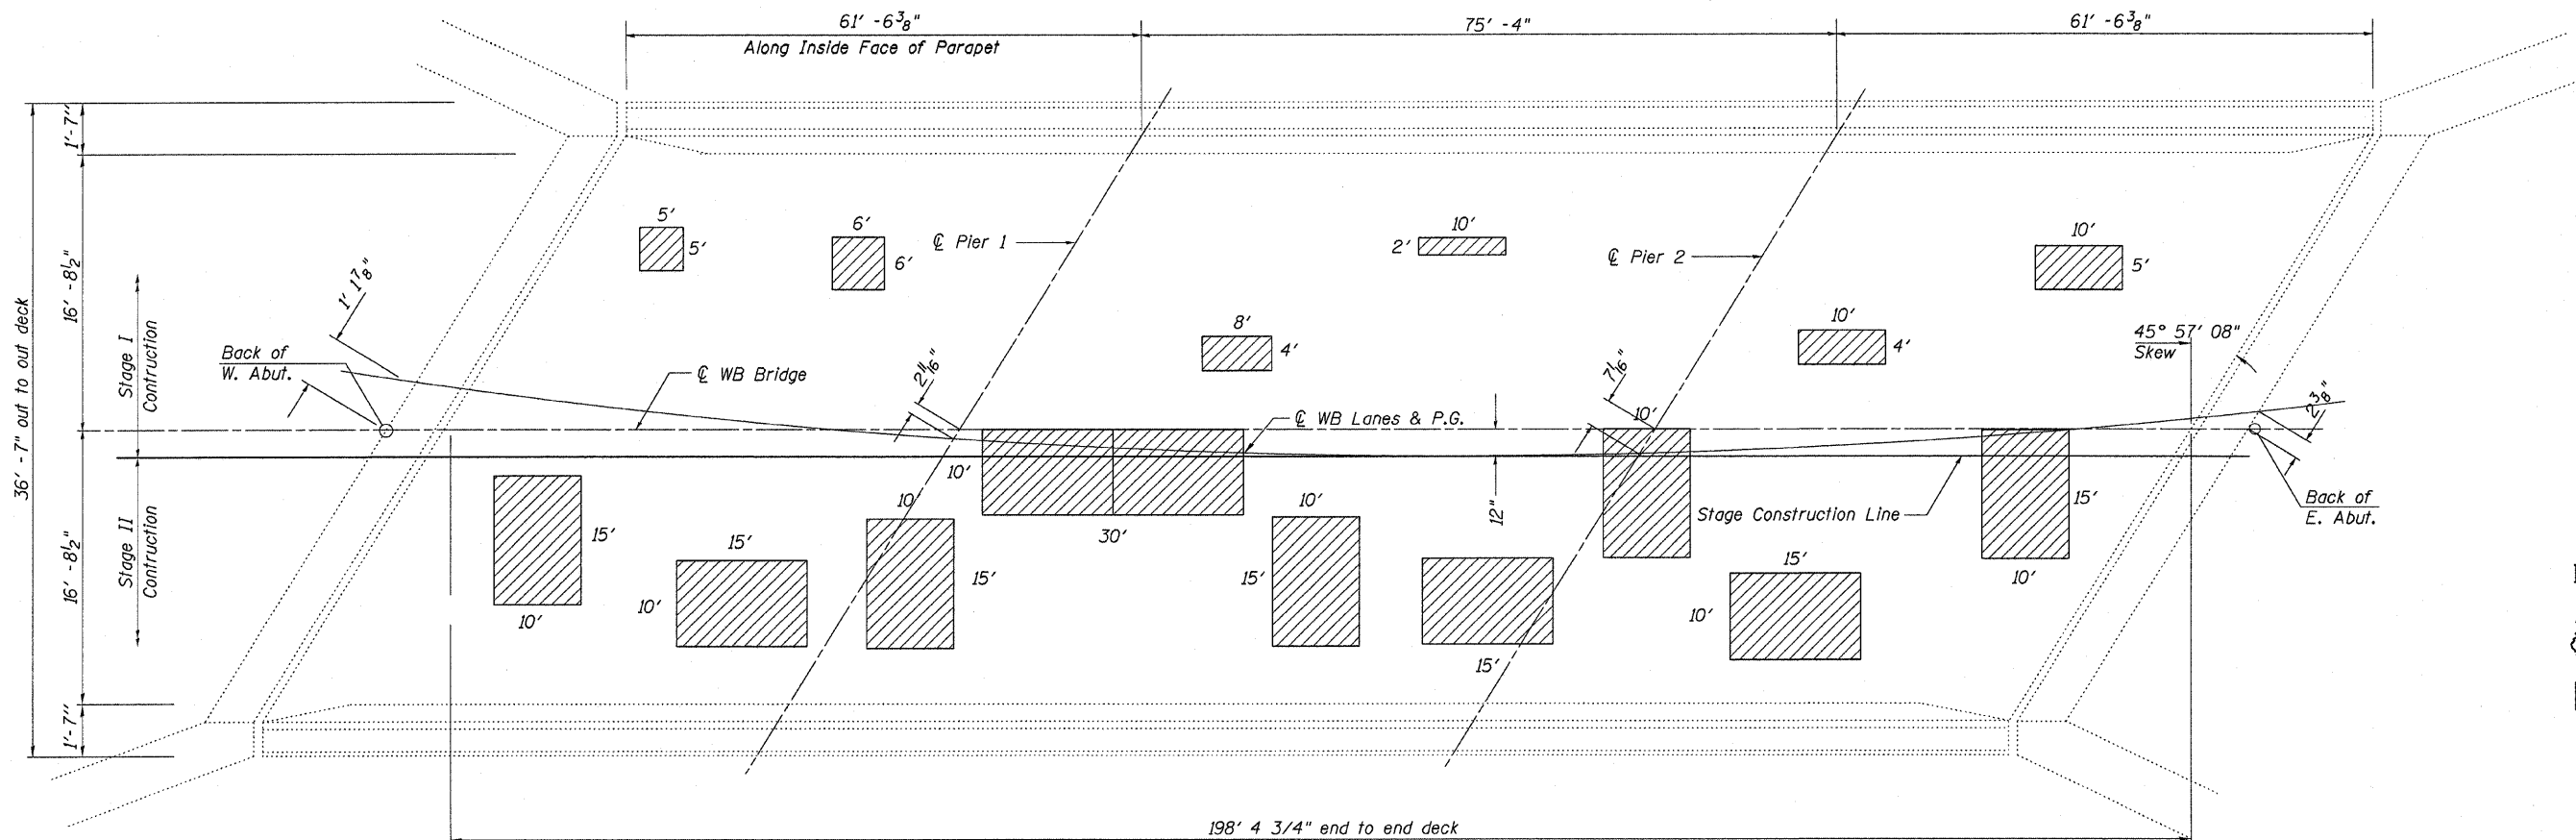
Legend
 Potential Deck Slab Repair (Partial)
 Date of Survey 10/2009

PLAN
 Areas shown for repair are potential areas of deck slab repair. Actual locations and quantities to be determined in the field. Resident Engineer to contact District Bridge Office for assistance with locating patches.
