DECK SLAB REPAIRS
 1ST AVENUE (IL. 171) OVER
 DES PLAINES RIVER
 COOK COUNTY
 STATION 50+80.00
 STRUCTURE NO. 016-0483 (S.B.) &
 STRUCTURE NO. 016-0985 (N.B.)

FILE NAME =	USER NAME =	DESIGNED - EM	REVISED -	STATE OF ILLINOIS DEPARTMENT OF TRANSPORTATION	DECK SLAB REPAIR PLAN STRUCTURE NO. 016-0483 (S.B.) & 016-0985 (N.B.)	F.A.P. RTE. 373	SECTION 2011-077-BR	COUNTY COOK	TOTAL SHEETS 32	SHEET NO. 19		
PLDT SCALE =	DRAWN - DR/PRH	REVISED -	CONTRACT NO. 60R03									
PLDT DATE =	CHECKED - JMH	REVISED -	ILLINOIS FED. AID PROJECT									
SHEET NO. 55 OF 513 SHEETS

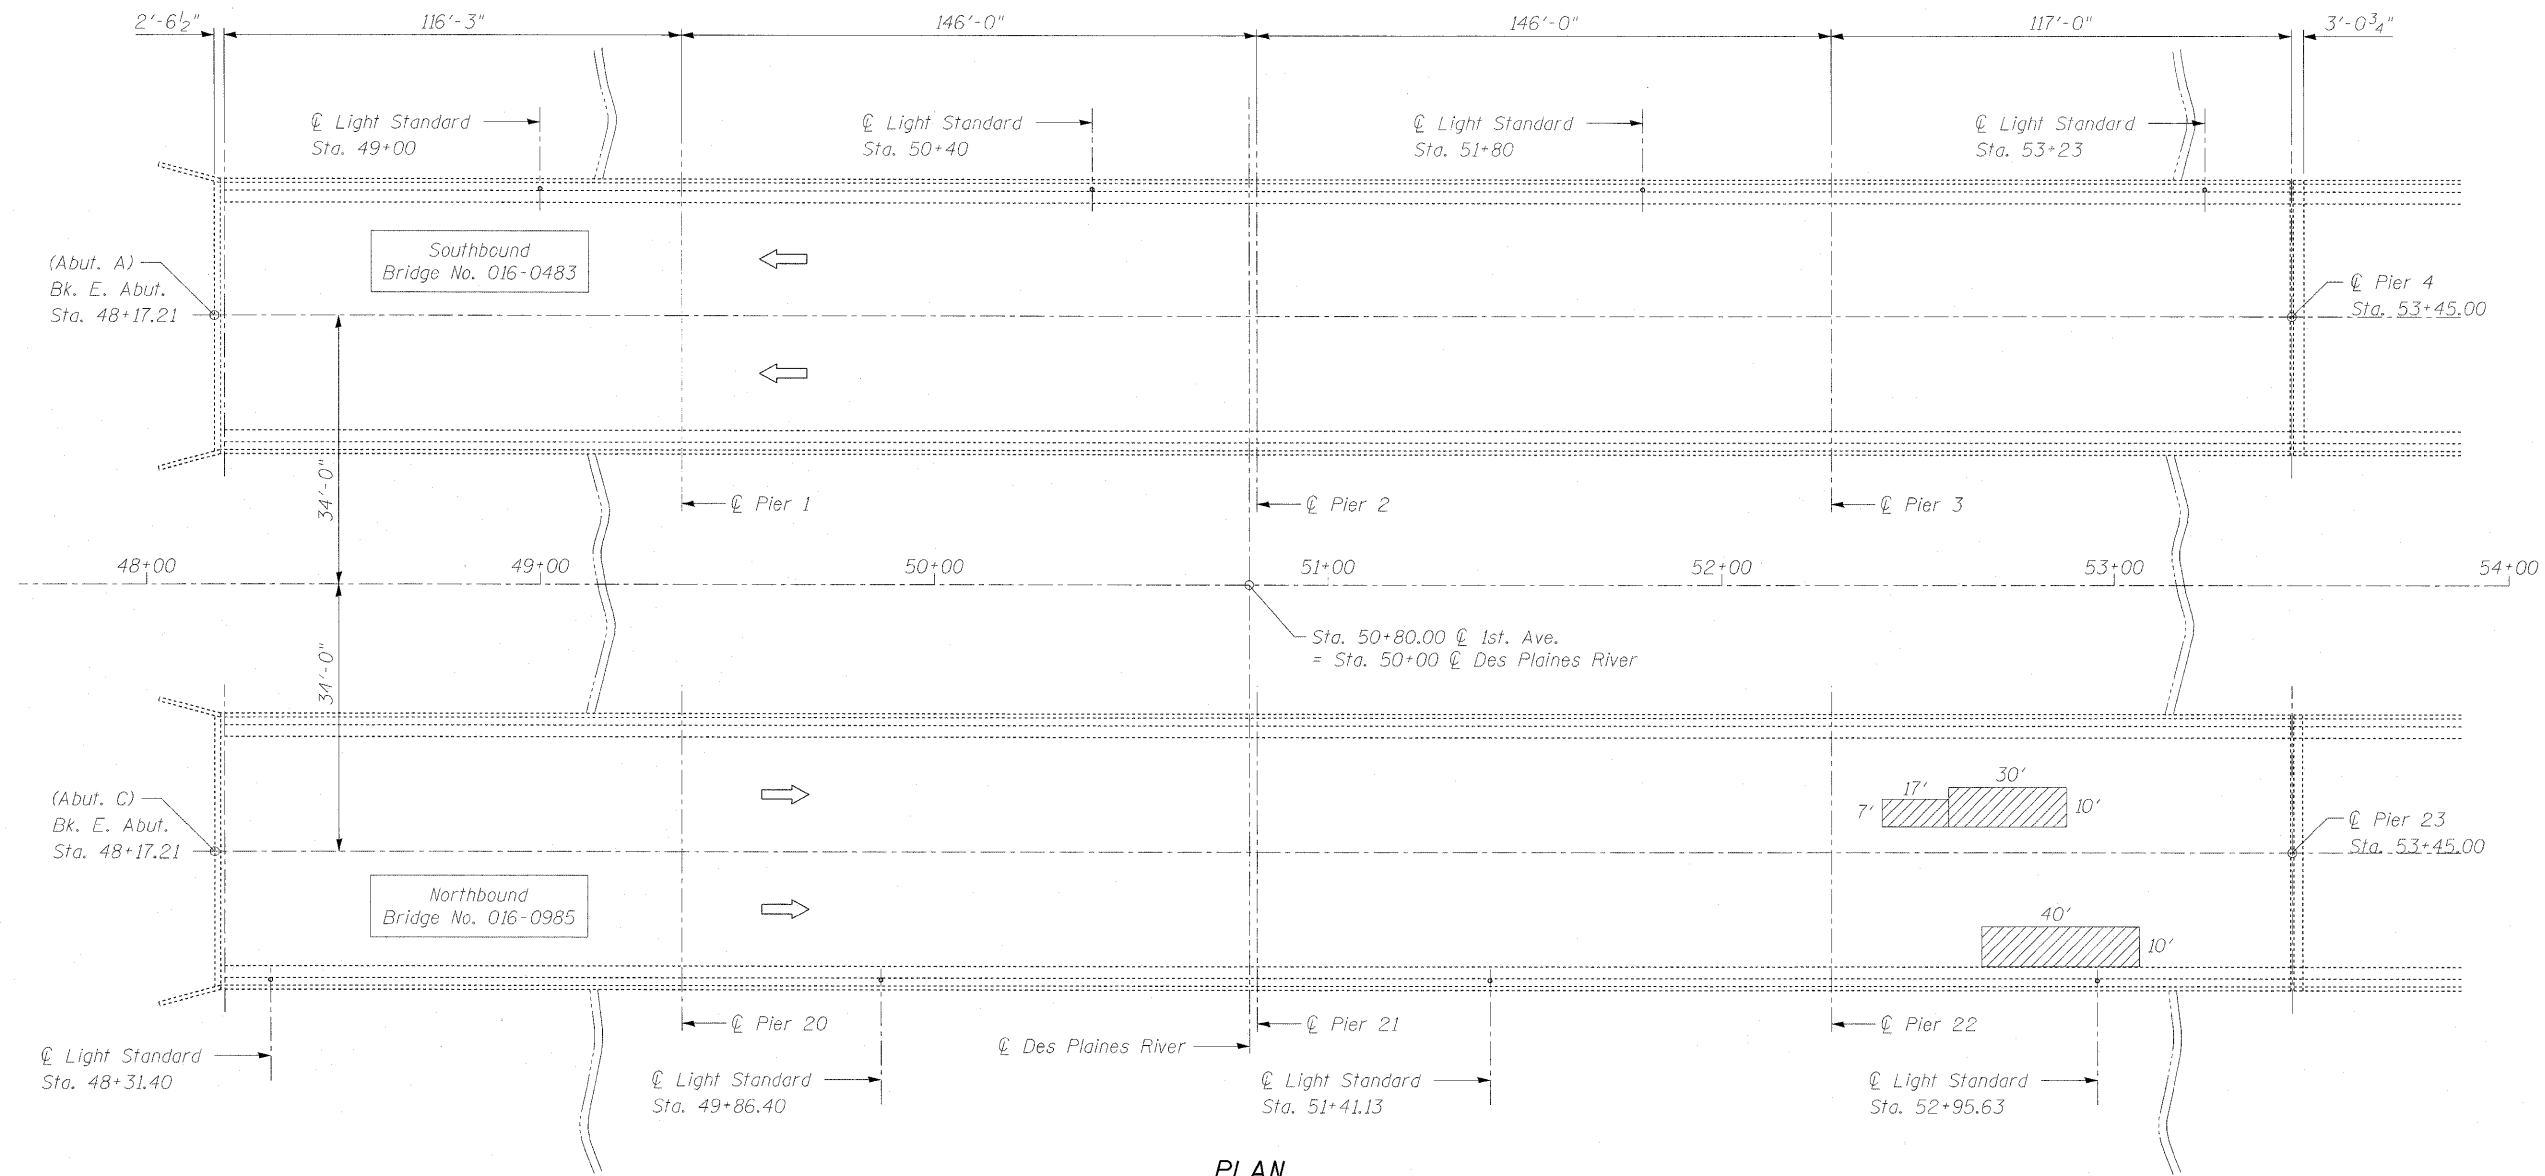
PLAN

Legend:
 Indicates Partial Deck Slab Repair

LAST DELAMINATION SURVEY
 July, 2011 (Provided by IDOT)
