**DECK SLAB REPAIRS
1ST AVE. (IL. 171) S.B. RAMP TO I-55
OVER DES PLAINES RIVER
COOK COUNTY
STATION 106+26.32
STRUCTURE NO. 016-1026 (S.B.)**

FILE NAME =	USER NAME =	DESIGNED - EM	REVISED -	STATE OF ILLINOIS DEPARTMENT OF TRANSPORTATION	DECK SLAB REPAIR PLAN STRUCTURE NO. 016-1026 (S.B.)	F.A.P. RTE.	SECTION	COUNTY	TOTAL SHEETS	SHEET NO.	
		CHECKED - JMH	REVISED -			373	2011-077-BR	COOK	32	24	
PLOT SCALE =		DRAWN - DR	REVISED -			CONTRACT NO. 60R03					
PLOT DATE =		CHECKED - JMH	REVISED -			ILLINOIS FED. AID PROJECT

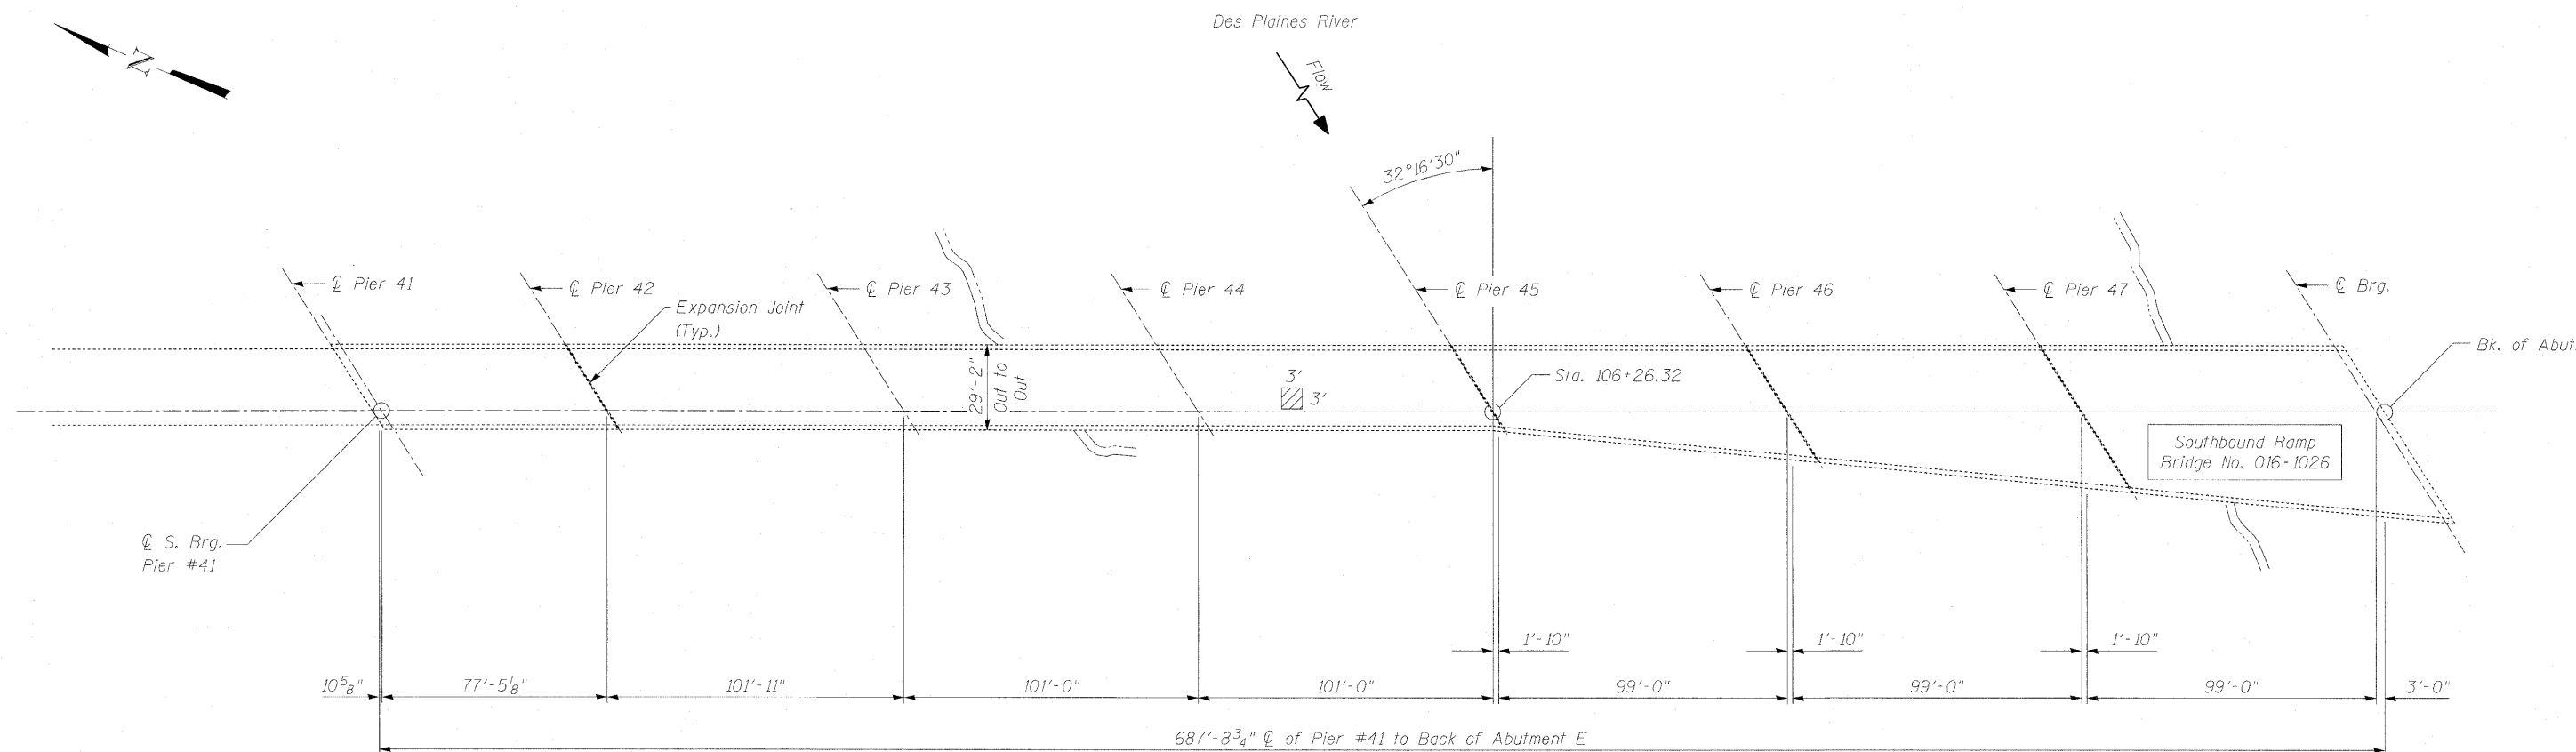
PLAN

LAST DELAMINATION SURVEY

July, 2011 (Provided by IDOT)

Indicates Partial Deck Slab Repair
