DECK REPAIR PLAN

FILE NAME =	USER NAME = #USER#	DESIGNED -	REVISED -	STATE OF ILLINOIS DEPARTMENT OF TRANSPORTATION	Deck Repair Plan Structure No. 081-0106			F.A.I. RTE. 280	SECTION (81-1B)M-2	COUNTY Rock Island	TOTAL SHEETS 30	SHEET NO. 27
#FILE#		DRAWN -	REVISED -		SCALE: _____	SHEET NO. 11 OF 14 SHEETS	STA. _____ TO STA. _____	ILLINOIS FED. AID PROJECT				
		CHECKED -	REVISED -									
		DATE -	REVISED -									
				CONTRACT NO. 64F22

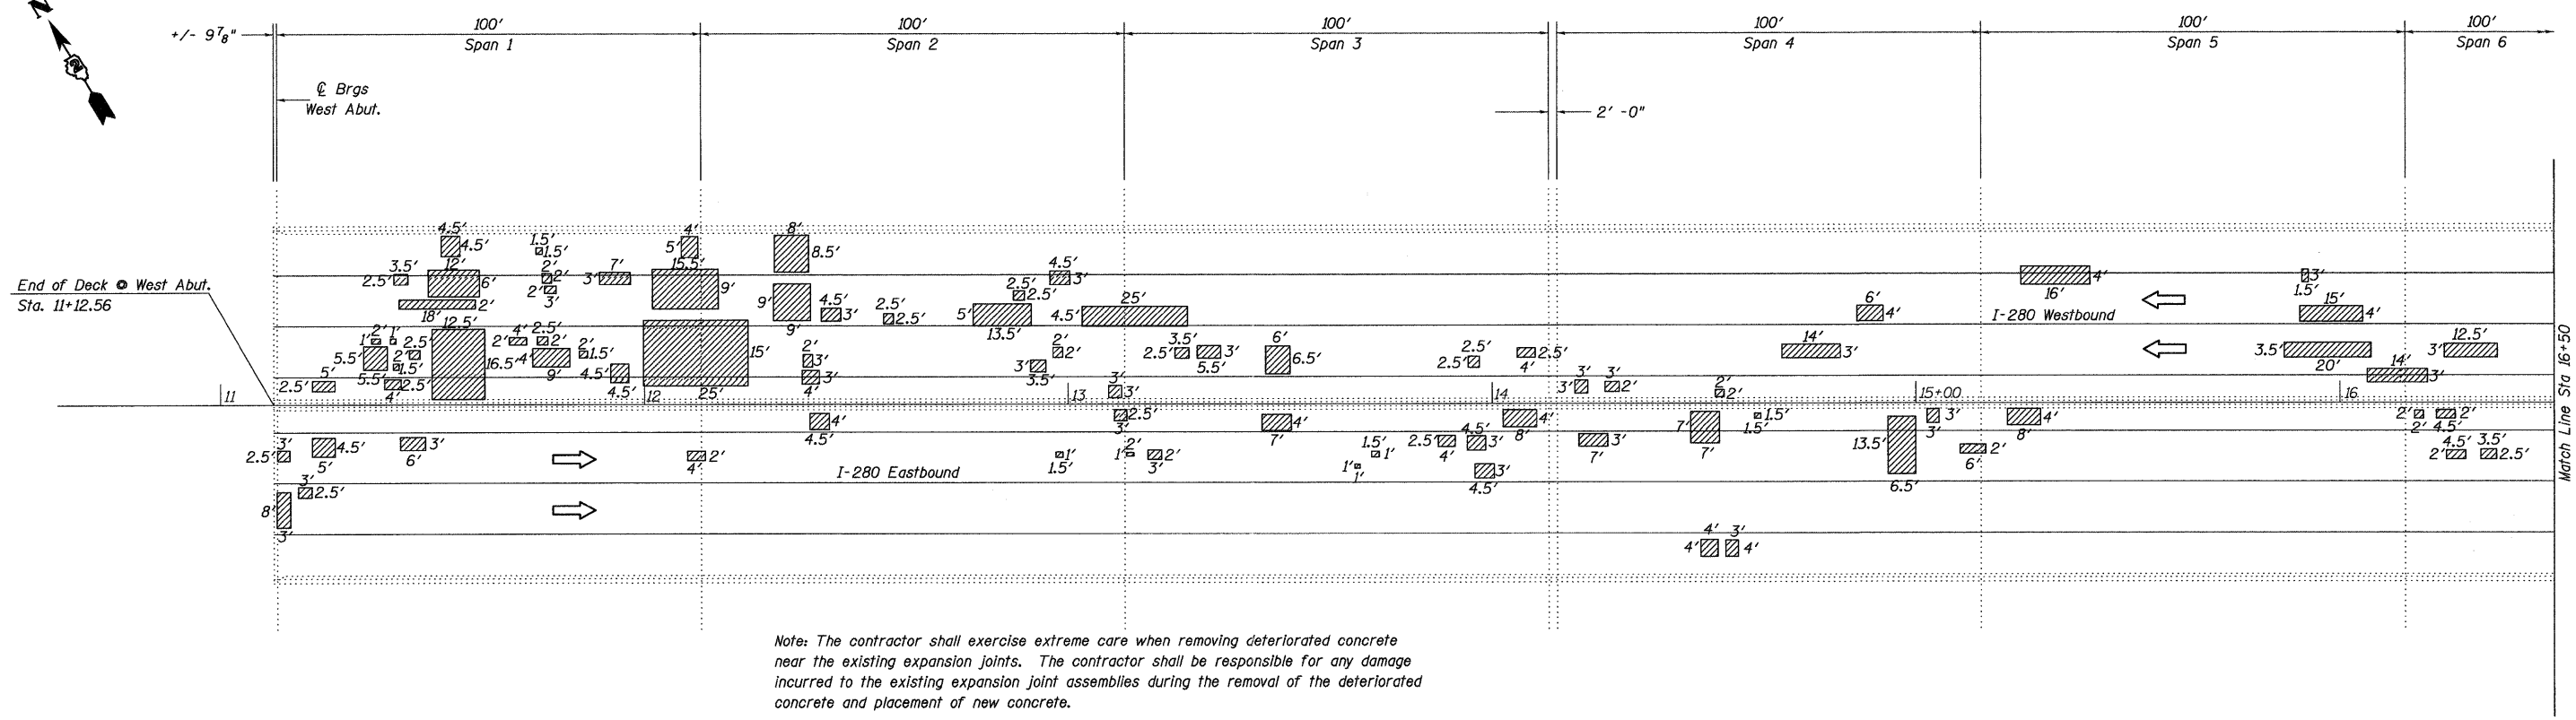
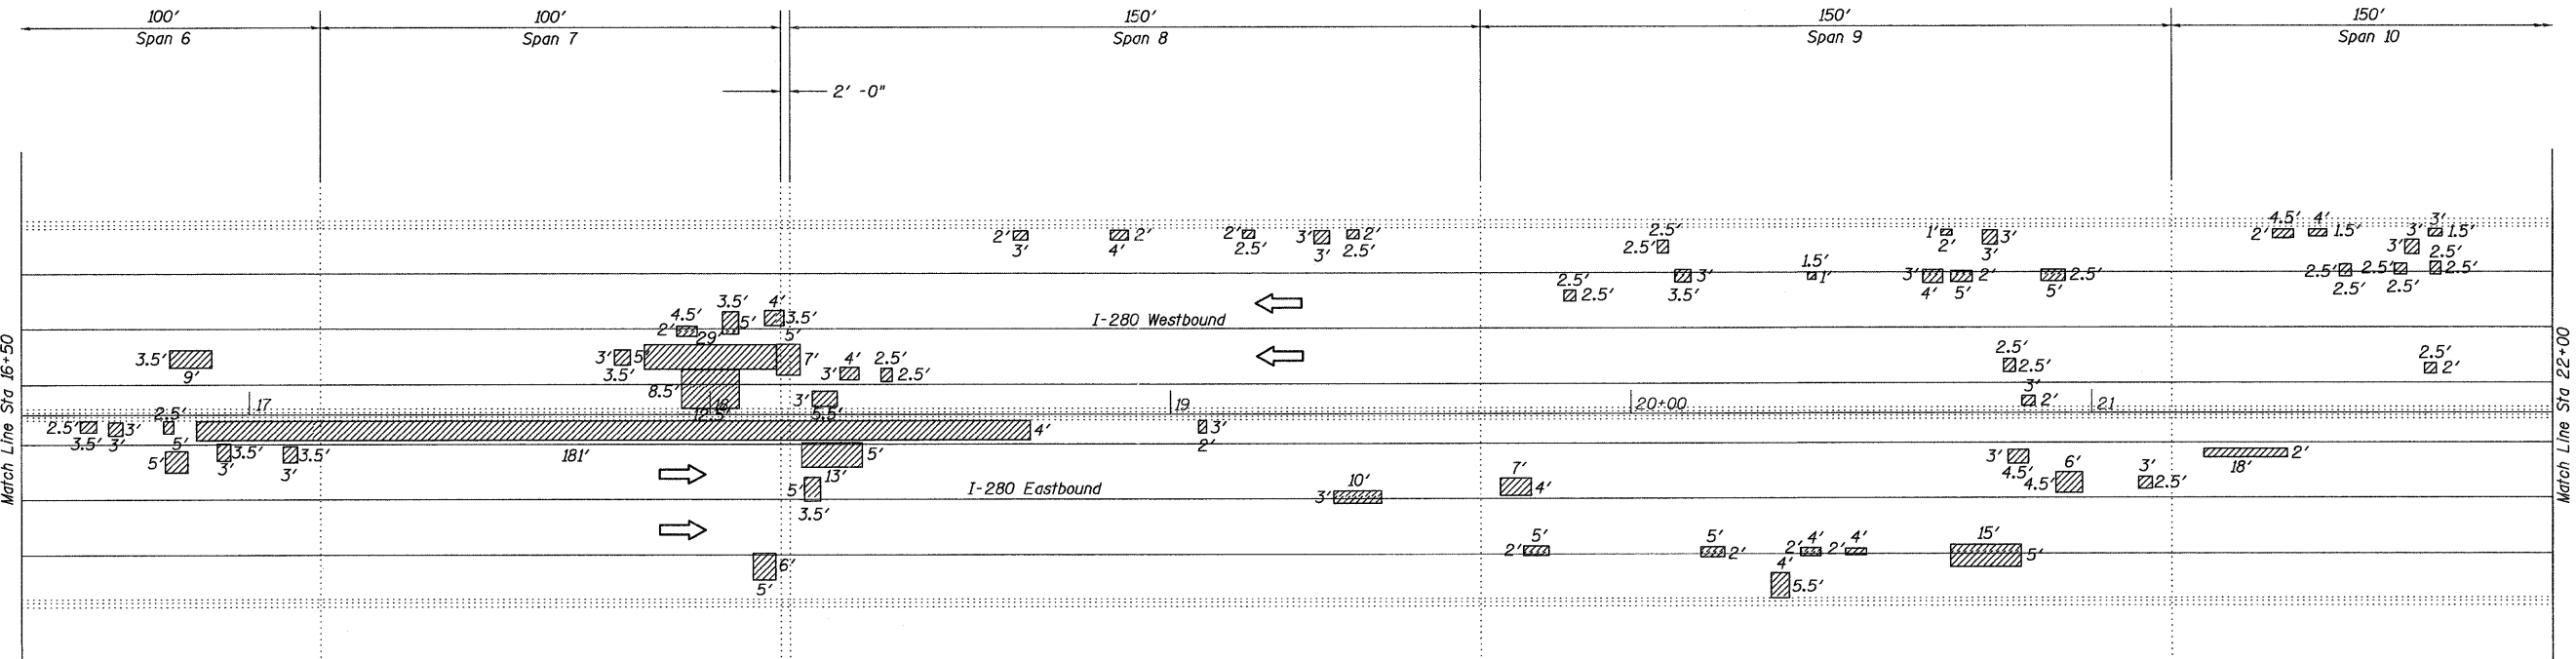
▨ Deck Slab Repair (Partial Depth)
 Patches shown are potential areas of deck slab repair.
 Actual areas to be determined in the field.

Date of Deck Survey: October 2010
