STATE OF ILLINOIS
DEPARTMENT OF TRANSPORTATION

PIER REPAIR
STRUCTURE NO. 082-0167 (E.B.)
STRUCTURE NO. 082-0168 (W.B.)

SHEET NO. A19 OF 21 SHEETS

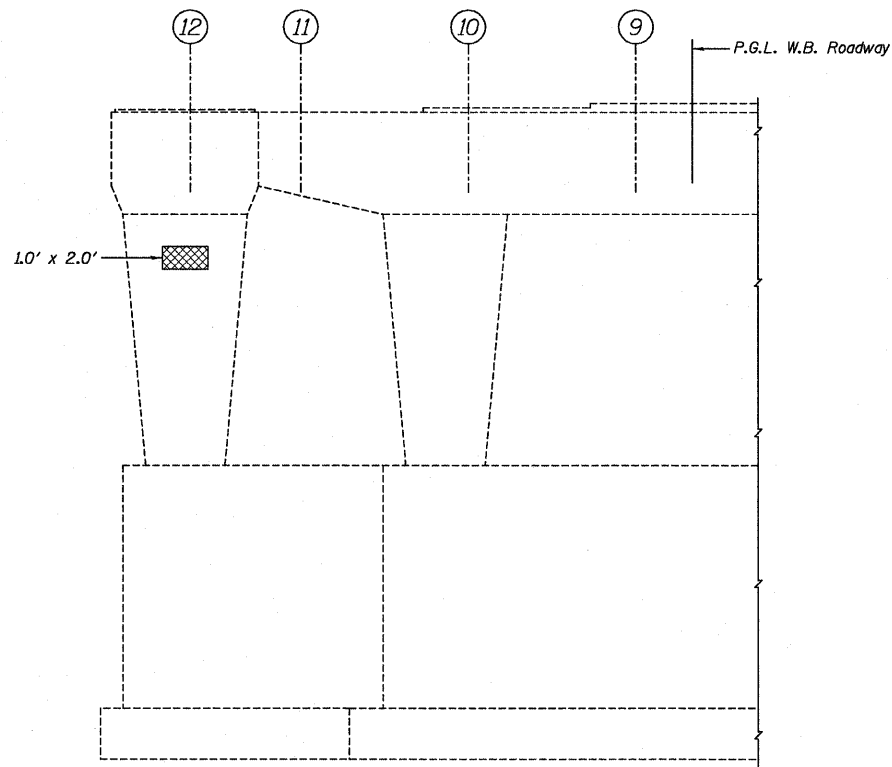
PARTIAL ELEVATION
(Looking West)

PIER NO. 2, WESTBOUND ROADWAY

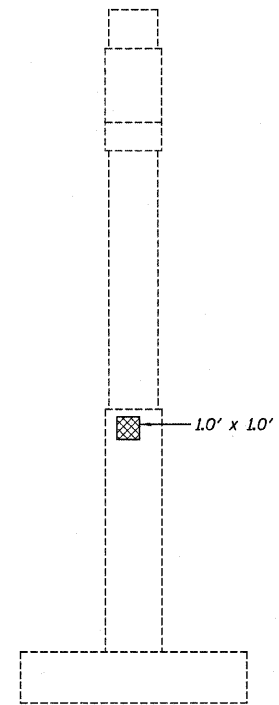
NORTH END VIEW
(Looking South)

PIER NO. 1, EASTBOUND ROADWAY
