STATE OF ILLINOIS  
DEPARTMENT OF TRANSPORTATION

**CONCRETE REPAIRS**  
**STRUCTURE NO. 099-2000**

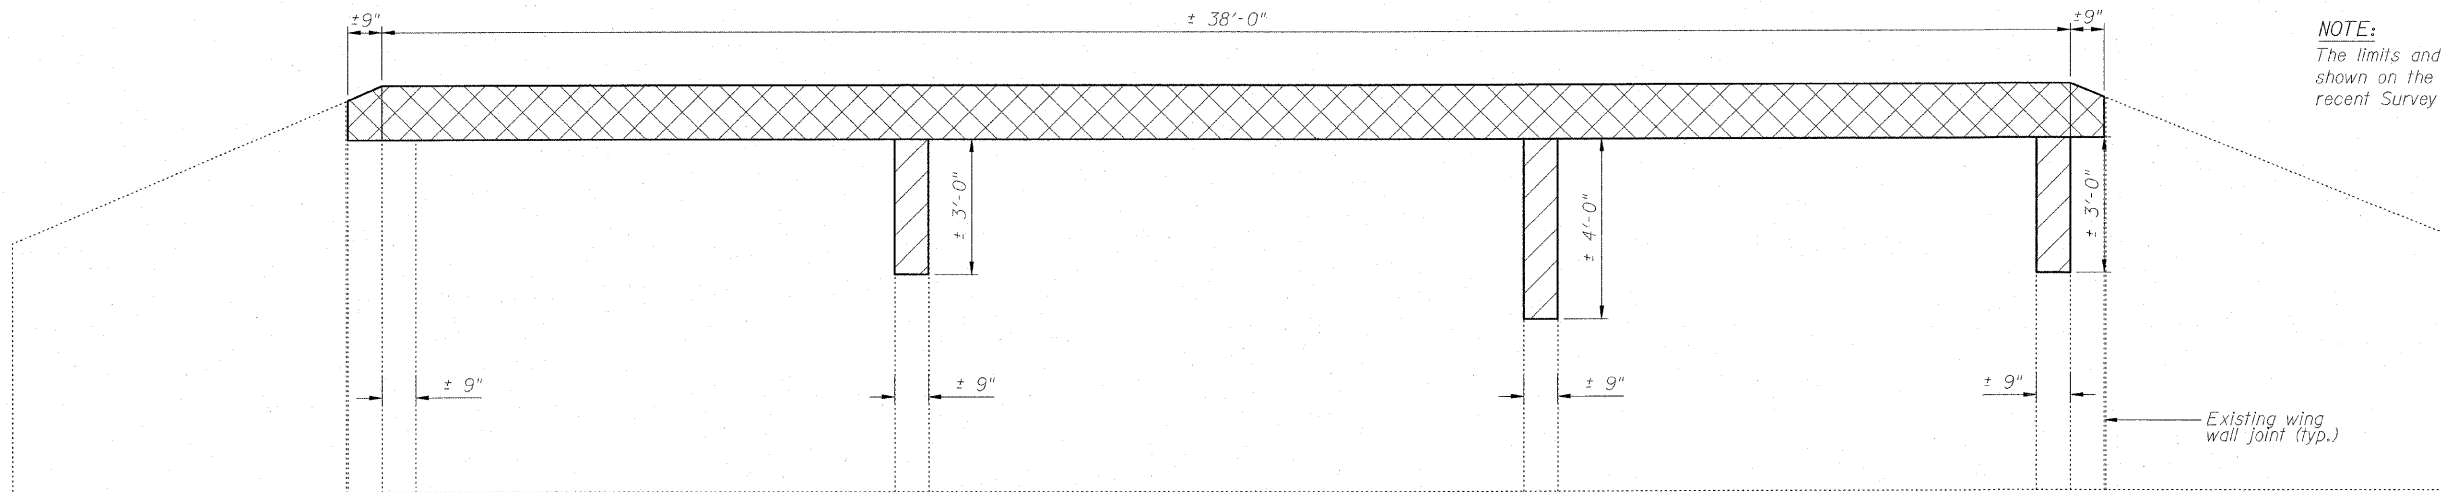
**WEST HEADWALL ELEVATION**  
(Looking East)

**NOTE:**  
The limits and locations of Structural Repair of Concrete shown on the Headwall Elevations are taken from the most recent Survey performed by the District in October 2009.
