**PIER CONCRETE REPAIR DETAILS**  
S.N. 014-0049

F.A.P. RTE.	SECTION	COUNTY	TOTAL SHEETS	SHEET NO.
327	14-12BR-1	CLINTON	72	56
<b>CONTRACT NO. 76B27</b>				
FED. ROAD DIST. NO. _ ILLINOIS FED. AID PROJECT

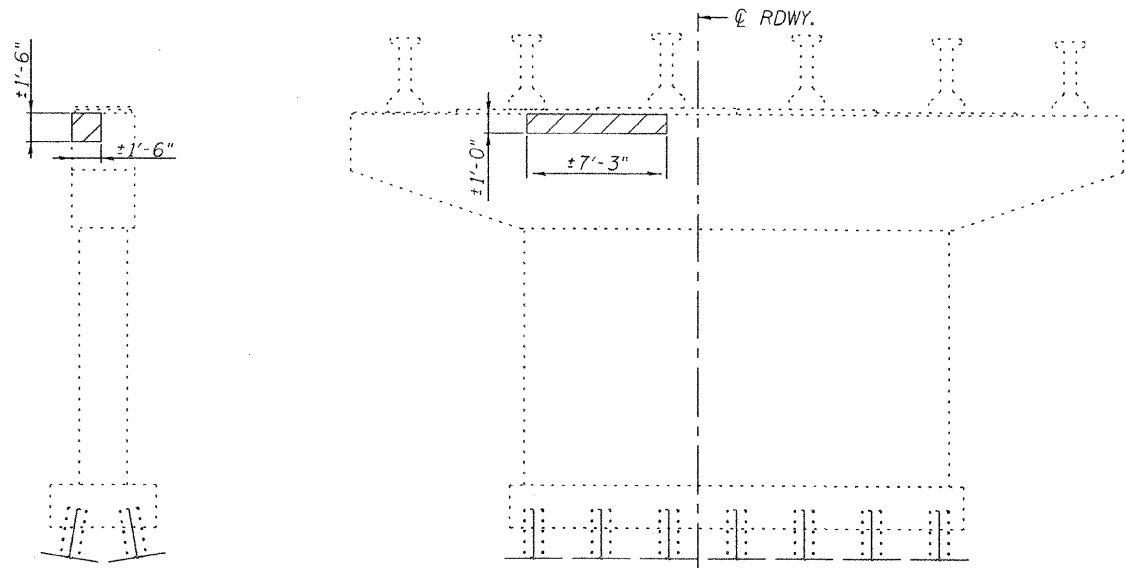
**END VIEW PIER 3**  
(Looking North)

**ELEVATION PIER 3**  
(Looking East)

Notes: Hatched area indicates approximate area of Structural Repair of Concrete.  
Exact repairs are to be determined by the Engineer.  
Pier seats at Piers 3 & 6 shall be cleaned & sealed.  
Work will be paid for as Cleaning Bridge Seats.
