**STATE OF ILLINOIS
 DEPARTMENT OF TRANSPORTATION**

**PIER REPAIRS
 STRUCTURE NO. 045-3094**

SHEET NO. 11 OF 17 SHEETS

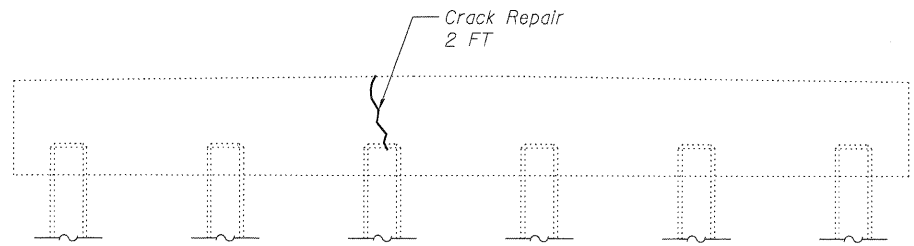
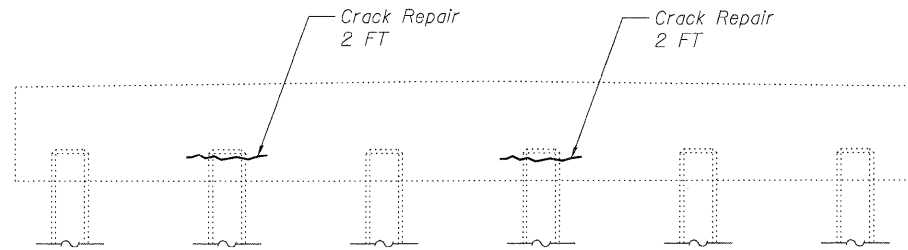
PIER 1 (WEST PIER)

ELEVATION
Looking West
