Contract #64B25

PIER REPAIRS

F.A.S. ROUTE 227 (OSCO ROAD)
OVER CAMP CREEK
SECTION 105BR-2
HENRY COUNTY
STATION 65+47.16
STRUCTURE NO. 037-0083

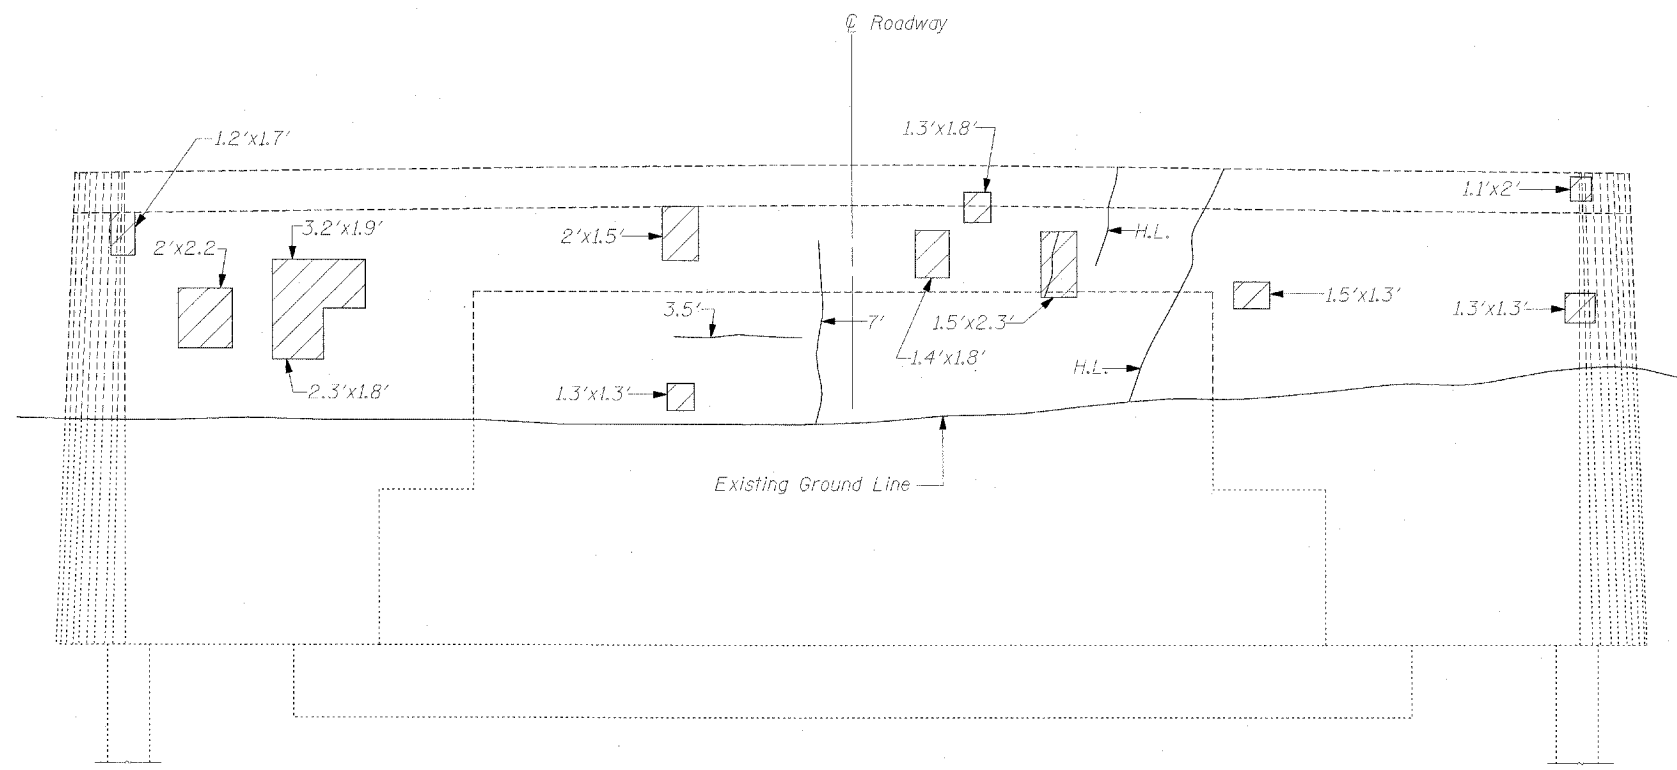
ELEVATION-NORTH FACE

- Formed Concrete Repair
Depth equal to or less than 5"
- Epoxy Crack Sealing
- Hairline Crack - Not to be sealed

Note: Crack widths are $\frac{1}{8}'' \pm \frac{1}{16}''$ unless otherwise noted.

ITEM	UNIT	QUANTITY
Epoxy Crack Sealing	Foot	20
Formed Concrete Repair (Depth equal to or less than 5")	Sq Ft	71
