SHEET NO. B20

ILLINOIS DEPARTMENT OF TRANSPORTATION
PIER NO. 2 CONCRETE REPAIRS
F.A.P. 681 (IL116) OVER FELKY SLOUGH
SECTION 113BR-2
LIVINGSTON COUNTY
STATION 436+75.00
STRUCTURE NO. 053-0075
DESIGNED BY: JML
DATE: 12/09/05
DRAWN BY: DJM
CHECKED BY: MSW

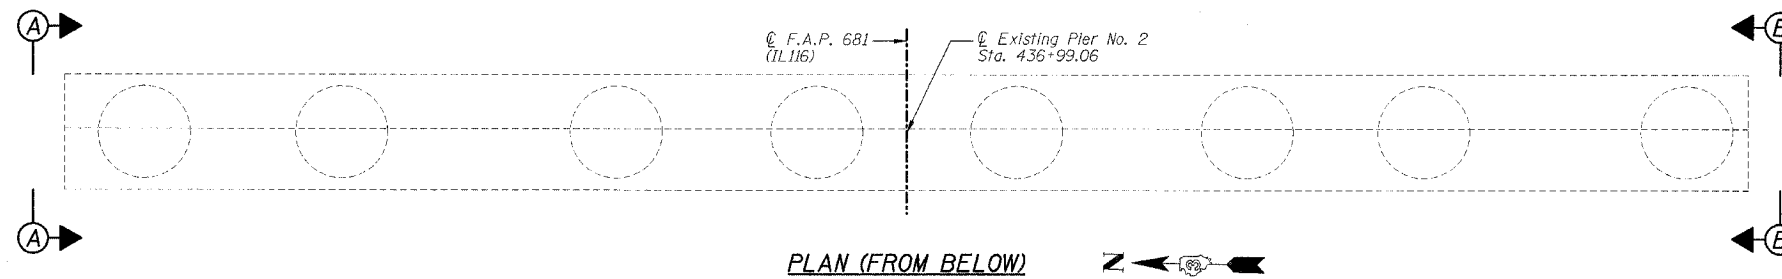
PLAN (FROM BELOW)

- 1.) Work this sheet with Sheets B21 & B22.
- 2.) The number next to the hatched areas is the square footage of each damaged area.

Formed Concrete Repair
(Depth Equal To Or
Less Than 5")

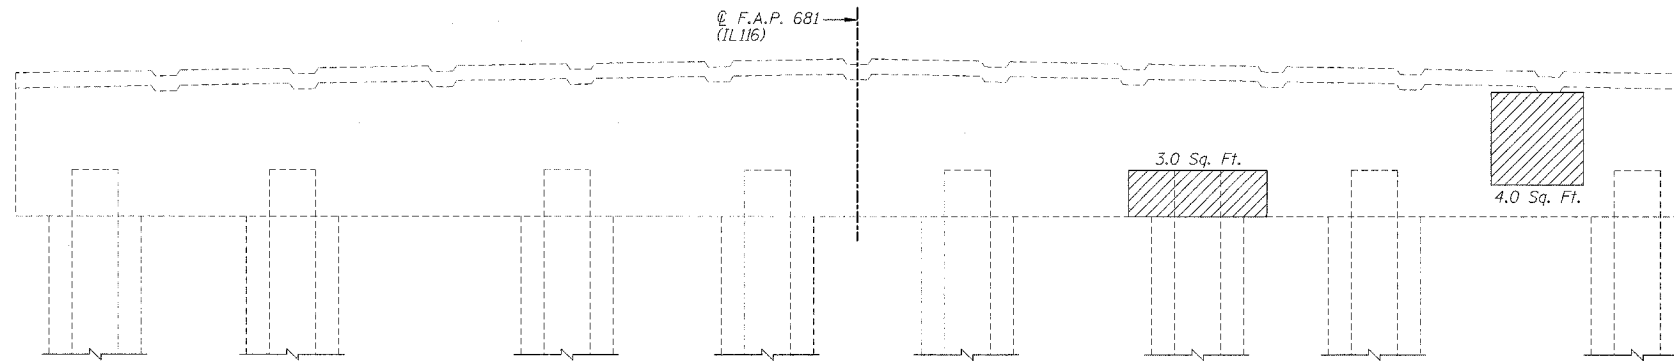
ELEVATION A-A

ELEVATION - LOOKING EAST

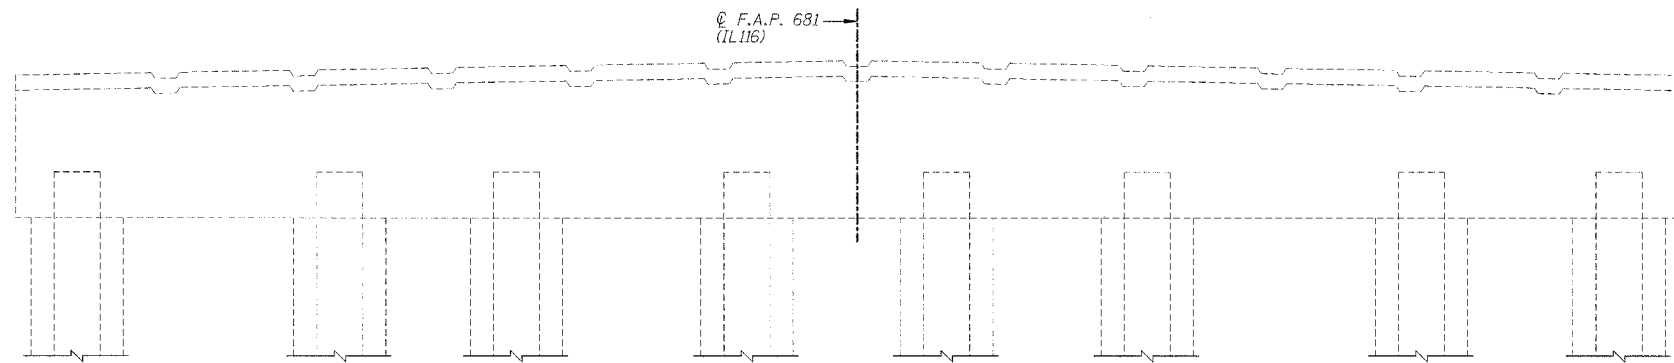
ELEVATION B-B

ELEVATION - LOOKING WEST
