**PIER REPAIR DETAILS**  
**WESTBOUND FAI-80 OVER DES PLAINES RIVER**  
**STRUCTURE NO. 099-0057**

F.A.I. RTE. 80	SECTION 99(4&4-1)RS-3	COUNTY WILL	TOTAL SHEETS 203	SHEET NO. 135
FED. ROAD DIST. NO. [ILLINOIS] FED. AID PROJECT			CONTRACT NO. 60M66

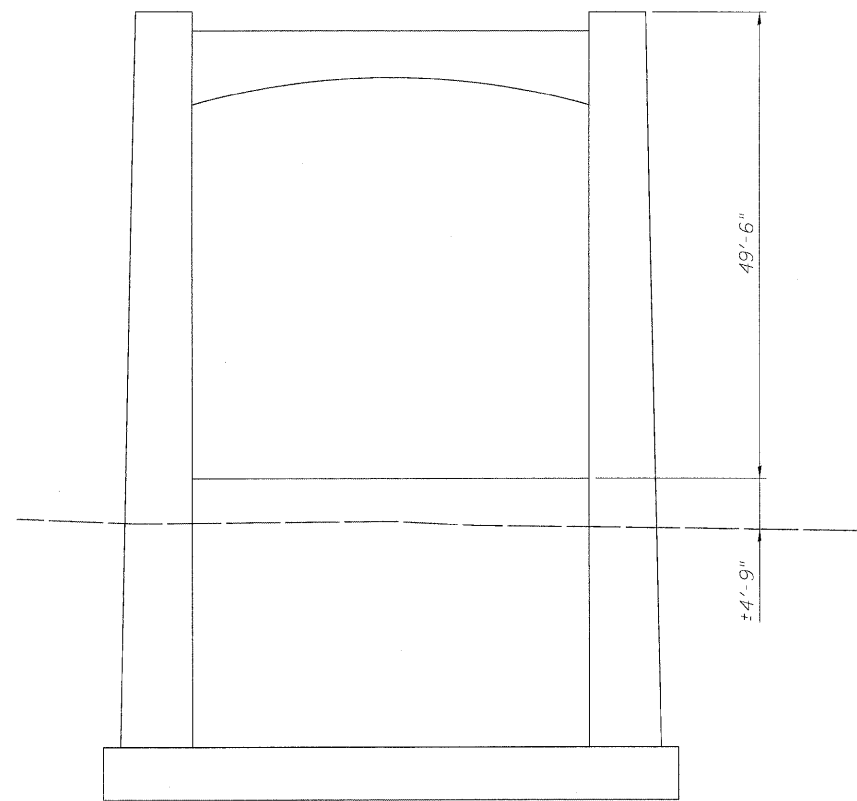
**PIER 7**

Structural Repair of Concrete (Depth ≤ 5") = 81 Sq. Ft.  
 Structural Repair of Concrete (Depth > 5") = 20 Sq. Ft.
