STATE OF ILLINOIS
DEPARTMENT OF TRANSPORTATION

PIER REPAIR DETAILS
WESTBOUND I-80 OVER DES PLAINES RIVER
STRUCTURE NO. 099-0057

F.A.I. RTE. 80	SECTION 99(4&4-1)RS-3	COUNTY WILL	TOTAL SHEETS 203	SHEET NO. 136
FED. ROAD DIST. NO.		ILLINOIS FED. AID PROJECT		
CONTRACT NO. 60M66

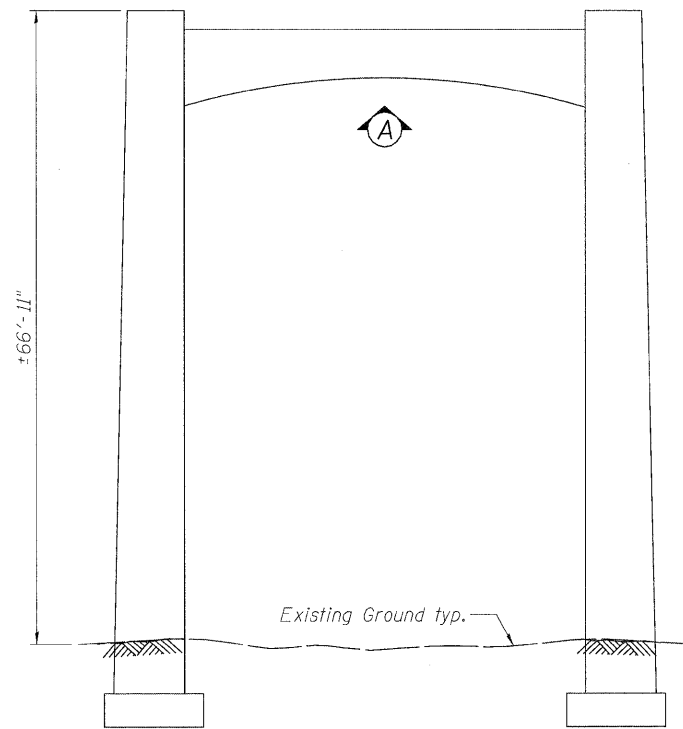
WEST ELEVATION
(Looking East)

PIER 9

- Structural Repair of Concrete (Depth \leq 5") = 29 Sq. Ft.
- Structural Repair of Concrete (Depth $>$ 5") = 0 Sq. Ft.
