STATE OF ILLINOIS  
DEPARTMENT OF TRANSPORTATION

**SUPERSTRUCTURE - DECK REPAIRS**  
**STRUCTURE NO. 079-0036**

SHEET 3 OF 22	F.A.P. RTE. 312	SECTION 73BR-II	COUNTY RANDOLPH	TOTAL SHEETS 51	SHEET NO. 26
	STA. 793+80			CONTRACT NO. 76883	
FED. ROAD DIST. NO.		ILLINOIS FED. AID PROJECT

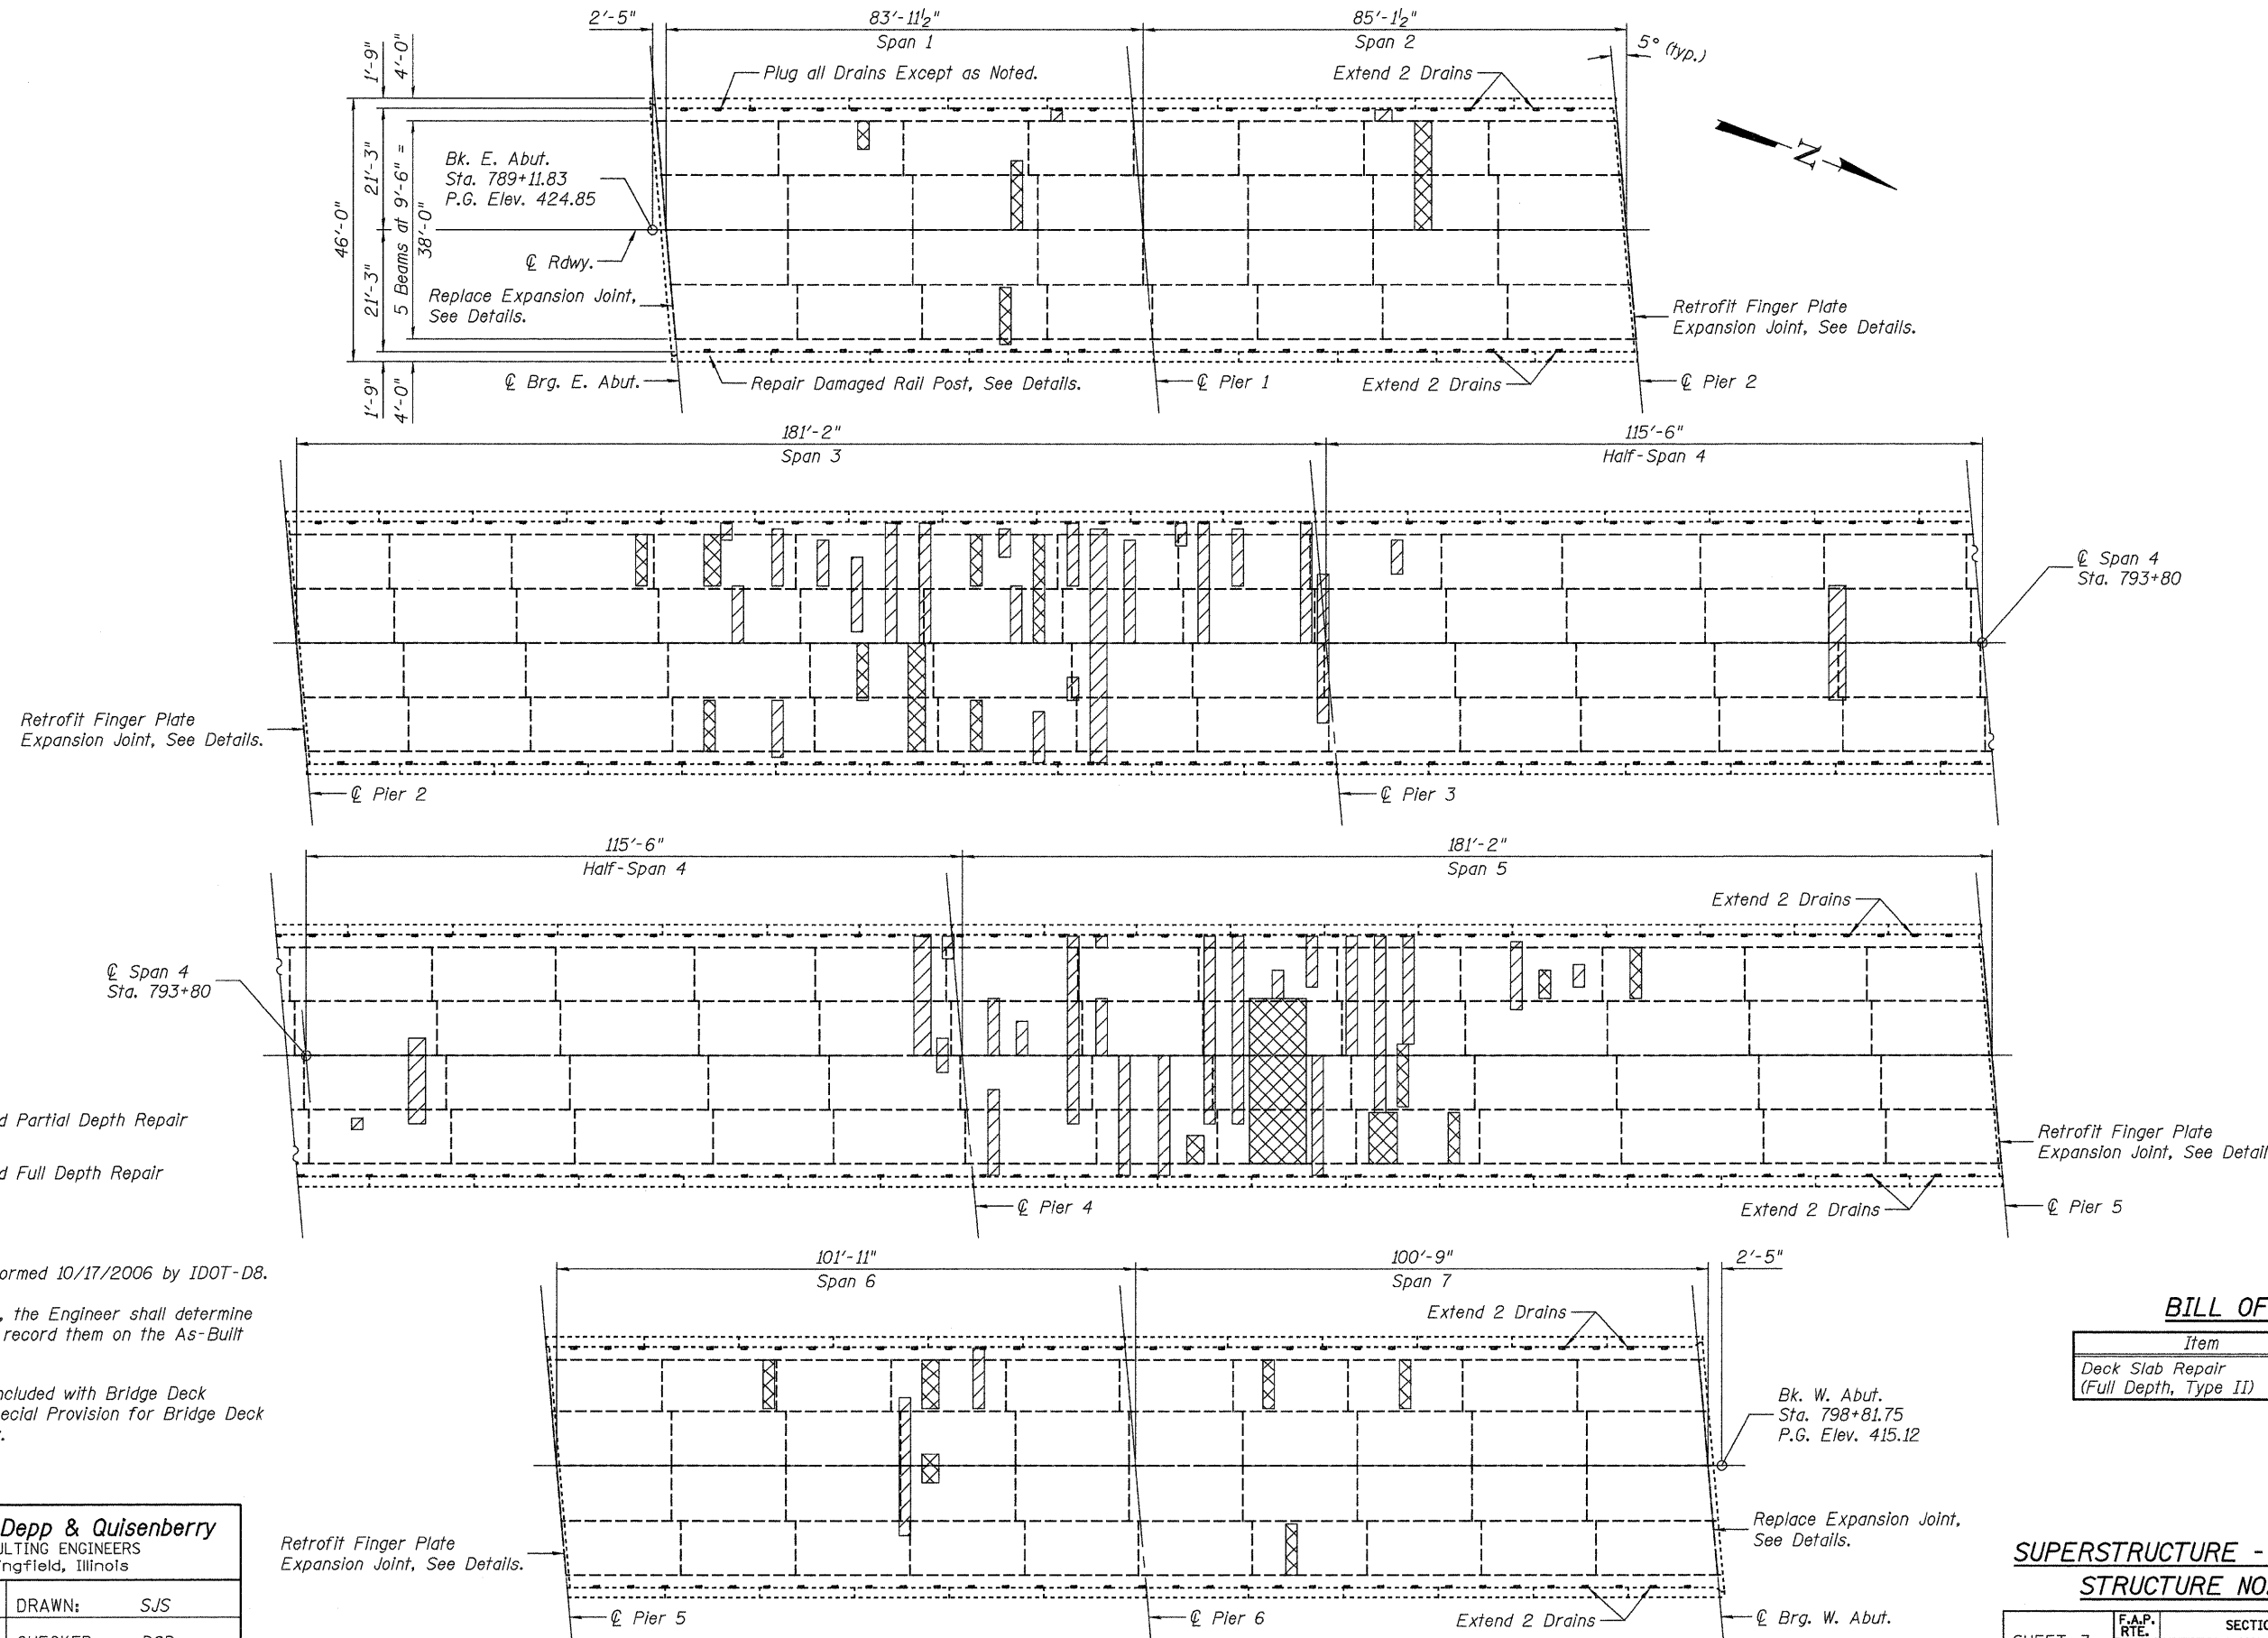
**Notes:**  
Deck Condition Survey performed 10/17/2006 by IDOT-D8.

Repair areas are estimated, the Engineer shall determine actual repair locations and record them on the As-Built plans.

Partial depth repairs are included with Bridge Deck Hydro-scarification, see Special Provision for Bridge Deck Microsilica Concrete Overlay.
