FILE NAME = I:\183123.1-55 over Des Planes\Structural\CADD Sheets\0168652-48-tr-steel-repairs-IV.dgn

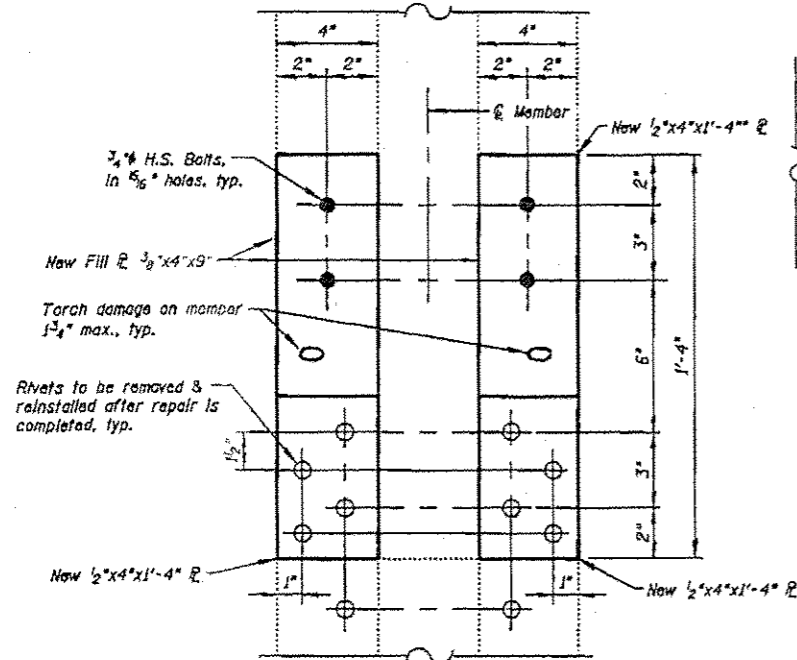
REPAIR DETAIL (15)

REPAIR NO. S33
(showing vertical member)

ELEVATION

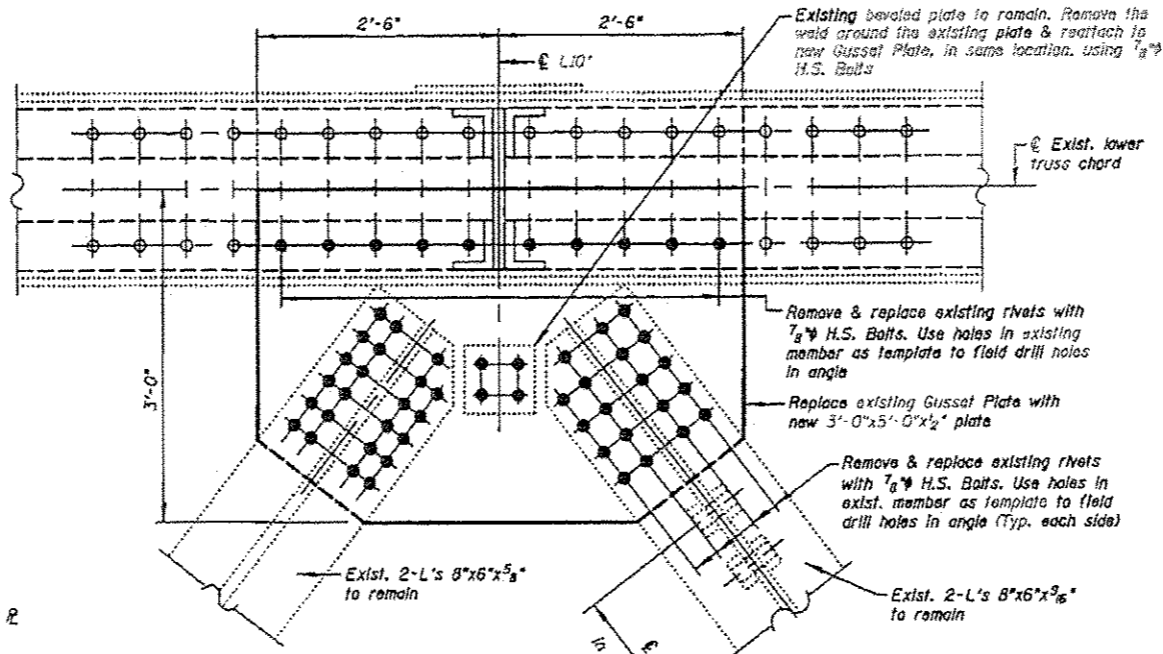
REPAIR DETAIL (16)

REPAIR NO. S36
(Gusset plate replacement)

PLAN

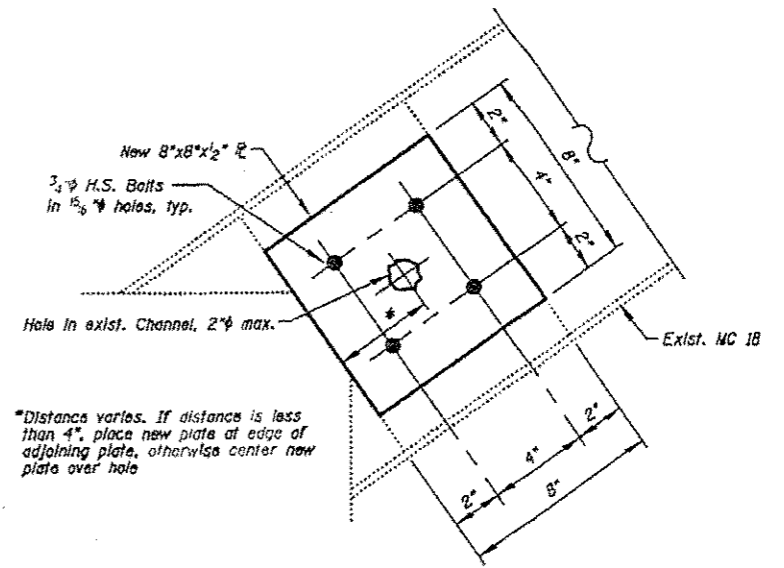
REPAIR DETAIL (17)

REPAIR NO'S. S39, S41 & S42
(showing vertical member)

ELEVATION

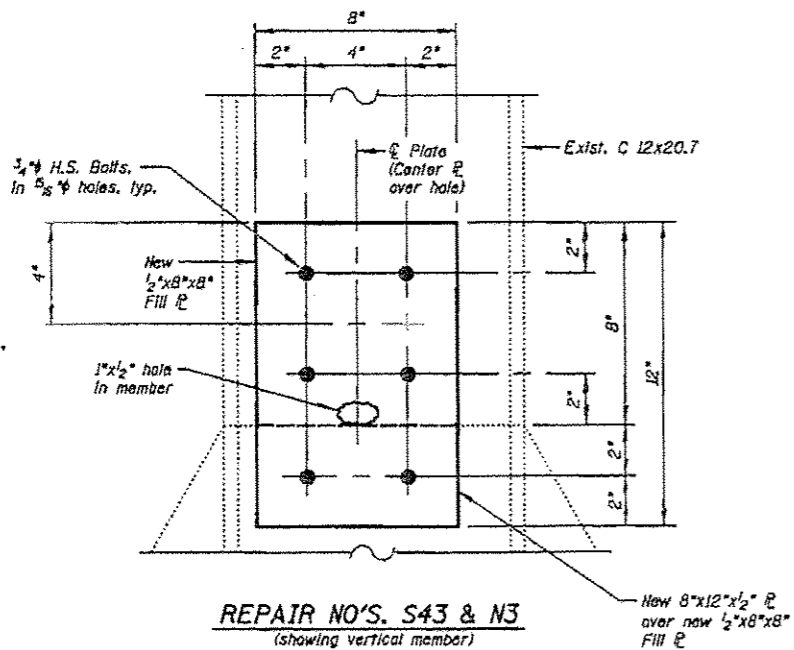
REPAIR DETAIL (18)

REPAIR NO'S. S43 & N3
(showing vertical member)

ELEVATION

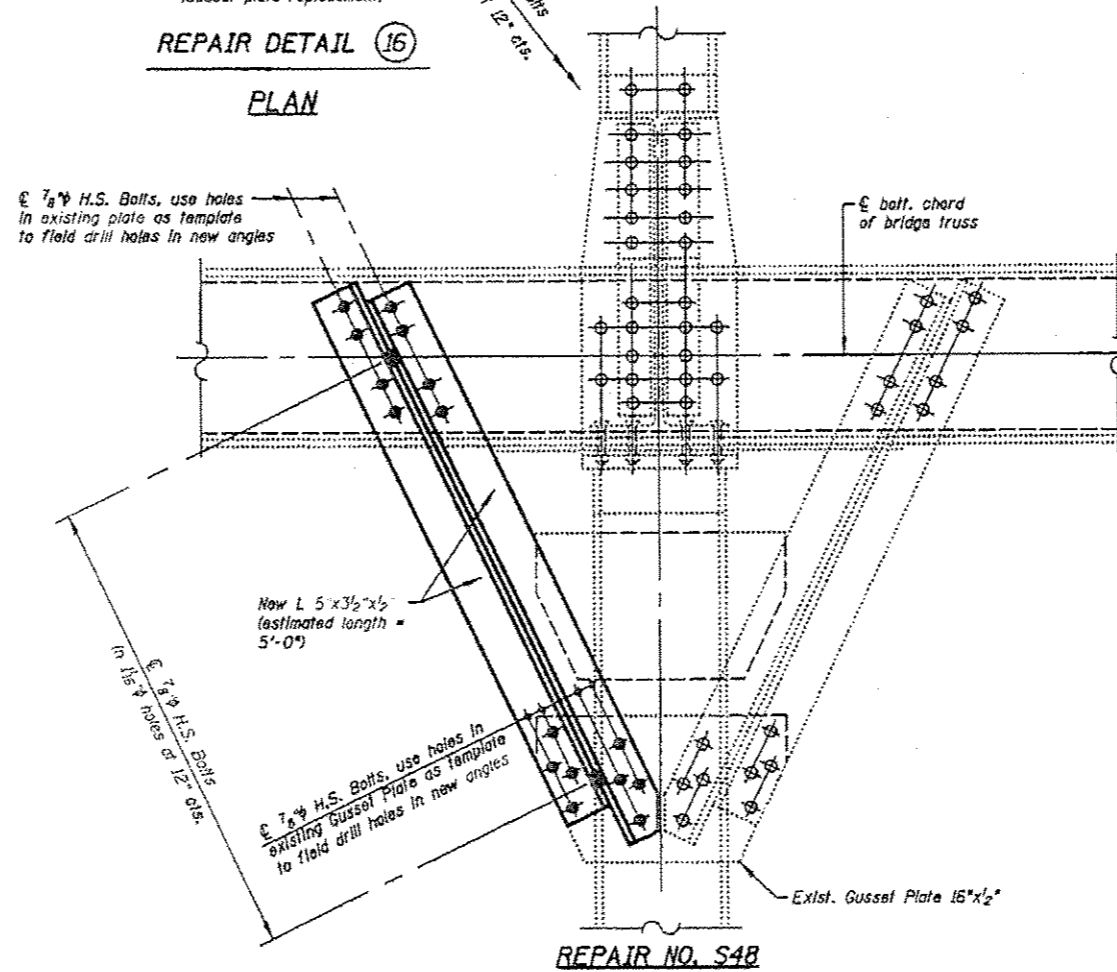
REPAIR DETAIL (19)

REPAIR NO. S48

ELEVATION
