INFRARED THERMOGRAPHIC INSPECTION RESULTS

STATE OF ILLINOIS
DEPARTMENT OF TRANSPORTATION
REHABILITATION AND RETROFIT REPAIRS
FAI ROUTE 70
POPLAR STREET BRIDGE APPROACHES
ST. CLAIR COUNTY

STRUCTURE NO. 082-0141 (ROADWAY A)
SCALE: N.T.S.
DATE: 02/01/2007

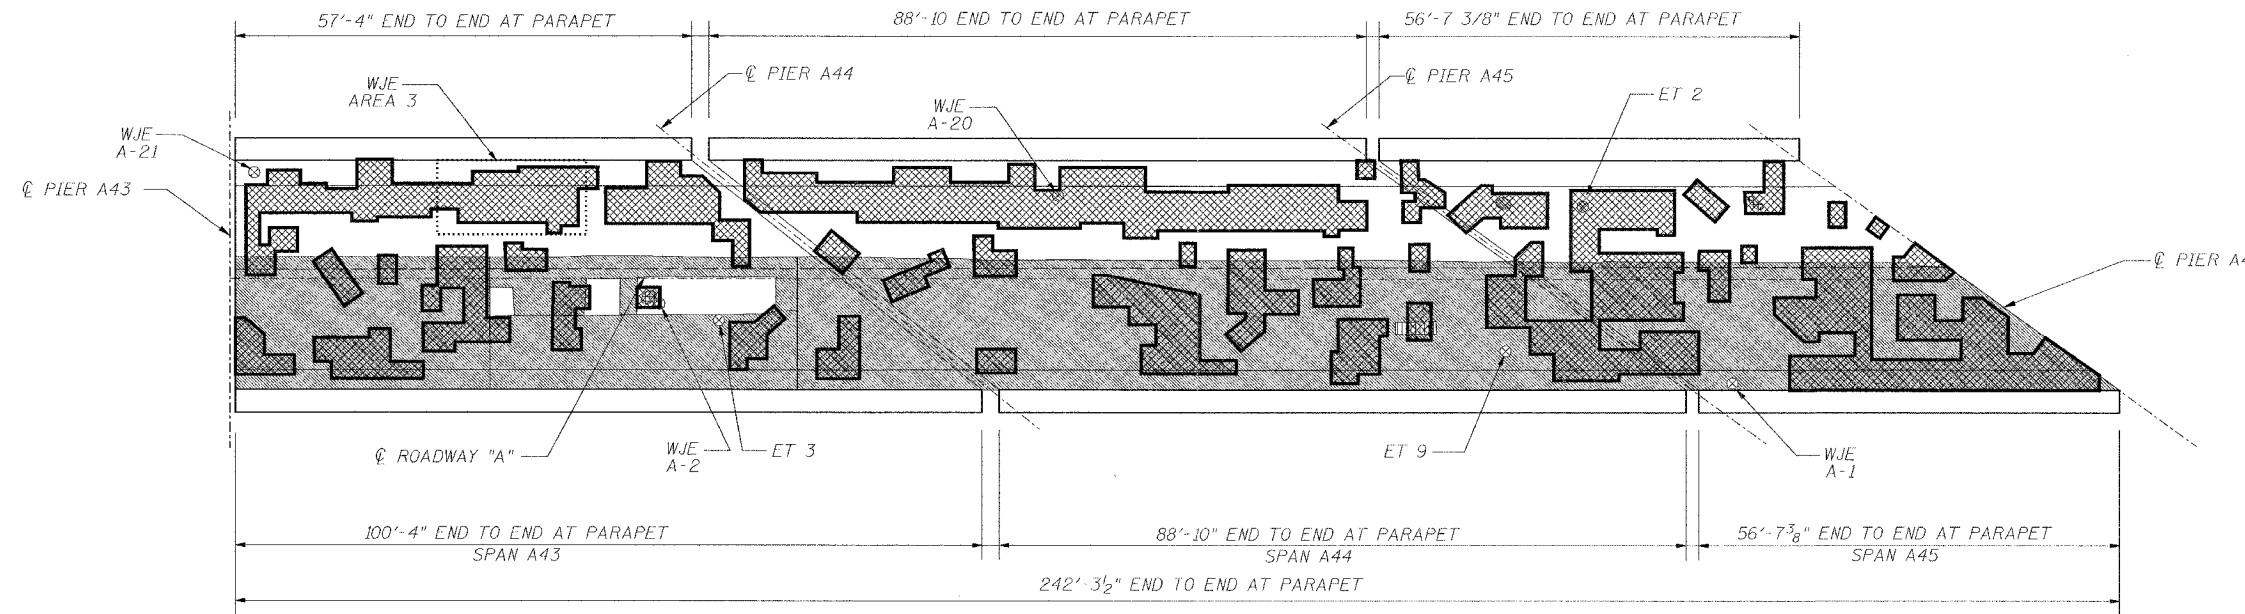
PLAN

FIELD OBSERVATIONS SUMMARY		TOPSIDE		LEGEND	
ITEM	UNIT	QUANT.	%		
TOTAL AREA	ft ²	7186		DELAMINATION	
SHADE/DEBRIS	ft ²	0		SPALL	
DELAMINATION	ft ²	741	10.3	DEBOND	
SPALL	ft ²	0	0	ASPHALT PATCH	
DEBOND	ft ²	4005	55.7	SUBSURFACE PATCH	
ASPHALT PATCH	ft ²	4	<0.1	SHADE/DEBRIS	
SUBSURFACE PATCH	ft ²	8	0.1

SPAN	2000 SURVEY RESULTS	2007 ANTICIPATED AREAS OF DEEPER REMOVAL
A43	850	1170
A44	960	1340
A45	610	850

AREAS OF DECK DELAMINATIONS AND SPALLS SHOWN REQUIRING REPAIR ARE ESTIMATED. ACTUAL REPAIR LOCATIONS SHOULD BE SHOWN ON AS-BUILT DRAWINGS.

INFRARED INSPECTION DATE: 7/24/00-7/26/00
SURFACE TYPE: CONCRETE OVERLAY

INFRARED THERMOGRAPHIC INSPECTION RESULTS

QUANTITIES IN THIS TABLE ARE FOR INFORMATIONAL PURPOSES ONLY AND ARE INCLUDED UNDER THE BRIDGE DECK HYDRO-SCARIFICATION AND BRIDGE DECK MICROSILICA CONCRETE OVERLAY PAY ITEMS. REFER TO SPECIAL PROVISIONS.
