DESIGNED - IJL	EXAMINED - <i>Joanne F. Jelliffe</i>	DATE - MARCH 11, 2011	STATE OF ILLINOIS DEPARTMENT OF TRANSPORTATION	ABUTMENT BACKWALL REPAIR DETAILS SN 101-0031 (S.B.)		F.A.P. RTE. 738	SECTION (5HB)M1	COUNTY WINNEBAGO	TOTAL SHEETS 9	SHEET NO. 6
CHECKED - GGE	PASSED - <i>Carl Perry</i>			SHEET NO. 2 OF 5 SHEETS	CONTRACT NO. 64G89		ILLINOIS FED. AID PROJECT			
DRAWN - Kyle M. Steffen	ACTING ENGINEER OF STRUCTURAL SERVICES									
CHECKED - IJL GGE	ACTING ENGINEER OF BRIDGES AND STRUCTURES

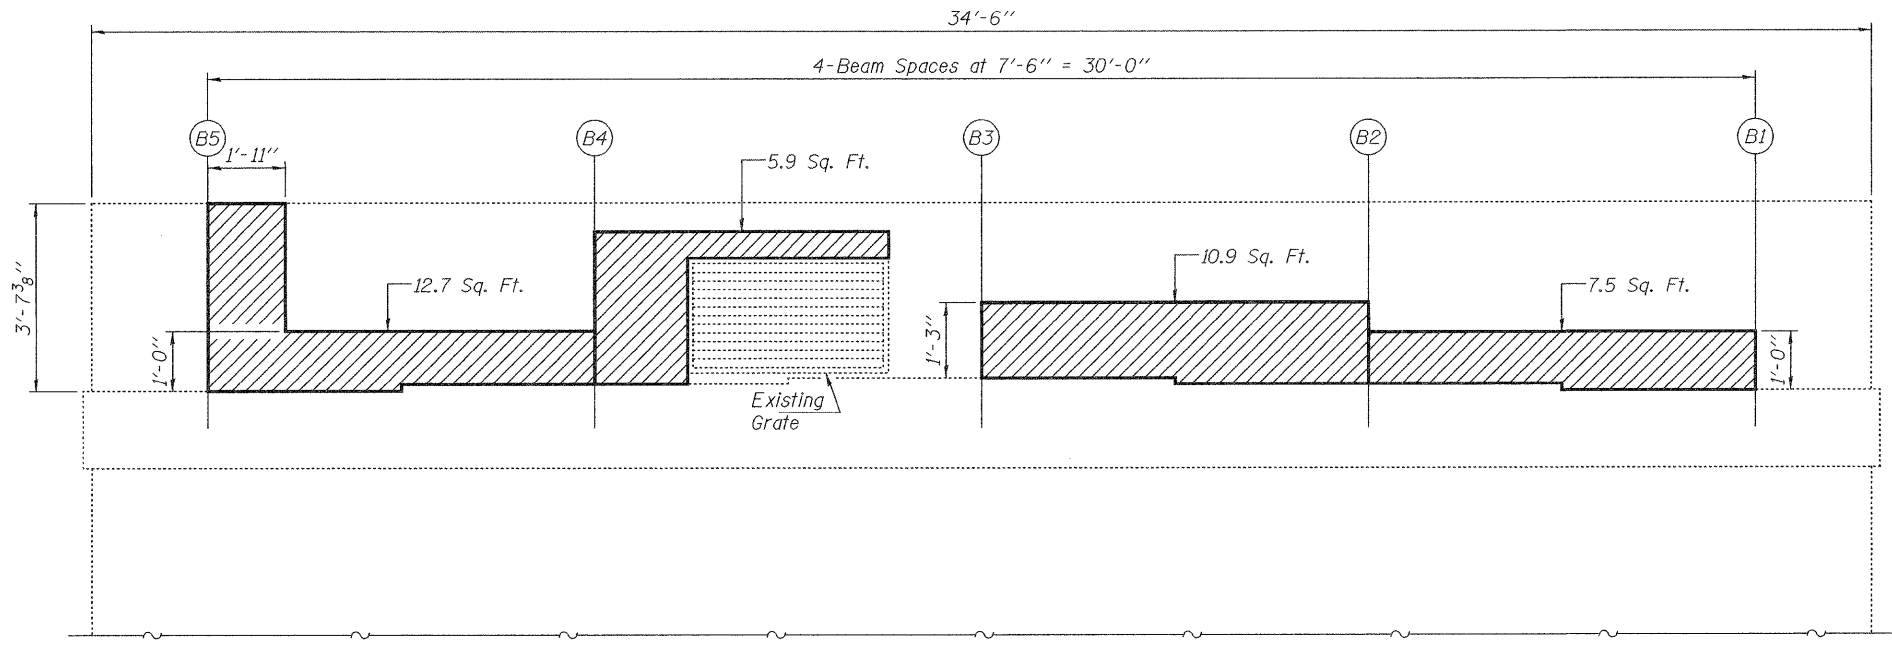
BACKWALL REPAIRS - NORTH ABUTMENT SN: 101-0031 (S.B.)
(Looking North)

- Structural Repair of Concrete ≤ 5 inches
