STATE OF ILLINOIS
DEPARTMENT OF TRANSPORTATION

DECK PLAN
NORTHBOUND STRUCTURE
I-39 OVER STEWARD CREEK
S.N. 052-0049

F.A.I. RTE.	SECTION	COUNTY	TOTAL SHEETS	SHEET NO.
39	103-1, 103-2/RS	LEE	313	167
CONTRACT NO. 64E97

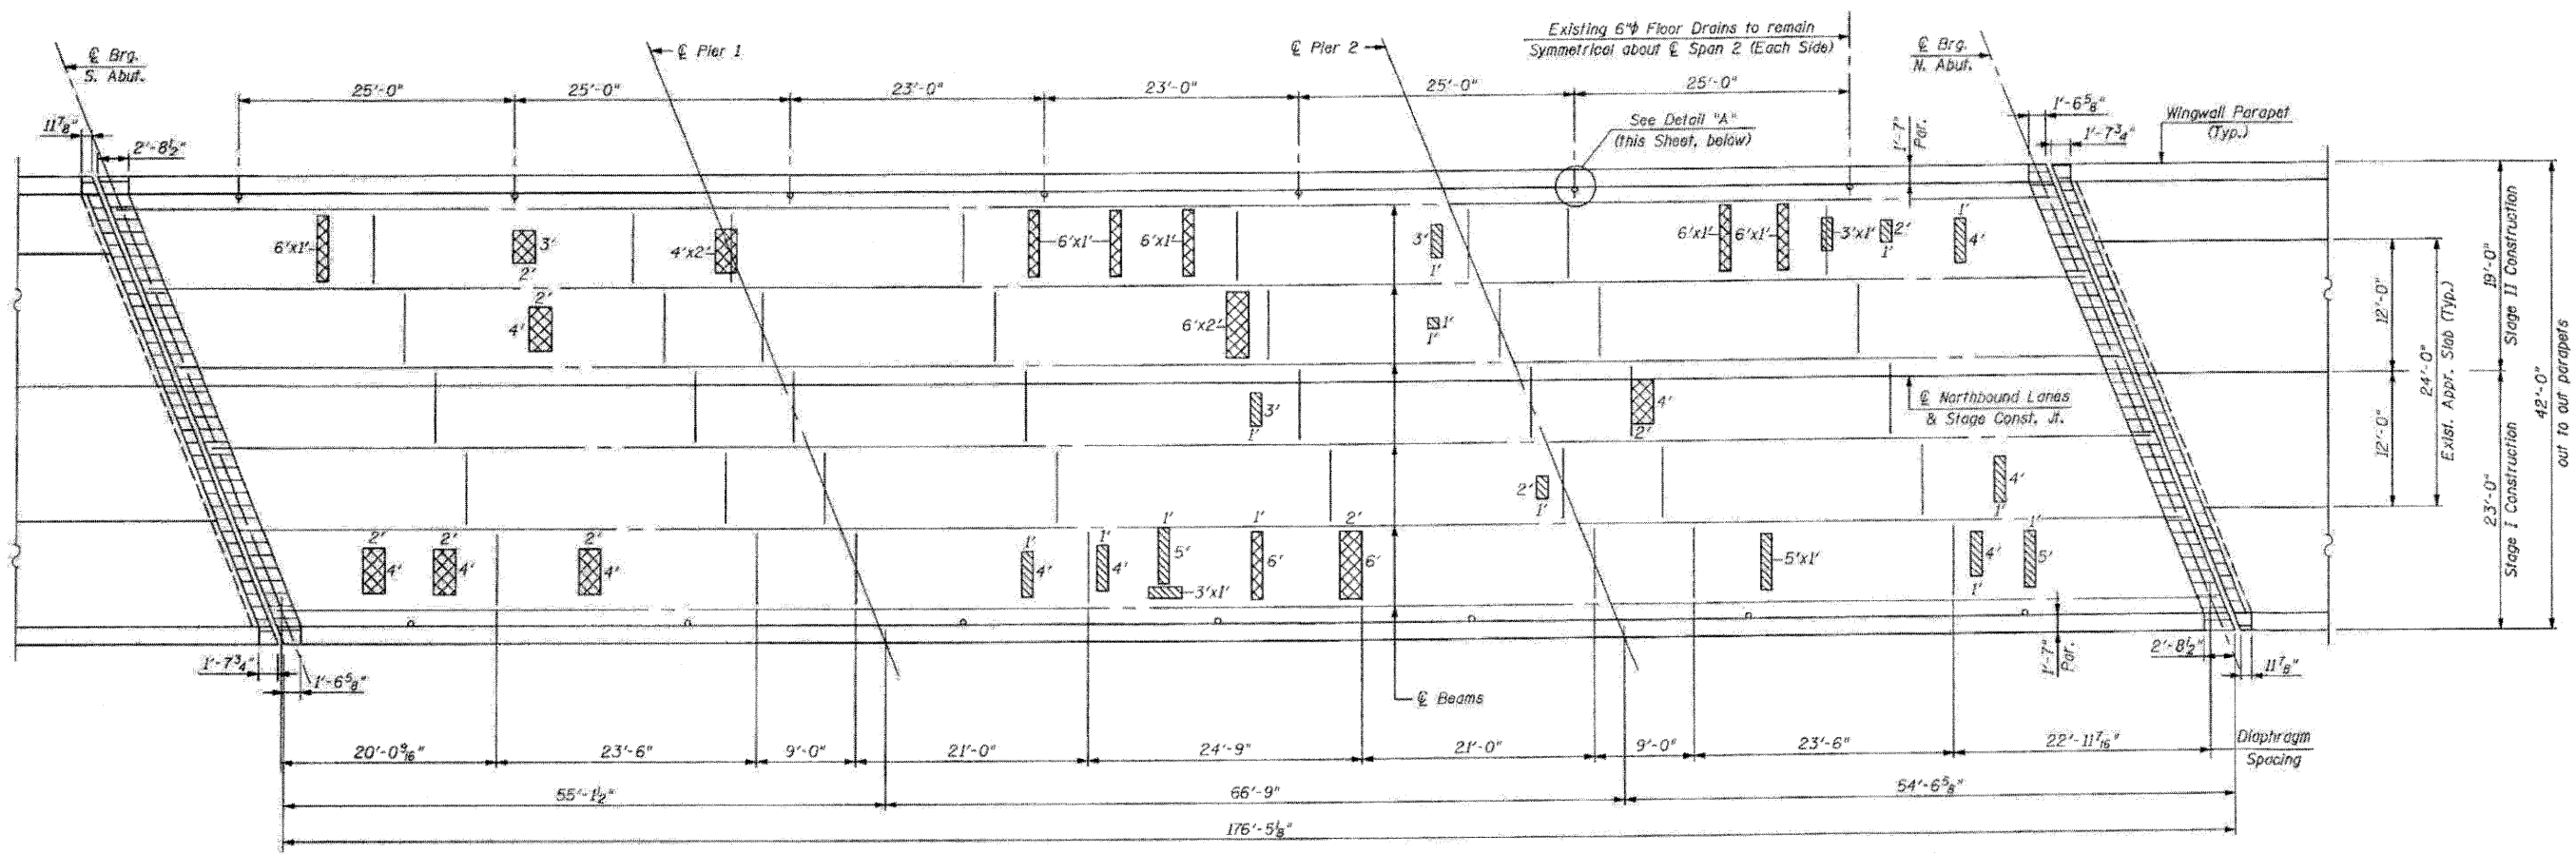
DECK PLAN

- Deck Slab Repair (Full Depth, Type I)
- Deck Slab Repair (Full Depth, Type II)
- Joint Reconstruction

NOTE
No Partial-Depth Repairs were Found
