DECK PATCHING PLAN
IL 106 OVER HADLEY CREEK
SN 075-0004

SHEET NO. 5	F.A.P. RTE.	SECTION	COUNTY	TOTAL SHEETS	SHEET NO.
	751	D6 BRIDGE REPAIR 2009	PIKE	22	22
5 SHEETS	CONTRACT NO. 72D44				
FED. ROAD DIST. NO.		ILLINOIS FED. AID PROJECT

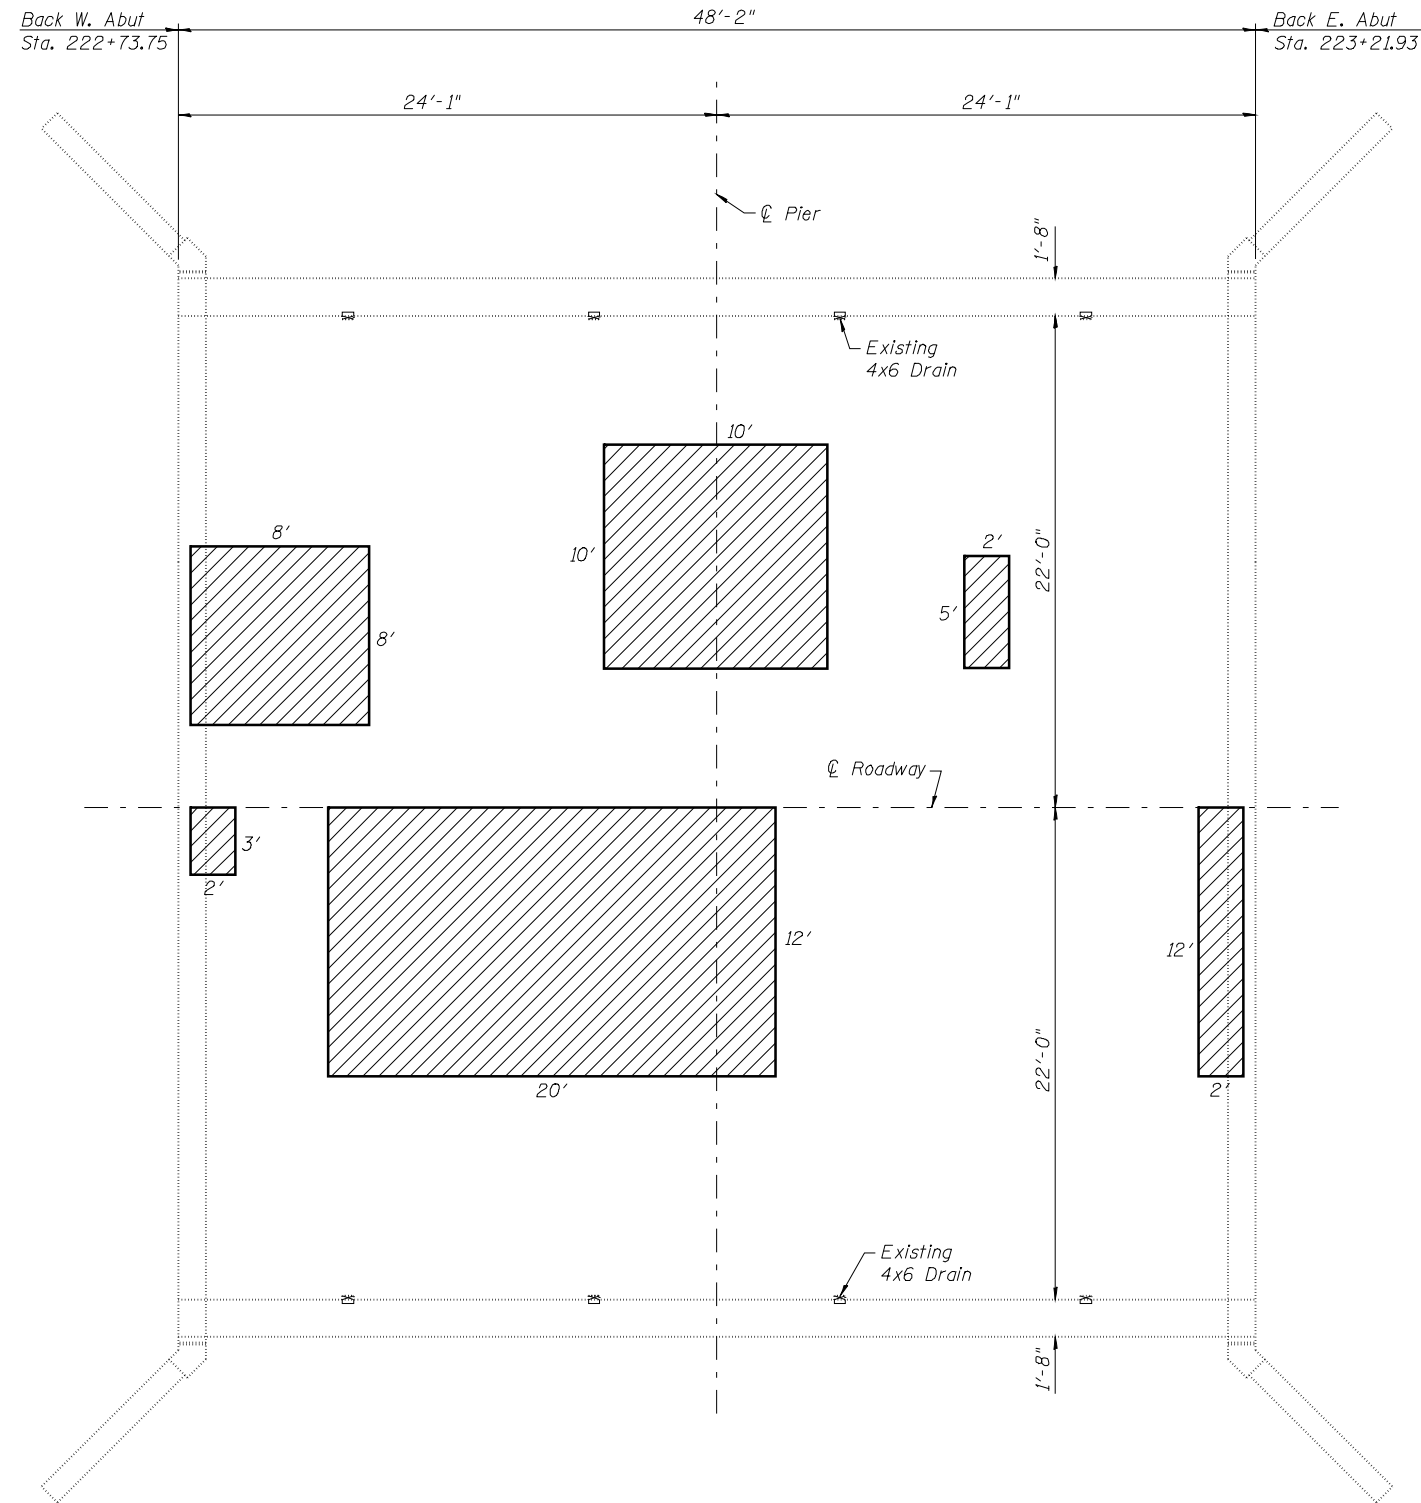
Deck Slab Repair (Partial Depth) - 50 SQ. YD.
 Note: Partial Depth Repair shall be achieved by bridge deck hydro-scarification and filled with microsilica concrete overlay. Cast included in "BRIDGE DECK HYDRO-SCARIFICATION 2 1/2" " and "BRIDGE DECK MICROSILICA CONCRETE OVERLAY 2 1/4" "
