TAYLORVILLE MUNICIPAL AIRPORT  
TAYLORVILLE, ILLINOIS

A.I.P. PROJ.: 3-17-0100-B11  
IL. PROJ.: TAZ-3890

REHABILITATE RUNWAY  
18-36 AND TAXIWAY "A"

PROPOSED PAVEMENT  
PREPARATION PLAN  
STA. 290+00 TO STA. 302+00

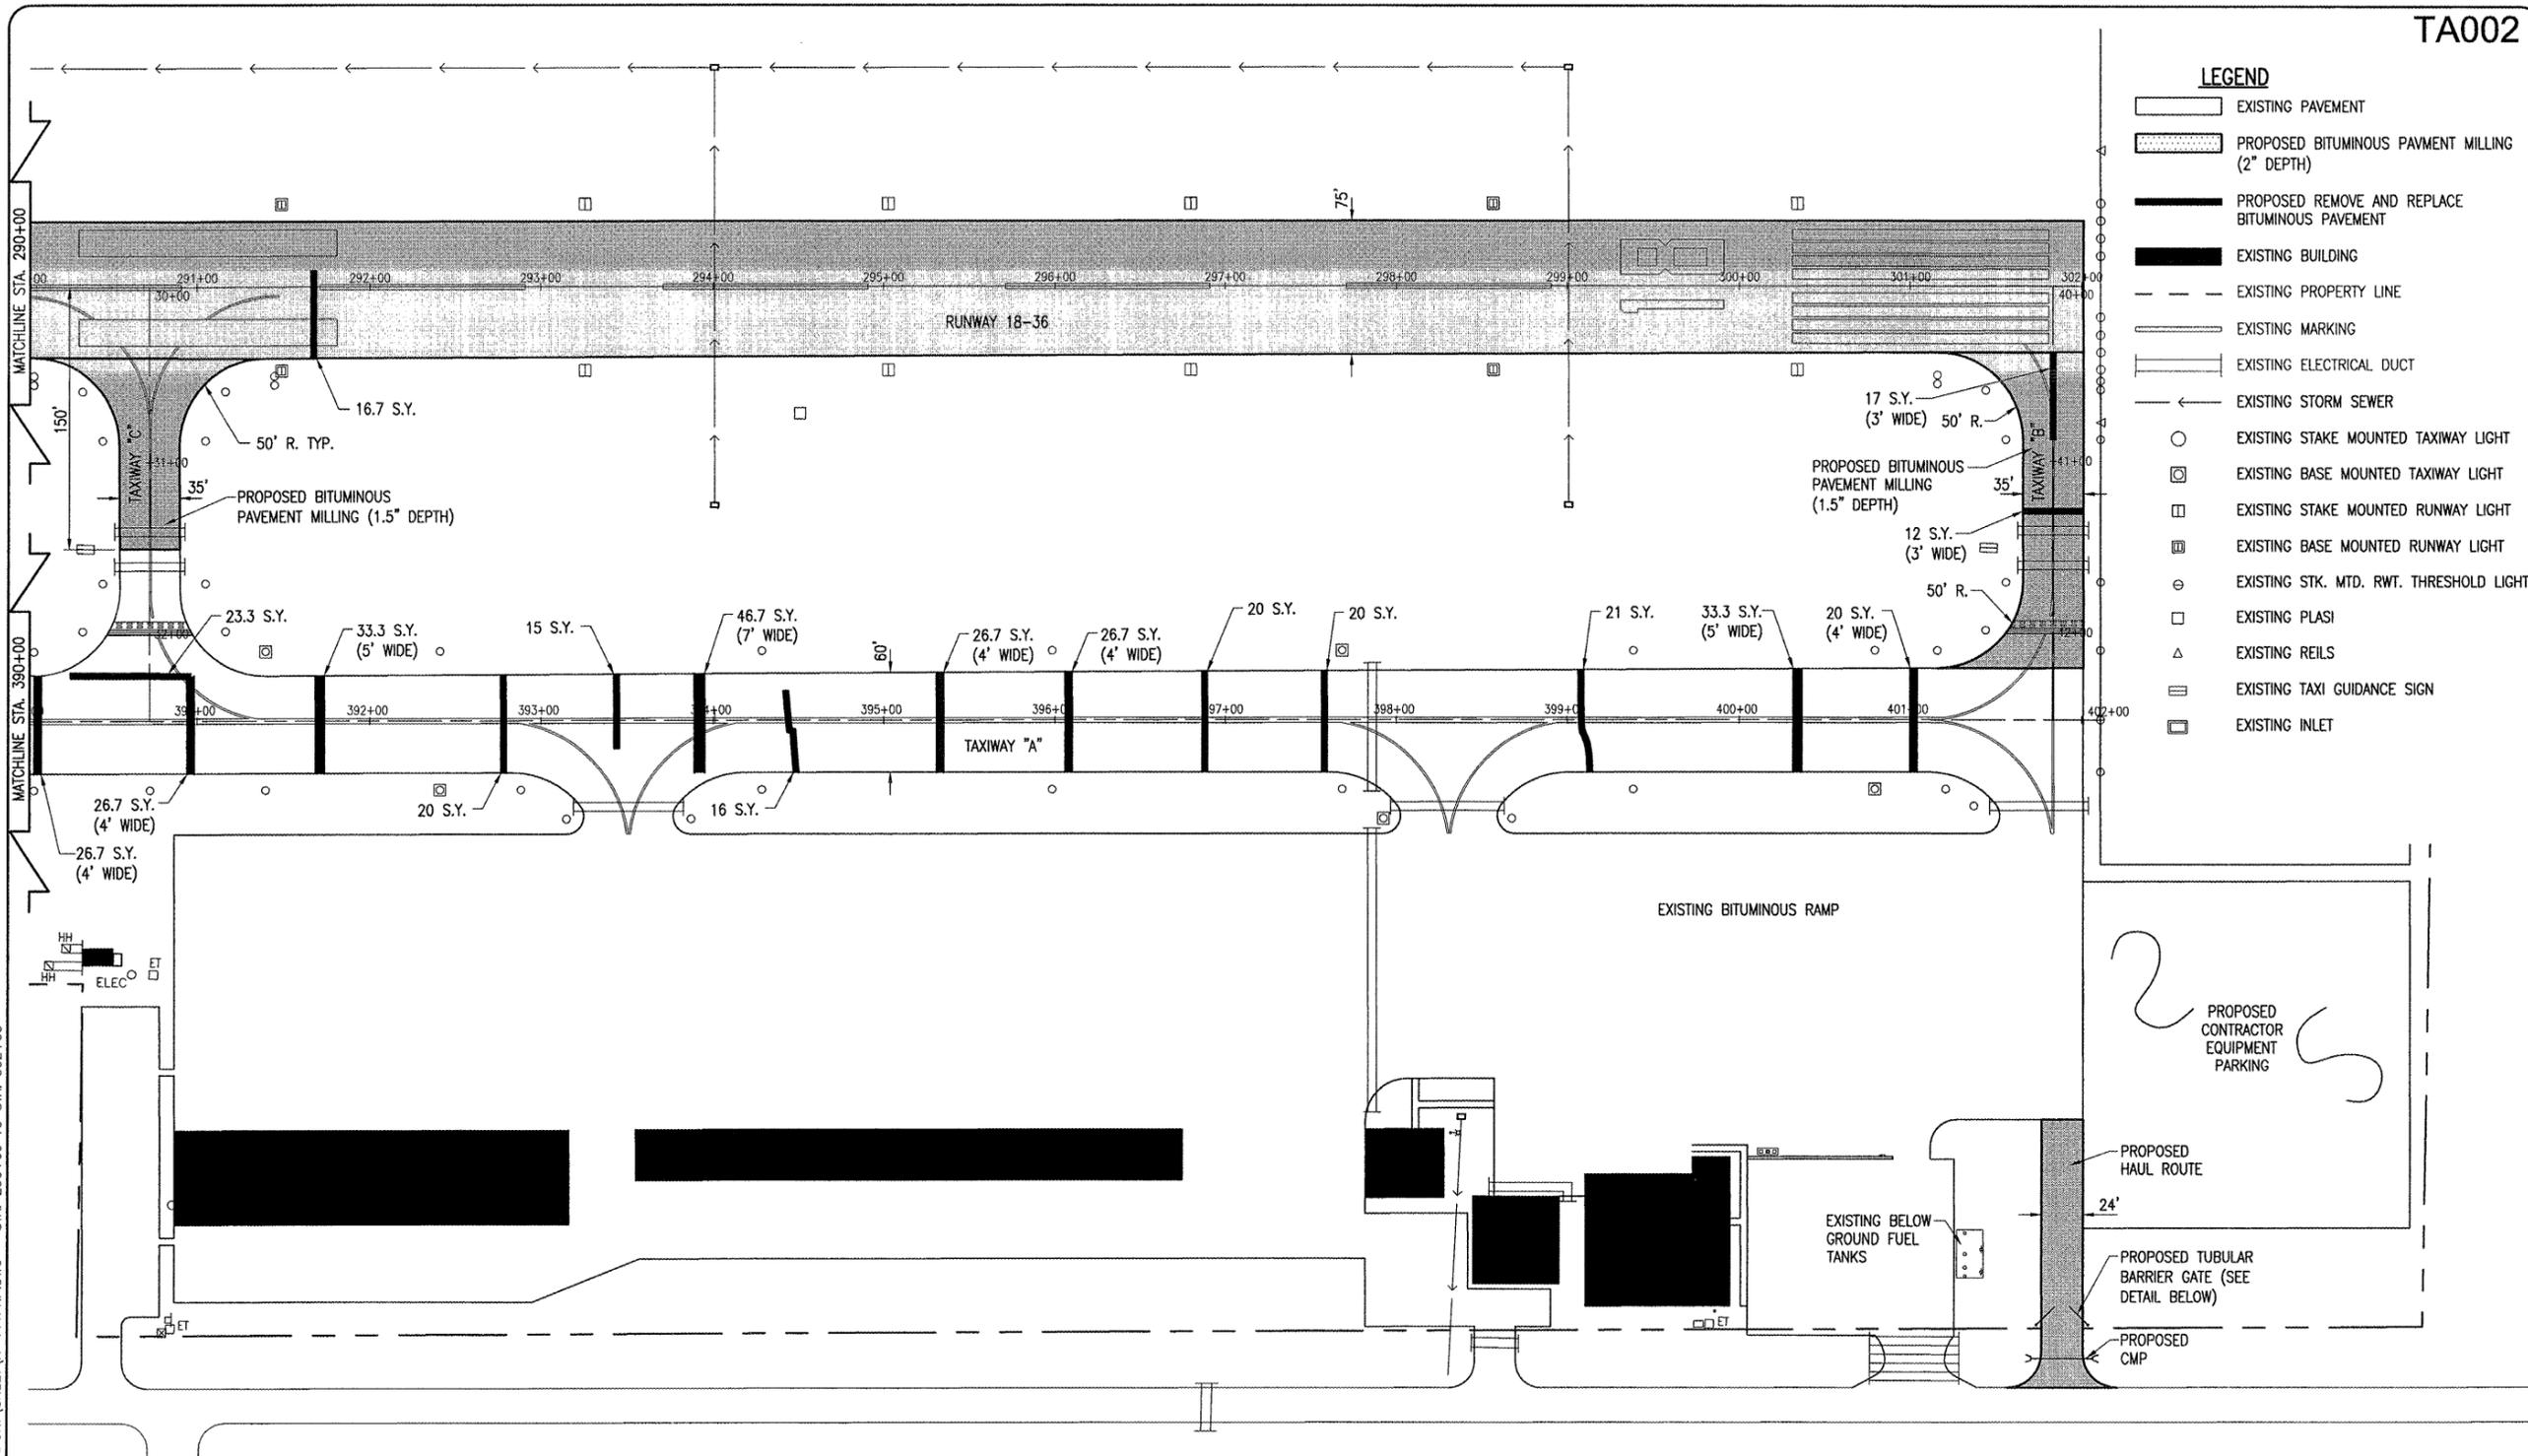
TA002

**THRESHOLD LIGHT REMOVAL NOTE**  
TEN FEET OFF EACH END OF THE RUNWAY ARE EIGHT EXISTING THRESHOLD LIGHTS. FOUR TO SIX OF THESE LIGHTS ON EACH END MAY BE IN THE PATH OF THE PAVING TRAIN (PAVER + TRUCK). THE CONTRACTOR, AT HIS DISCRETION MAY REMOVE THESE LIGHTS TO ALLOW FOR CLEARANCE OF THIS PAVING TRAIN. THE CONTRACTOR WILL DOCUMENT ANY EXISTING PROBLEMS/DAMAGE TO THESE LIGHTS AND RE-INSTALL THEM IN THE SAME LOCATION TO PRE-CONSTRUCTION CONDITION. THIS WILL BE AN ITEM THAT IS CONSIDERED PART OF THE PAVING OPERATION AND NO ADDITIONAL COMPENSATION WILL BE ALLOWED.
