SUBSTRUCTURE REPAIR DETAIL

SN 098-0051 SOUTH ABUTMENT (LOOKING SOUTH)

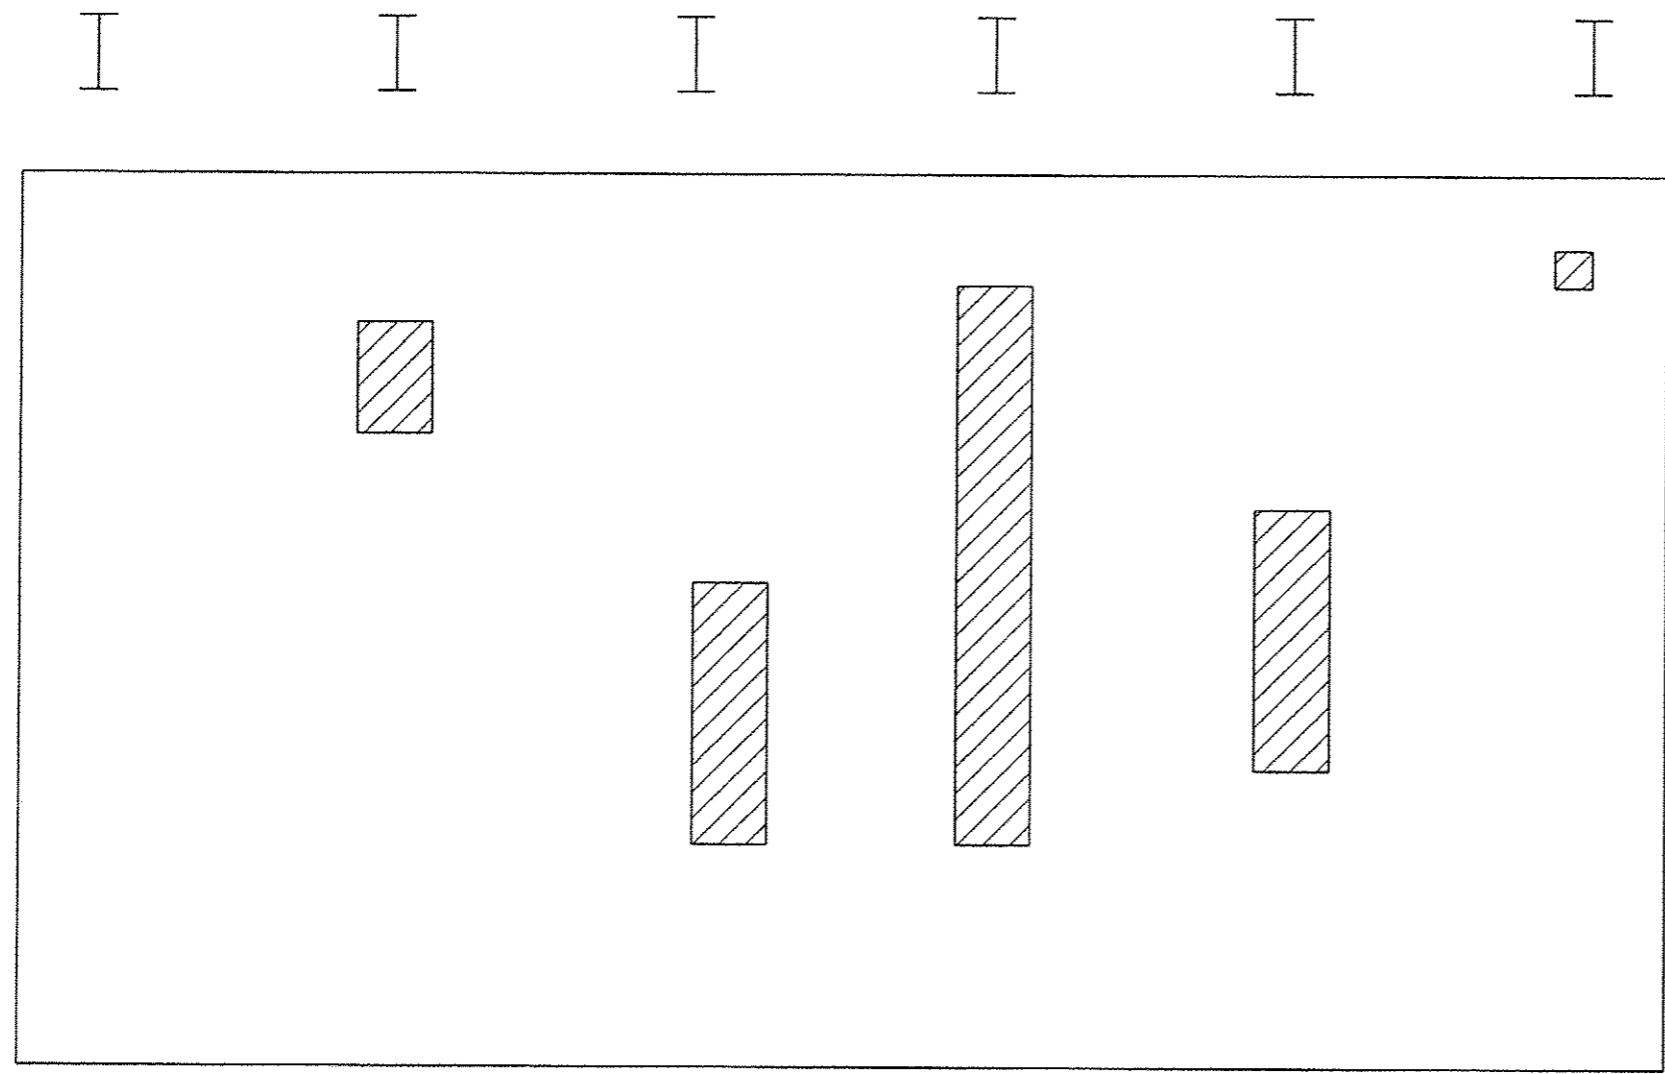
SN 098-0051
SOUTH ABUTMENT (LOOKING SOUTH)

ITEM	QUANTITY
(*) STRUCTURAL REPAIR OF CONCRETE \leq 5"	47.0 (SQ FT)
(*) STRUCTURAL REPAIR OF CONCRETE $>$ 5"	2.0 (SQ FT)

(*) THIS IS AN ESTIMATED QUANTITY. THE ACTUAL LOCATION OF DELAMINATED AREAS AND QUANTITIES WILL BE DETERMINED BY THE RESIDENT ENGINEER IN THE FIELD.
