SUBSTRUCTURE REPAIR DETAIL

SN 098-0051 PIER #3 (NORTH FACE - LOOKING SOUTH)

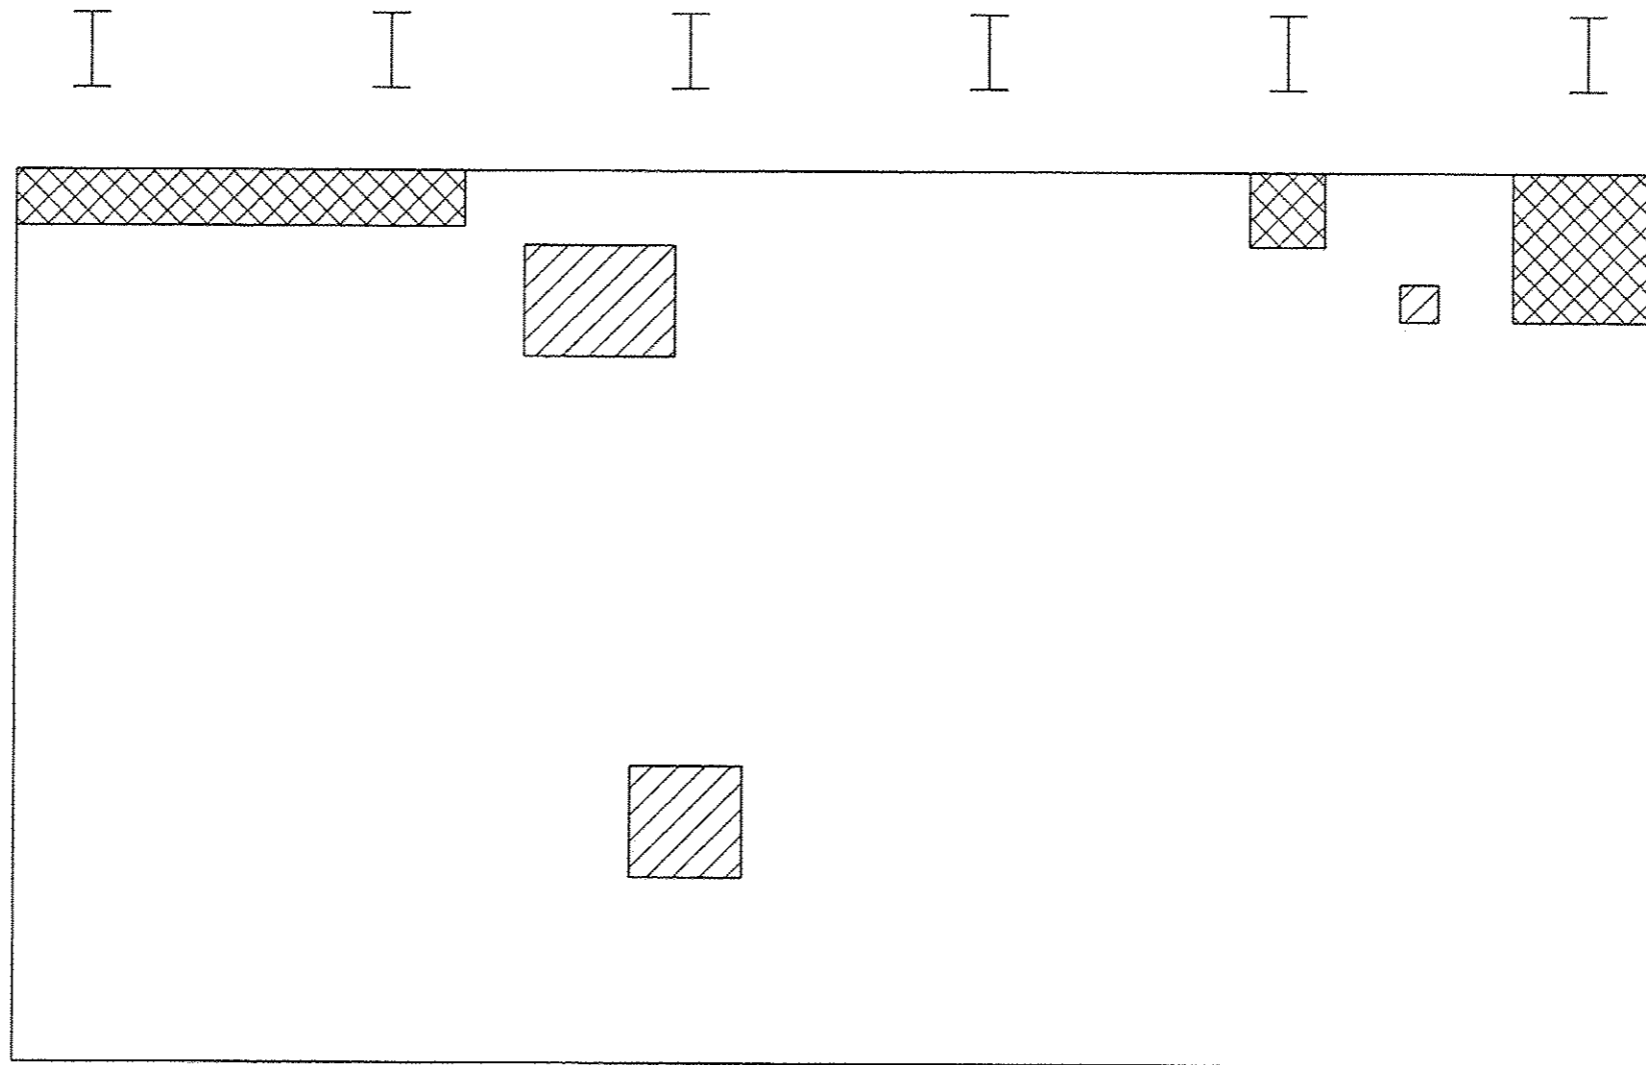
ITEM	QUANTITY
(*) STRUCTURAL REPAIR OF CONCRETE \leq 5"	22.0 (SQ FT)
(*) STRUCTURAL REPAIR OF CONCRETE $>$ 5"	38.0 (SQ FT)

(*) THIS IS AN ESTIMATED QUANTITY. THE ACTUAL LOCATION OF DELAMINATED AREAS AND QUANTITIES WILL BE DETERMINED BY THE RESIDENT ENGINEER IN THE FIELD.

⊗ DELAMINATED AREA $>$ 5"
 ⊘ DELAMINATED AREA \leq 5"
