# SUBSTRUCTURE REPAIR DETAIL

## SN 098-0052 SOUTH ABUTMENT (LOOKING SOUTH)

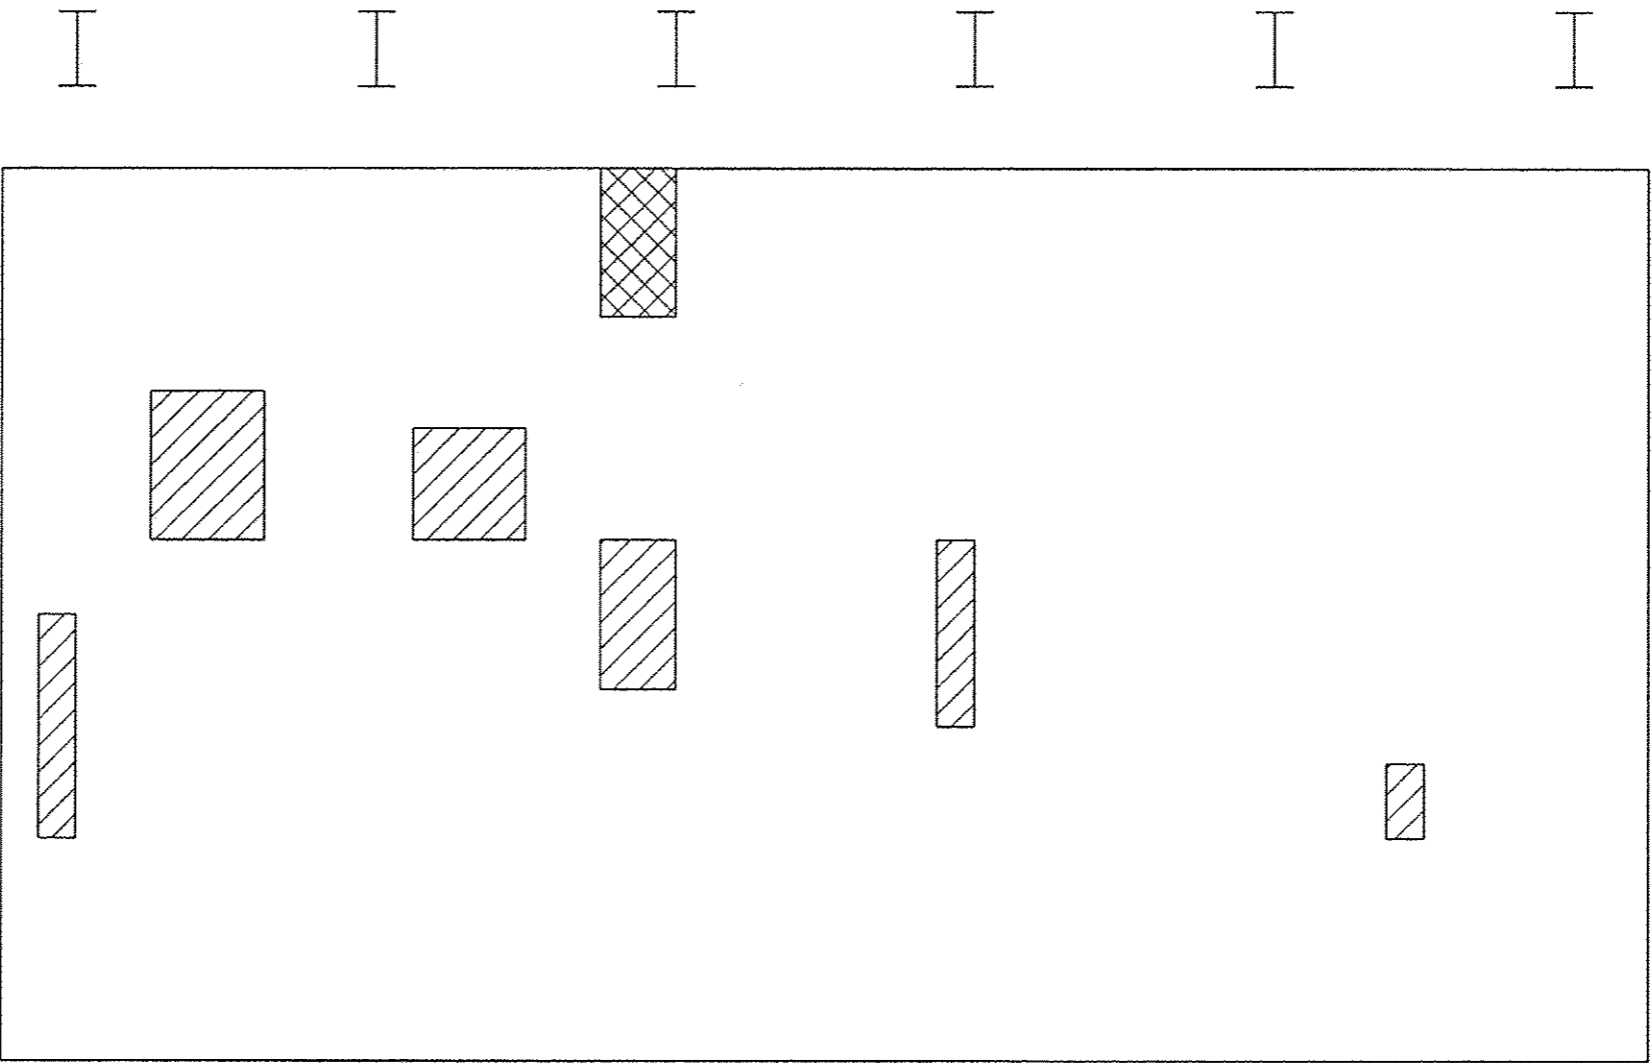
SN 098-0052  
SOUTH ABUTMENT (LOOKING SOUTH)

ITEM	QUANTITY
(*) STRUCTURAL REPAIR OF CONCRETE $\leq$ 5"	41.5 (SQ FT)
(*) STRUCTURAL REPAIR OF CONCRETE $>$ 5"	8.0 (SQ FT)

(\*) THIS IS AN ESTIMATED QUANTITY. THE ACTUAL LOCATION OF DELAMINATED AREAS AND QUANTITIES WILL BE DETERMINED BY THE RESIDENT ENGINEER IN THE FIELD.
