# SUBSTRUCTURE REPAIR DETAIL

## SN 098-0051 PIER #3 (SOUTH FACE - LOOKING NORTH)

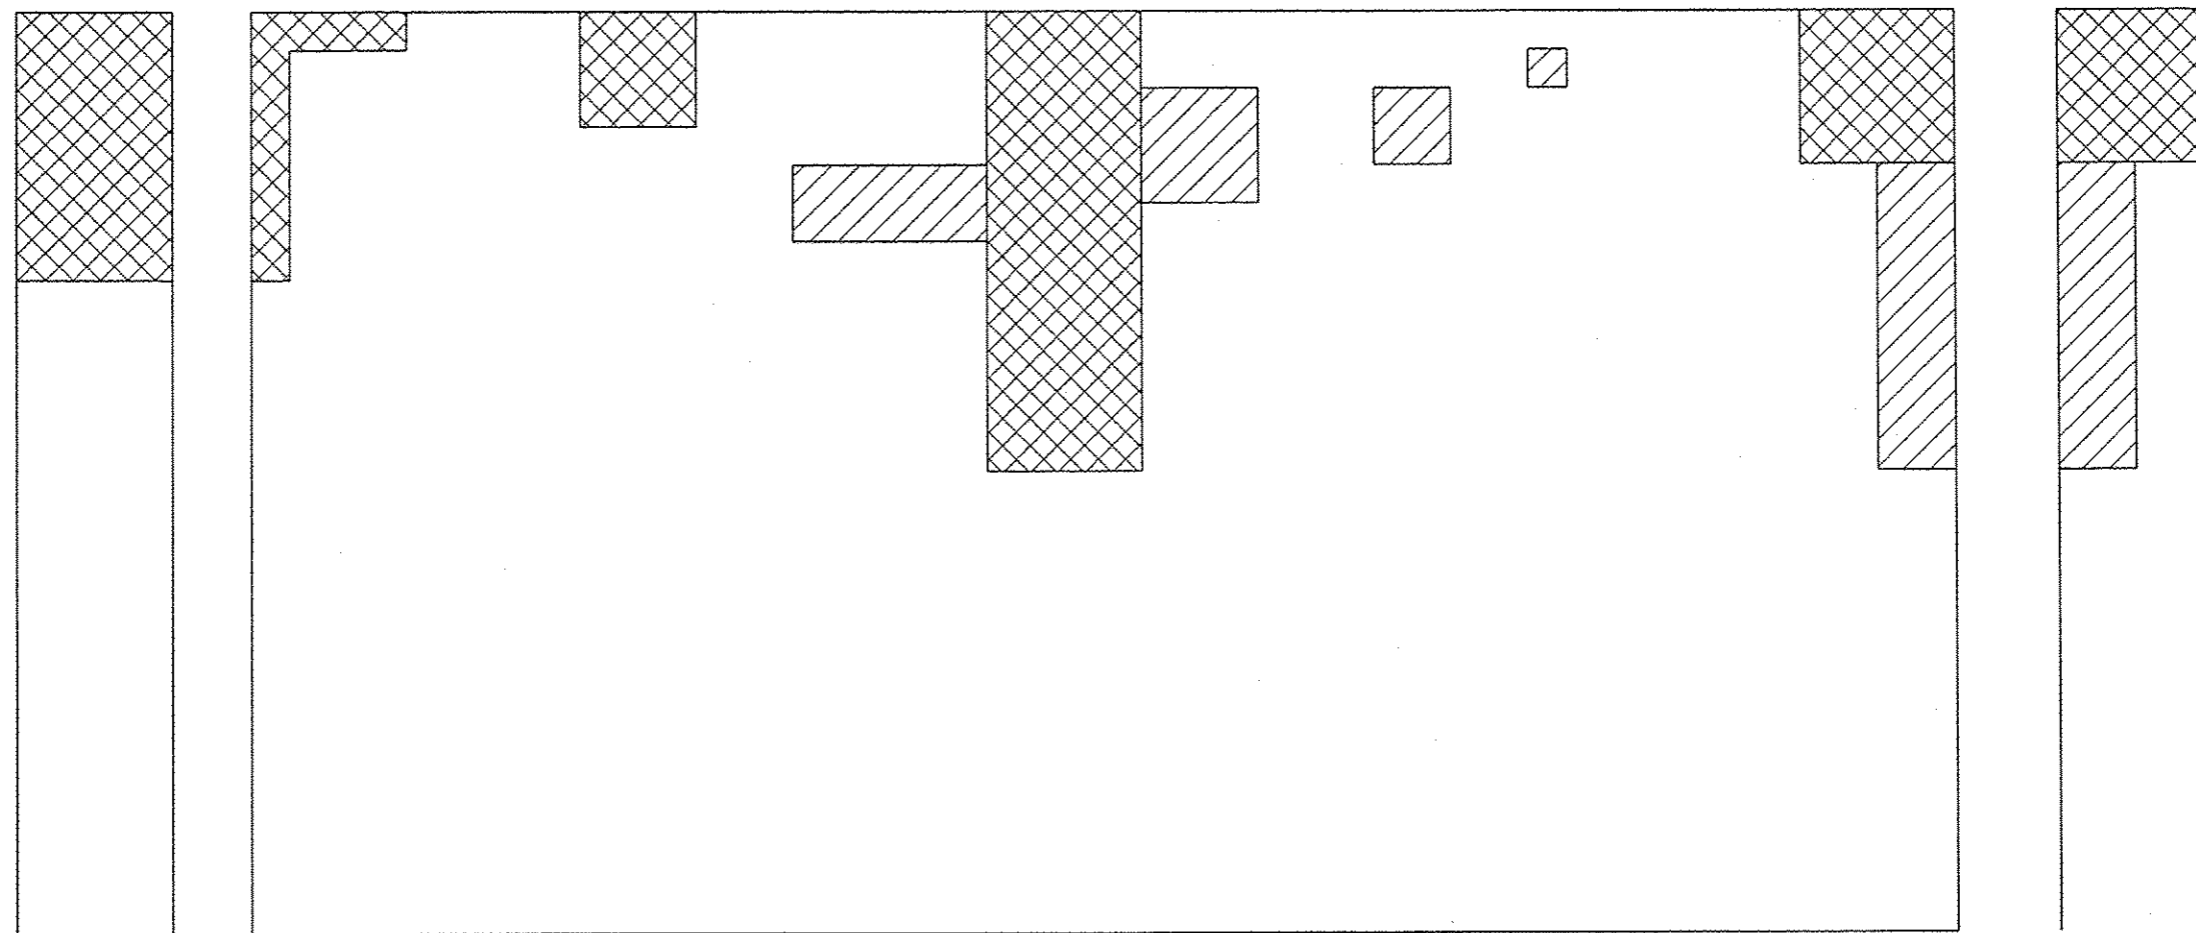
SN 098-0051  
PIER #3 (SOUTH FACE - LOOKING NORTH)

ITEM	QUANTITY
(*) STRUCTURAL REPAIR OF CONCRETE ≤ 5"	88.5 (SQ FT)
(*) STRUCTURAL REPAIR OF CONCRETE > 5"	159.0 (SQ FT)
TEMPORARY SHORING AND CRIBBING	1 (EACH)

(\* THIS IS AN ESTIMATED QUANTITY. THE ACTUAL LOCATION OF DELAMINATED AREAS AND QUANTITIES WILL BE DETERMINED BY THE RESIDENT ENGINEER IN THE FIELD.
