SUBSTRUCTURE REPAIR DETAIL

SN 098-0052 NORTH ABUTMENT (LOOKING NORTH)

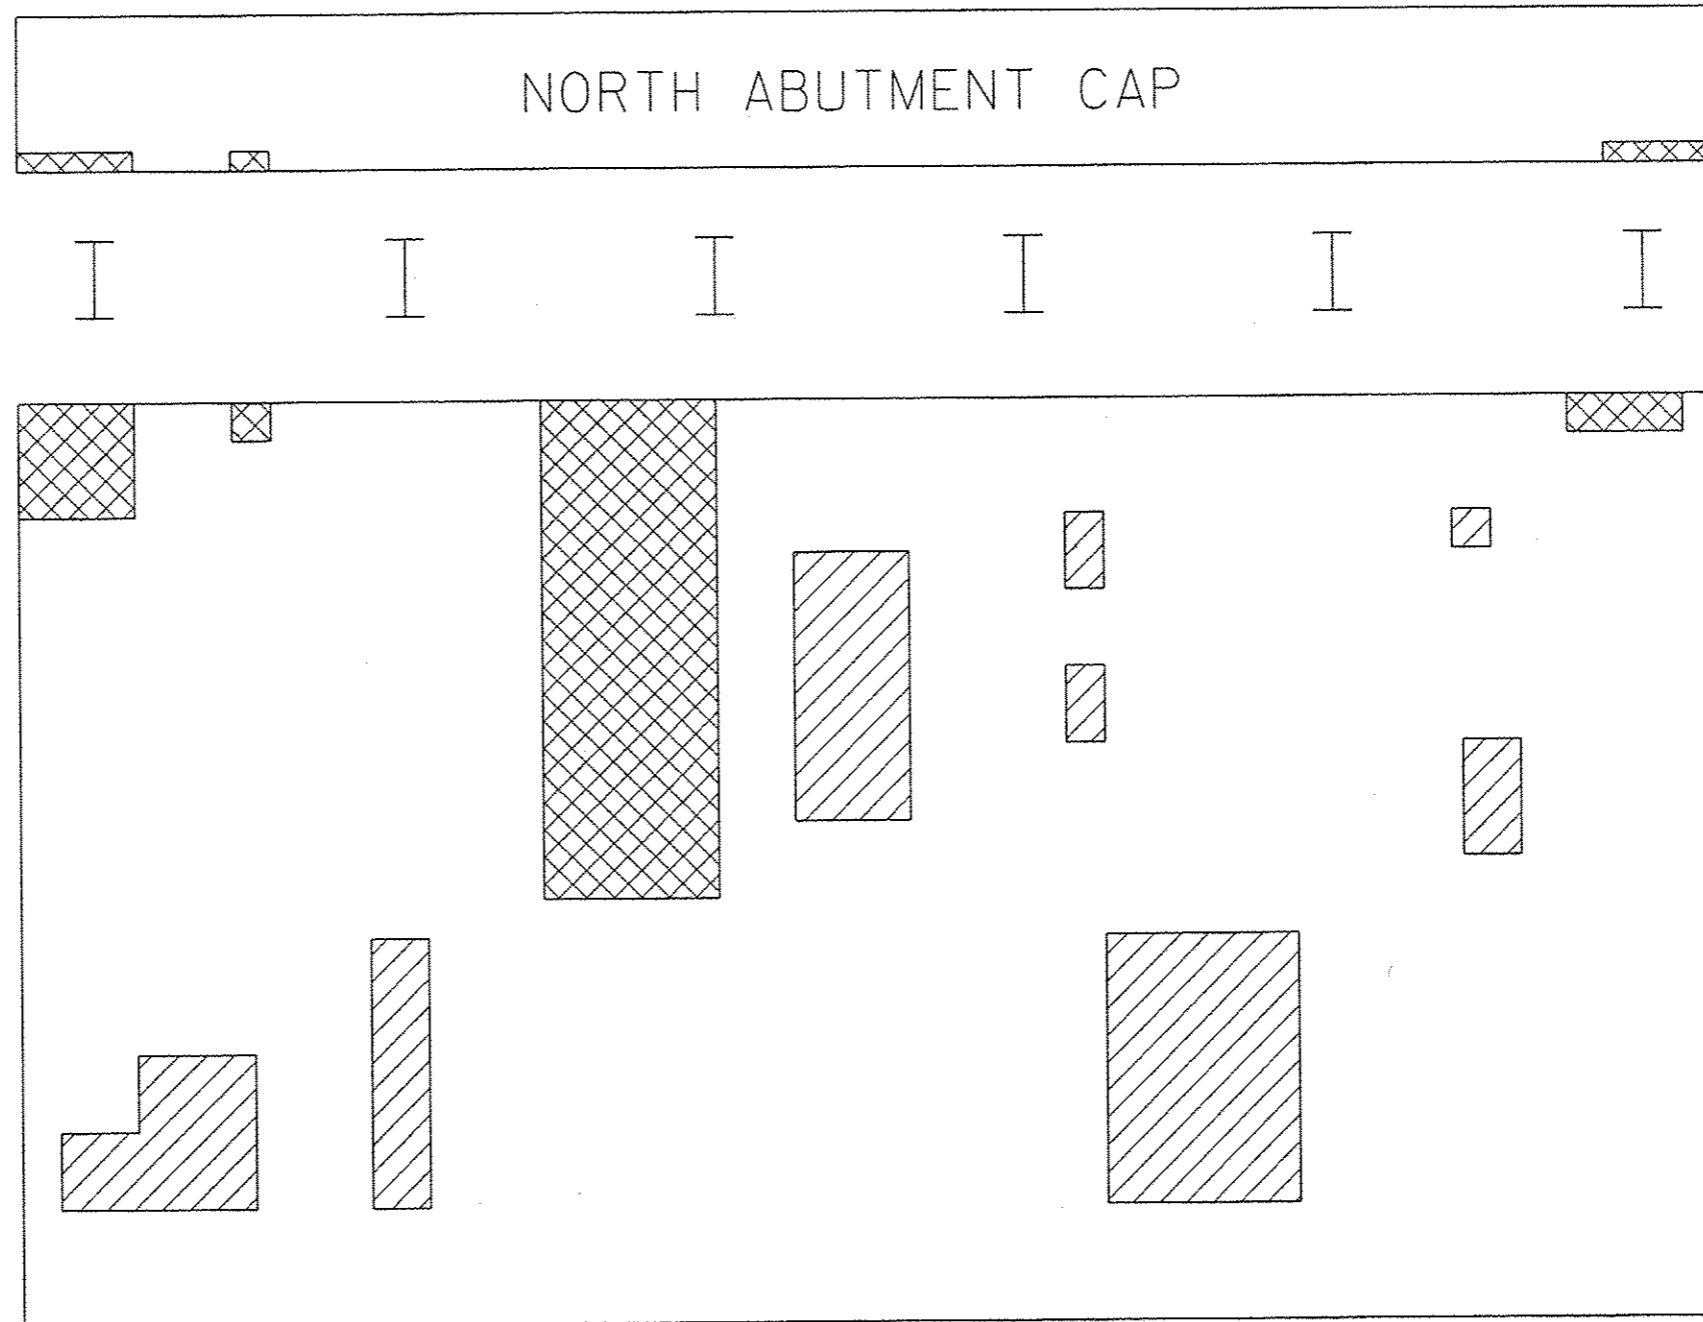
SN 098-0052
NORTH ABUTMENT (LOOKING NORTH)

(*) THIS IS AN ESTIMATED QUANTITY. THE ACTUAL LOCATION OF DELAMINATED AREAS AND QUANTITIES WILL BE DETERMINED BY THE RESIDENT ENGINEER IN THE FIELD.

ITEM	QUANTITY
(*) STRUCTURAL REPAIR OF CONCRETE \leq 5"	90.0 (SQ FT)
(*) STRUCTURAL REPAIR OF CONCRETE $>$ 5"	74.4 (SQ FT)
TEMPORARY SHORING AND CRIBBING	1 (EACH)
