**STATE OF ILLINOIS
DEPARTMENT OF TRANSPORTATION**

**PIER 8 REPAIRS
EB US ROUTE 20 OVER PECATONICA RIVER STRUCTURE NO. 089-0042**

SHEET NO. S24 OF S26 SHEETS

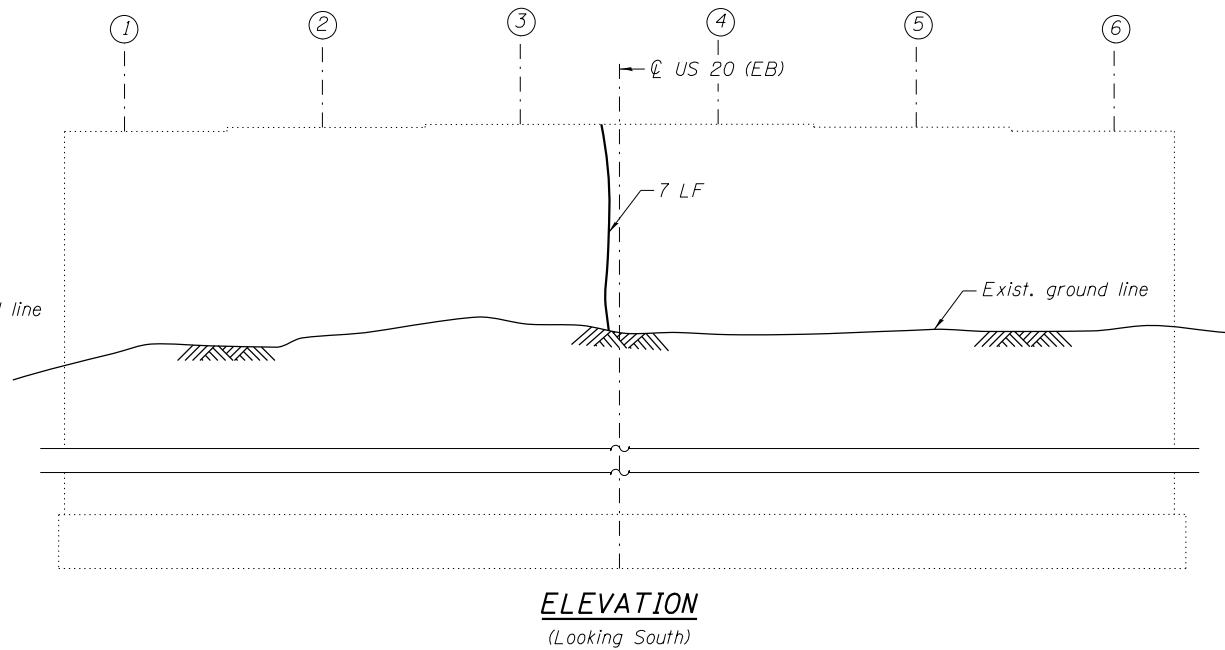
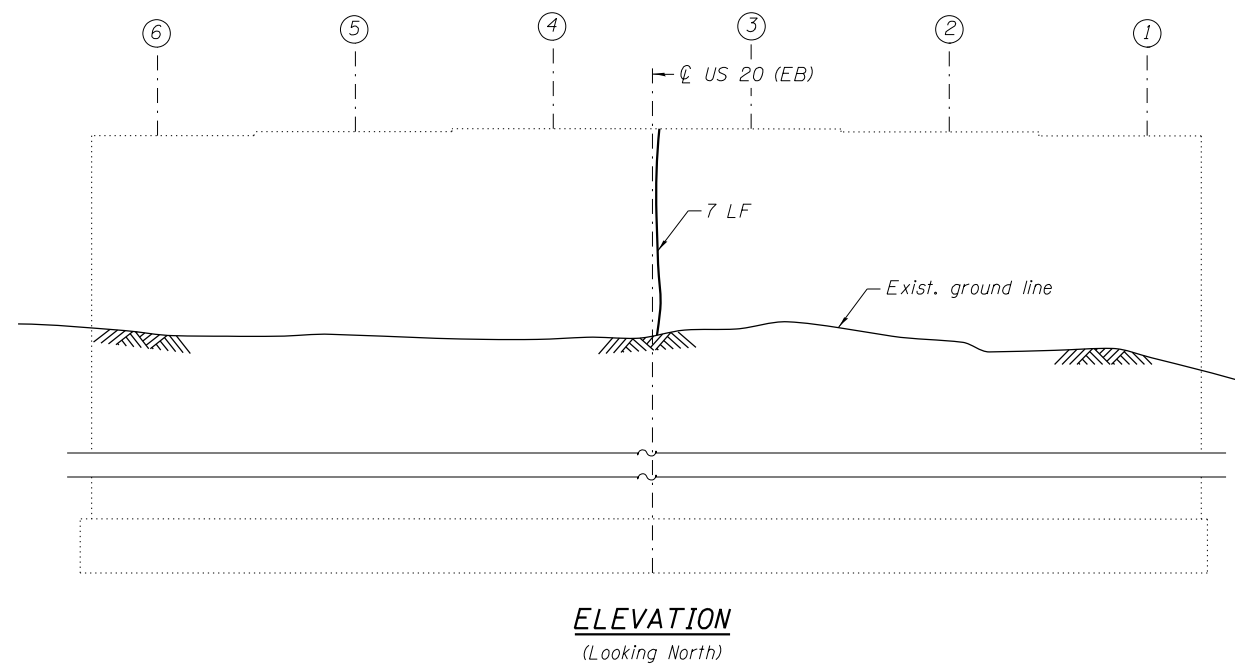
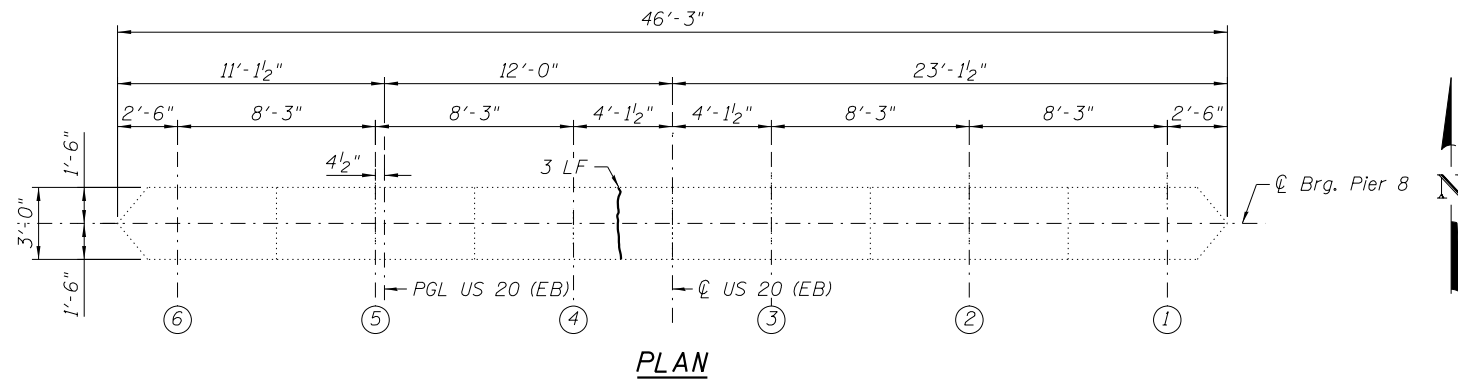
- Low Pressure Epoxy Injection (Width > 0.06")
- Linear Foot
