**STATE OF ILLINOIS
DEPARTMENT OF TRANSPORTATION**

**PIER REPAIRS
STRUCTURE NO. 054-0058 (SB)**
SHEET NO. 27 OF 31 SHEETS

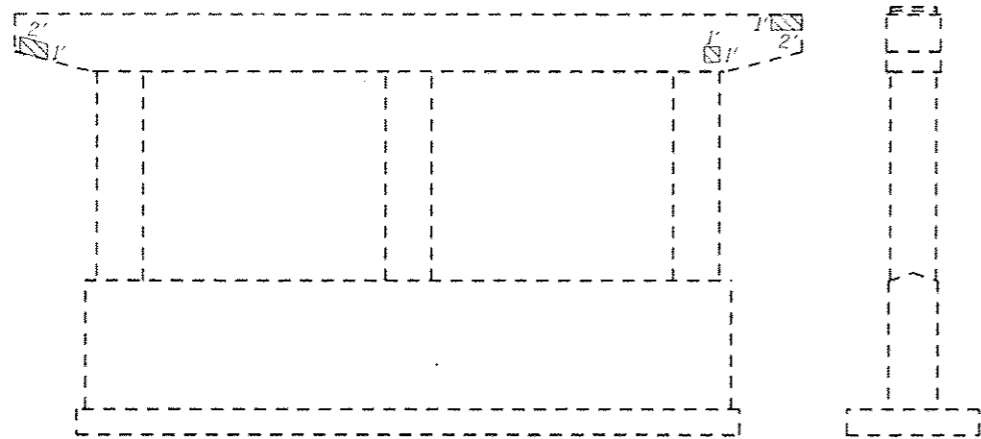
Pier 1 S.B. WEST FACE

Pier 1 S.B. SOUTH END
