PARTIAL PLAN

ILLINOIS DEPARTMENT OF TRANSPORTATION
DECK REPAIR-4
F.A.P. 326 (IL RTE. 47)
OVER FOX RIVER
SECTION (108,109)RS-4
KENDALL COUNTY
S.N. 047-0048

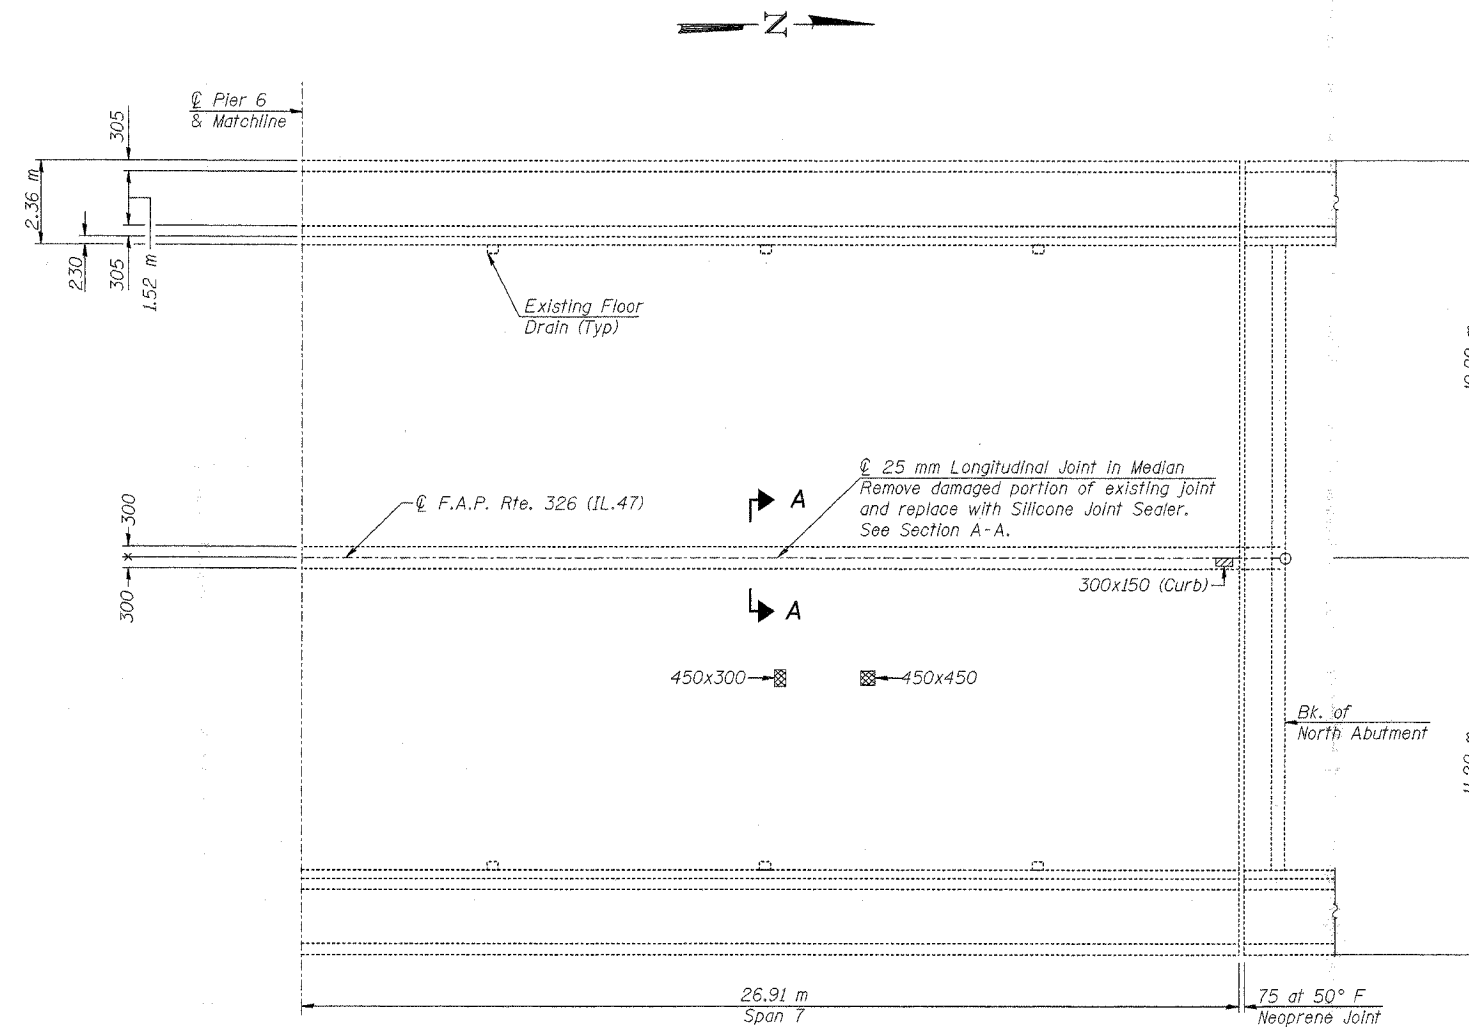
- * Deck Slab Repair (Full Depth, Type I) (In areas with planks)
- Structural Repair of Concrete (Depth equal to or less than 125 mm)

Deck Survey Date: 11/22/04

Notes: For details of Deck Slab Repair see Special Provision for "Deck Slab Repair."

The quantities shown for estimating purposes only. Area to be repaired will be determined by the Engineer at the time of Construction. Actual repair locations shall be shown on the same as-built plans.
