CONTRACT NO. 64M74

**PROPOSED
 HIGHWAY PLANS**

PROJECT: NHPP-PEA2(247)
 FAI ROUTE 39 (I-39)
 SECTION (201-1B)BDR
 BRIDGE REHABILITATION
 S.N. 101-0133 SOUTHBOUND
 S.N. 101-0134 NORTHBOUND
 WINNEBAGO COUNTY

PROPOSED SCOPE OF WORK
 EPOXY INJECTION OF CRACKS AND CONCRETE REPAIRS OF PARAPETS

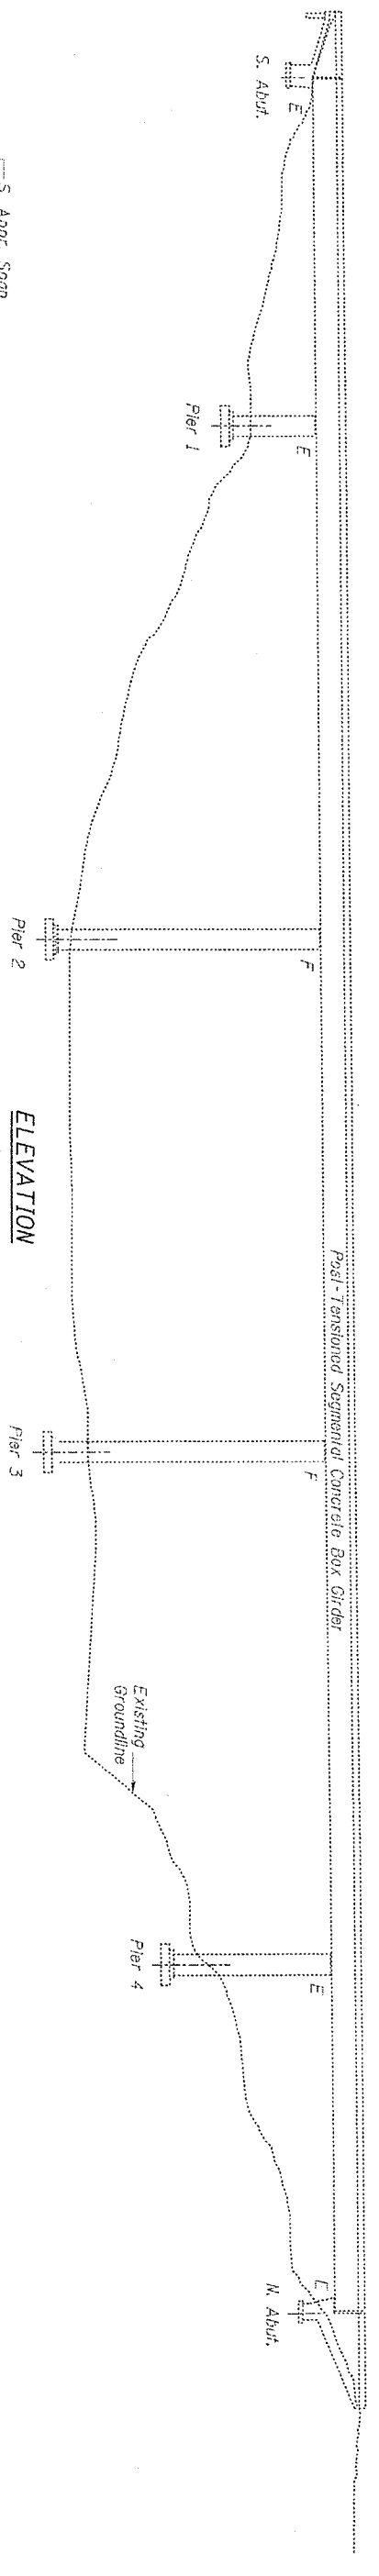
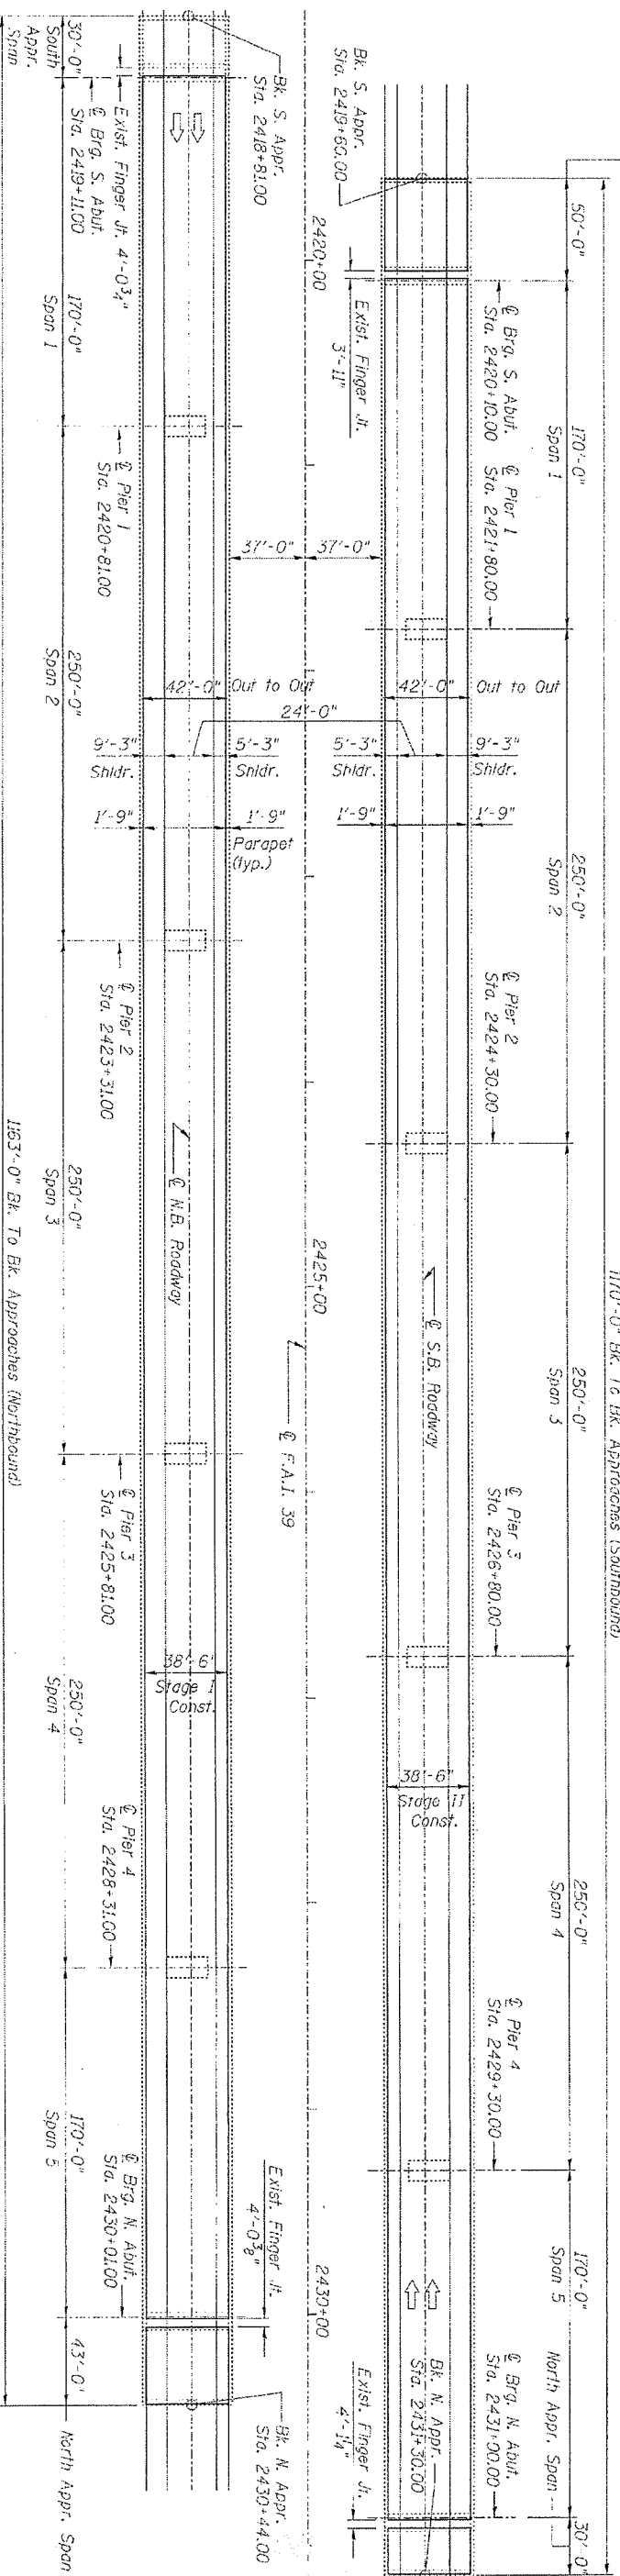
Existing Structure
 S.N. 101-0133 (S.B.) and S.N. 101-0134 (N.B.)
 Built as F.A. Route 412, Section 201 1B in 1980. The Southbound and Northbound superstructures each consist of a 1090'-0" post-tensioned segmental concrete box girder.
 In 2008 the Structure was reconstructed. The post-tensioned segmental concrete box girders were retrofitted with external post-tensioning, waterproofing membrane and wearing surface were removed and replaced, and a FAST system installed.

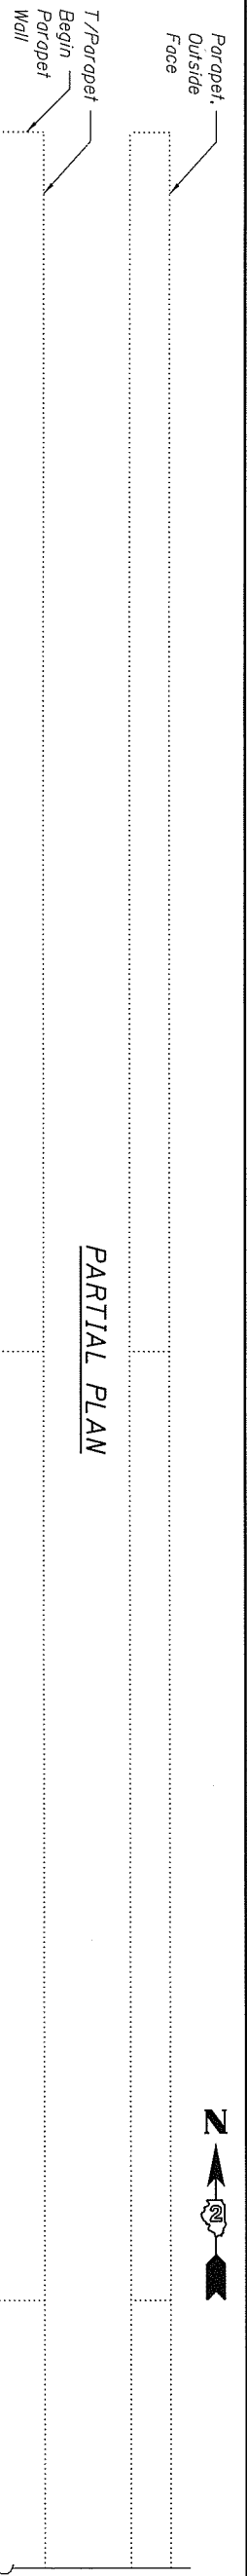
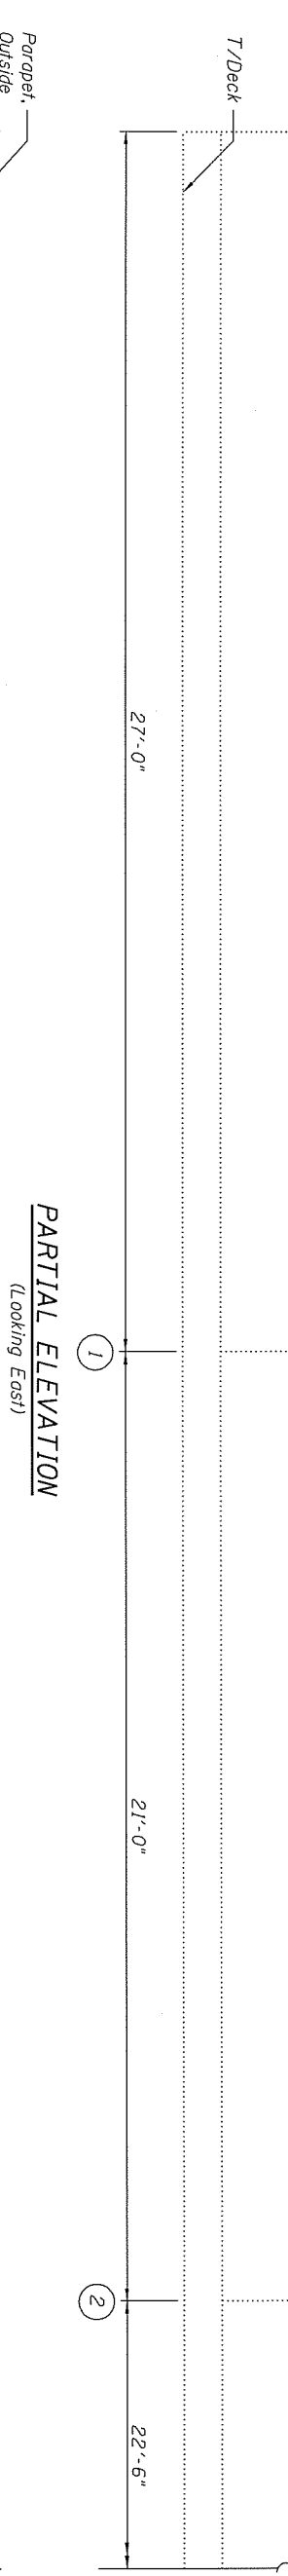
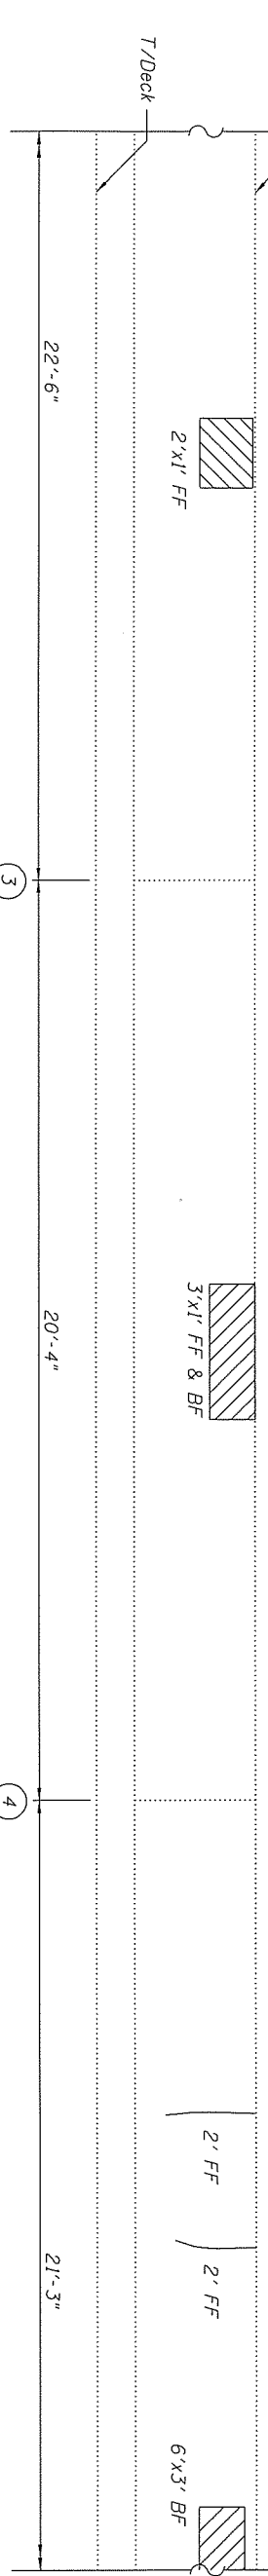
PARTIAL ELEVATION
(Looking East)

ITEM	UNIT	QUANTITY
Epoxy Crack Injection	Foot	12
Structural Repair of Concrete (Depth Equal to or less than 5 inches)	Sq. Ft.	42

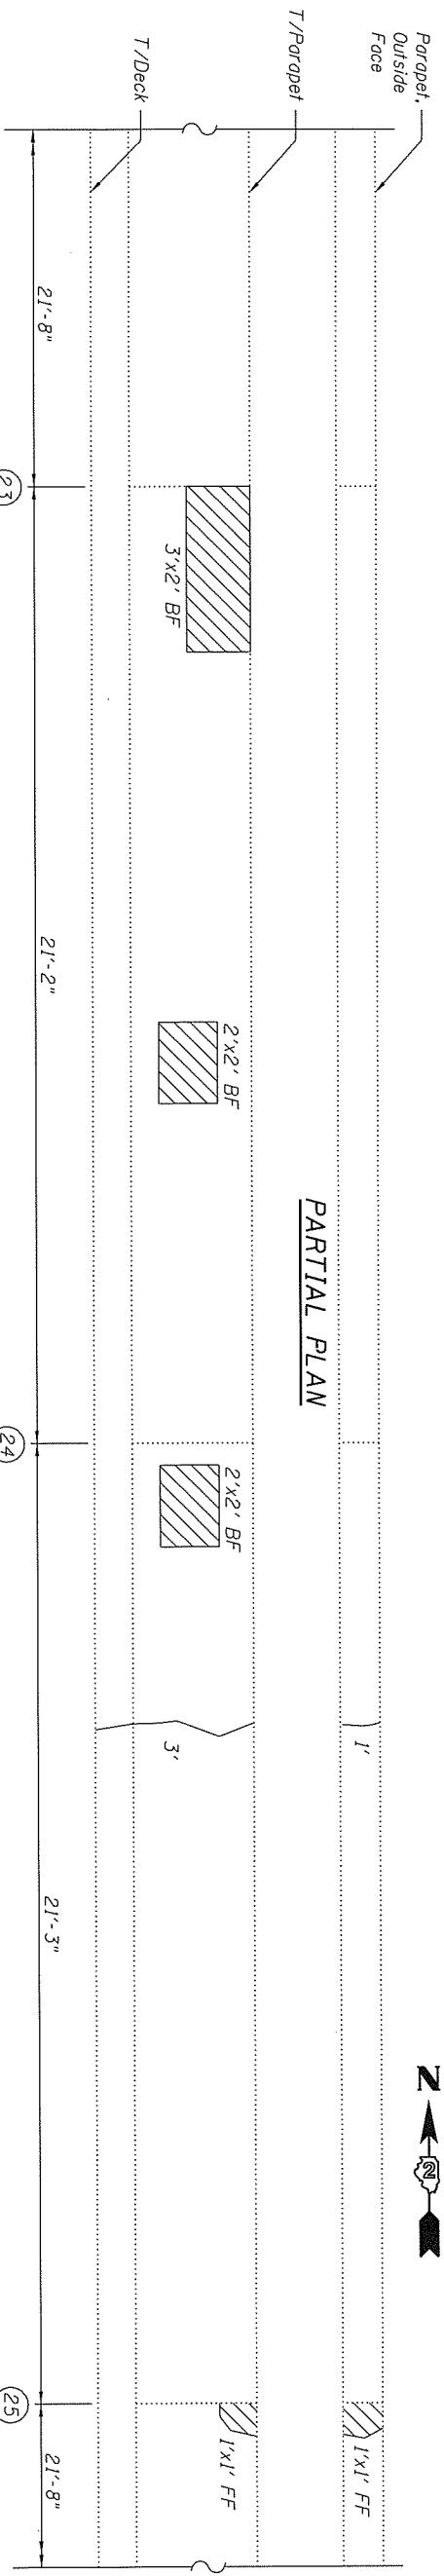
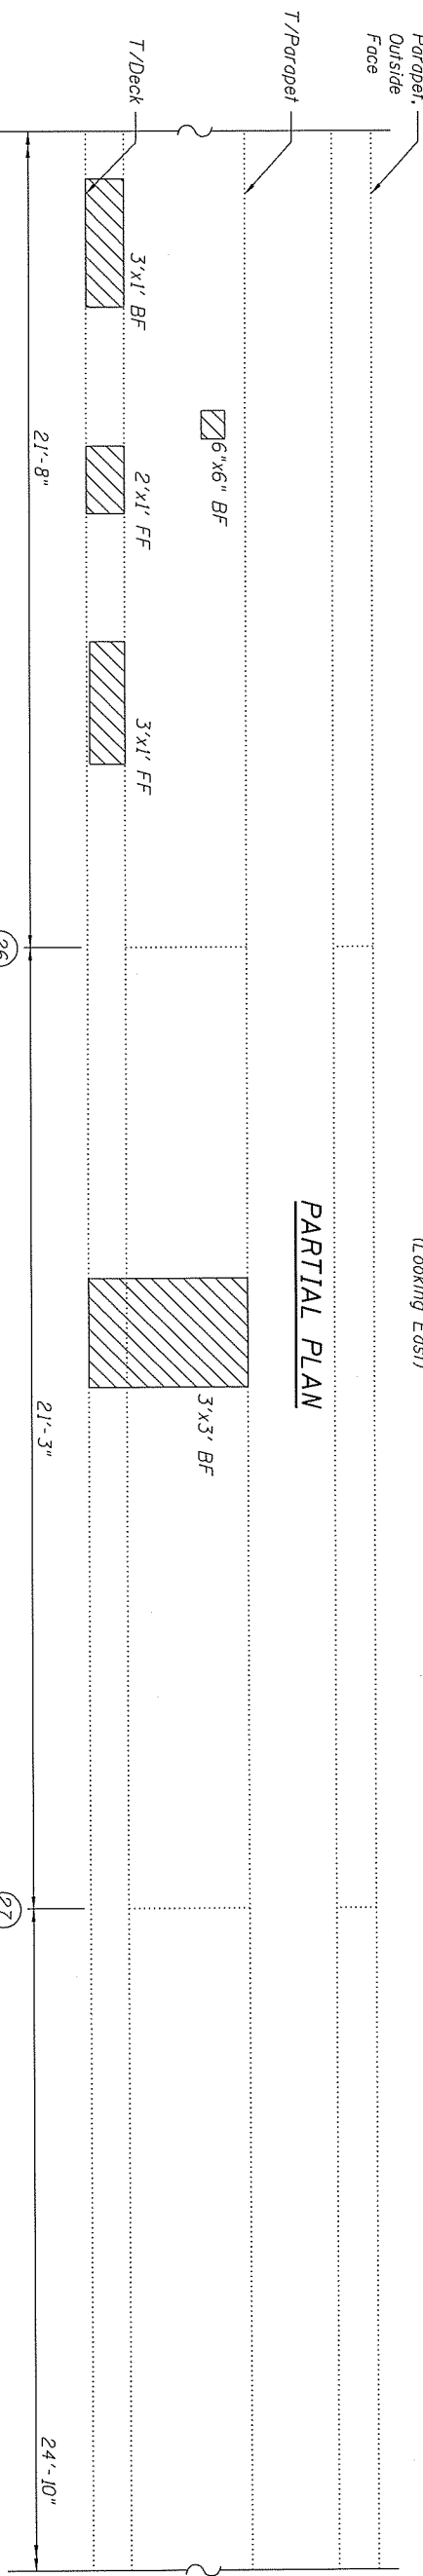
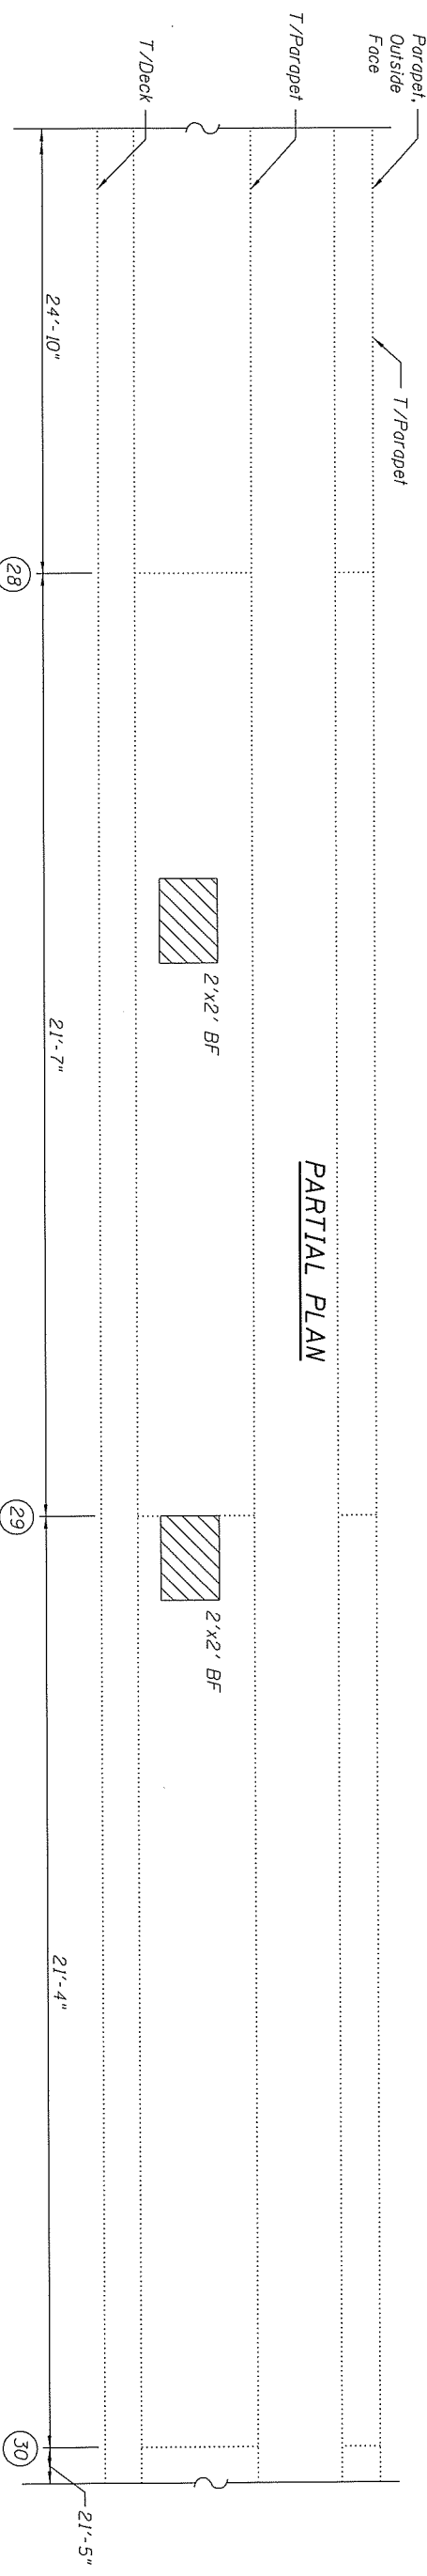
PARTIAL ELEVATION
(Looking East)

ITEM	UNIT	QUANTITY
Epoxy Crack Injection	Foot	4
Structural Repair of Concrete (Depth Equal to or less than 5 inches)	Sq. Ft.	41.3

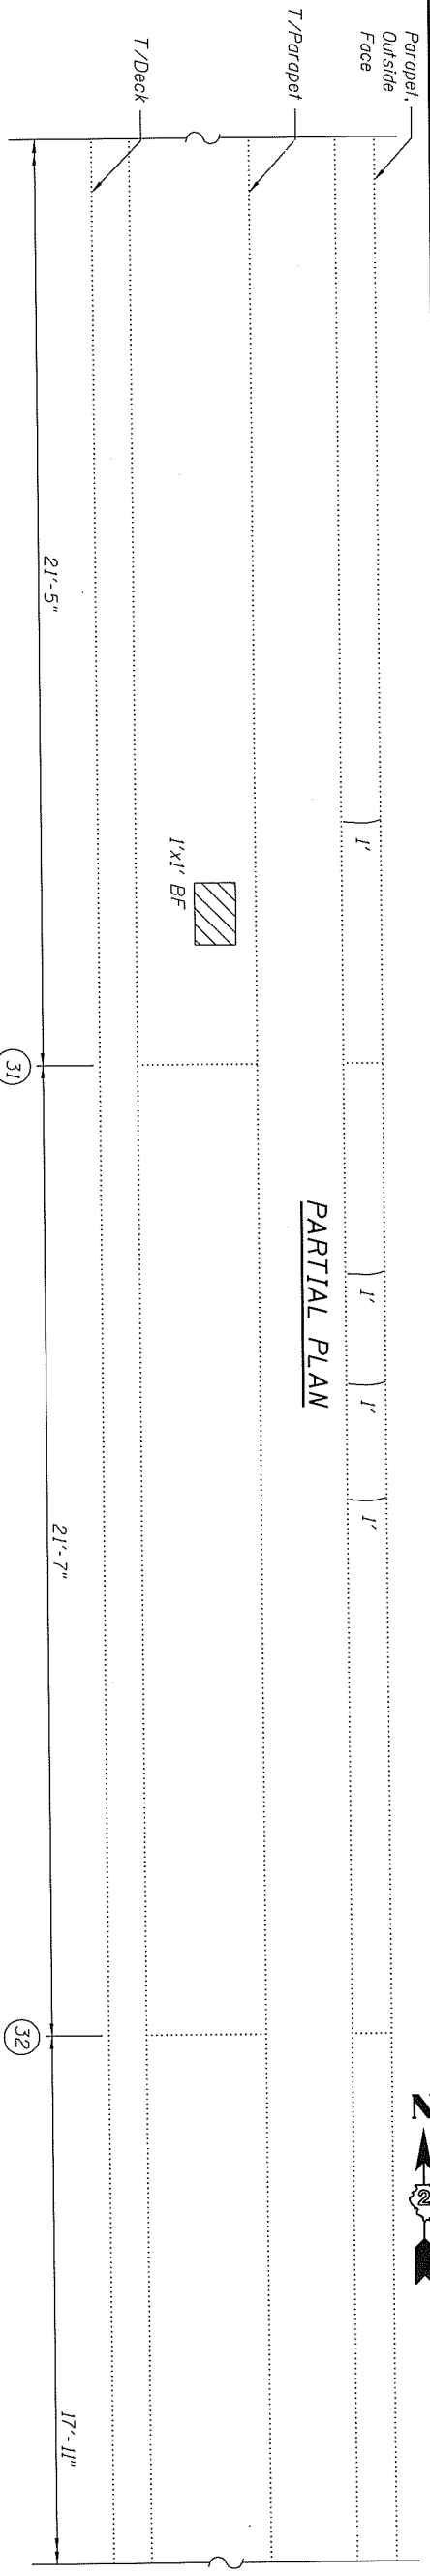
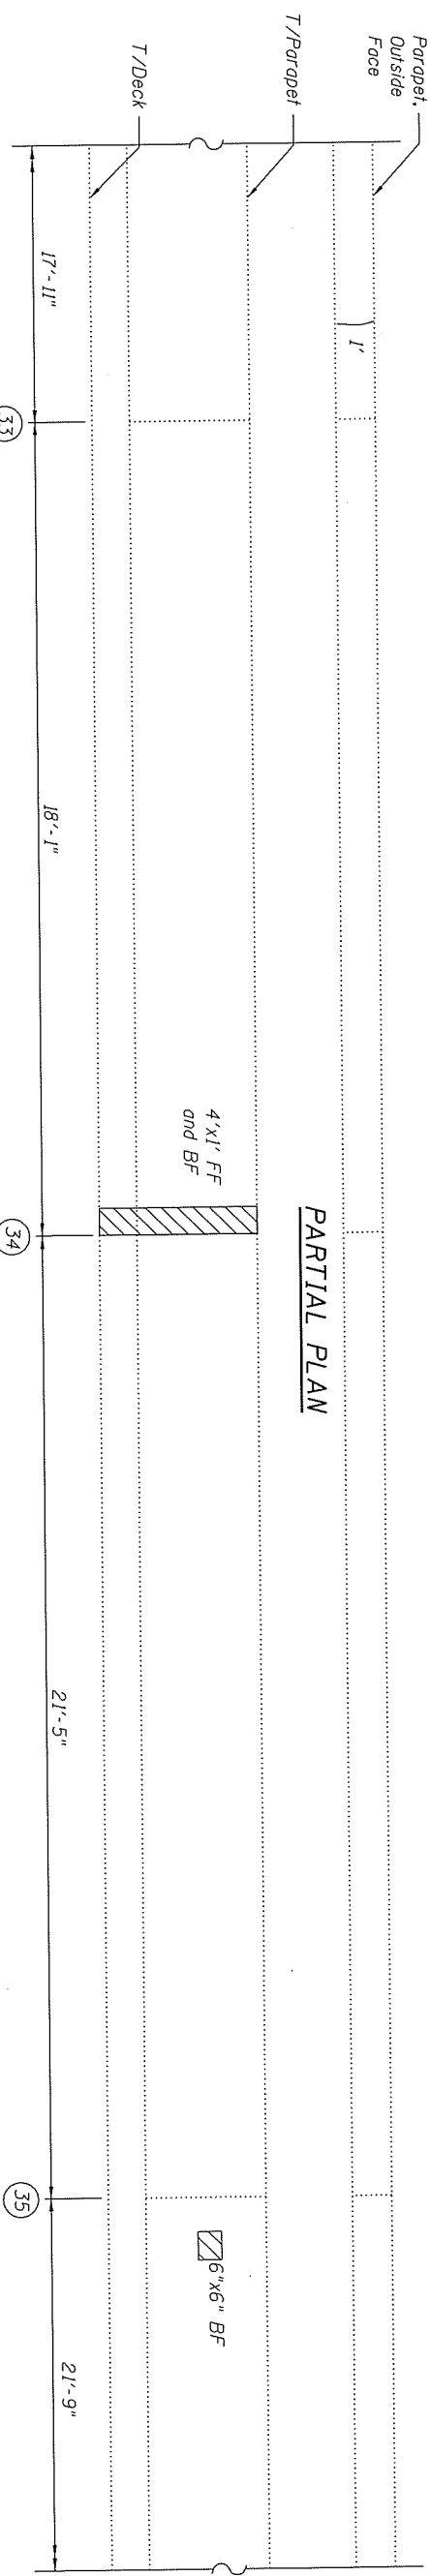
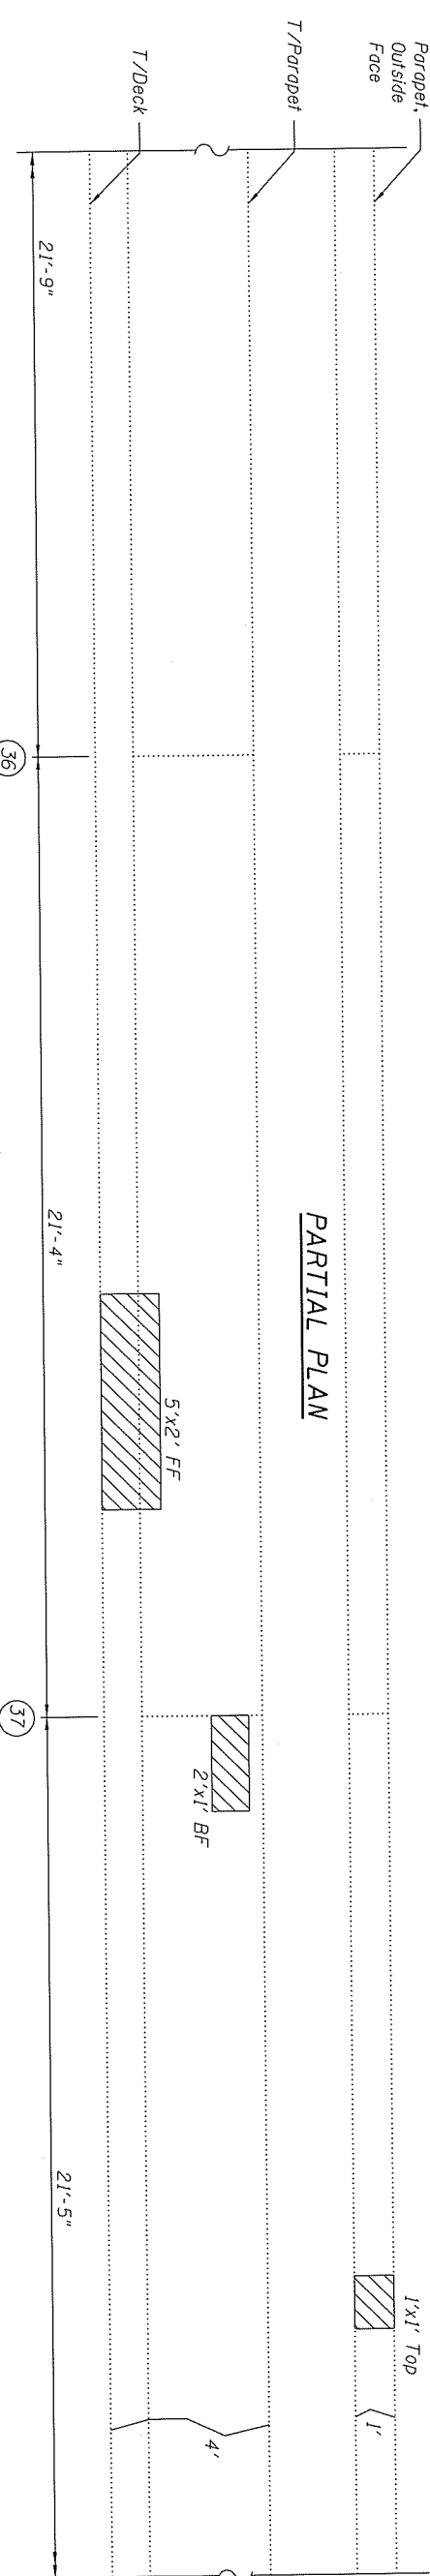
PARTIAL ELEVATION
(Looking East)

ITEM	UNIT	QUANTITY
Epoxy Crack Injection	Foot	9
Structural Repair of Concrete (Depth Equal to or less than 5 inches)	Sq. Ft.	24.3

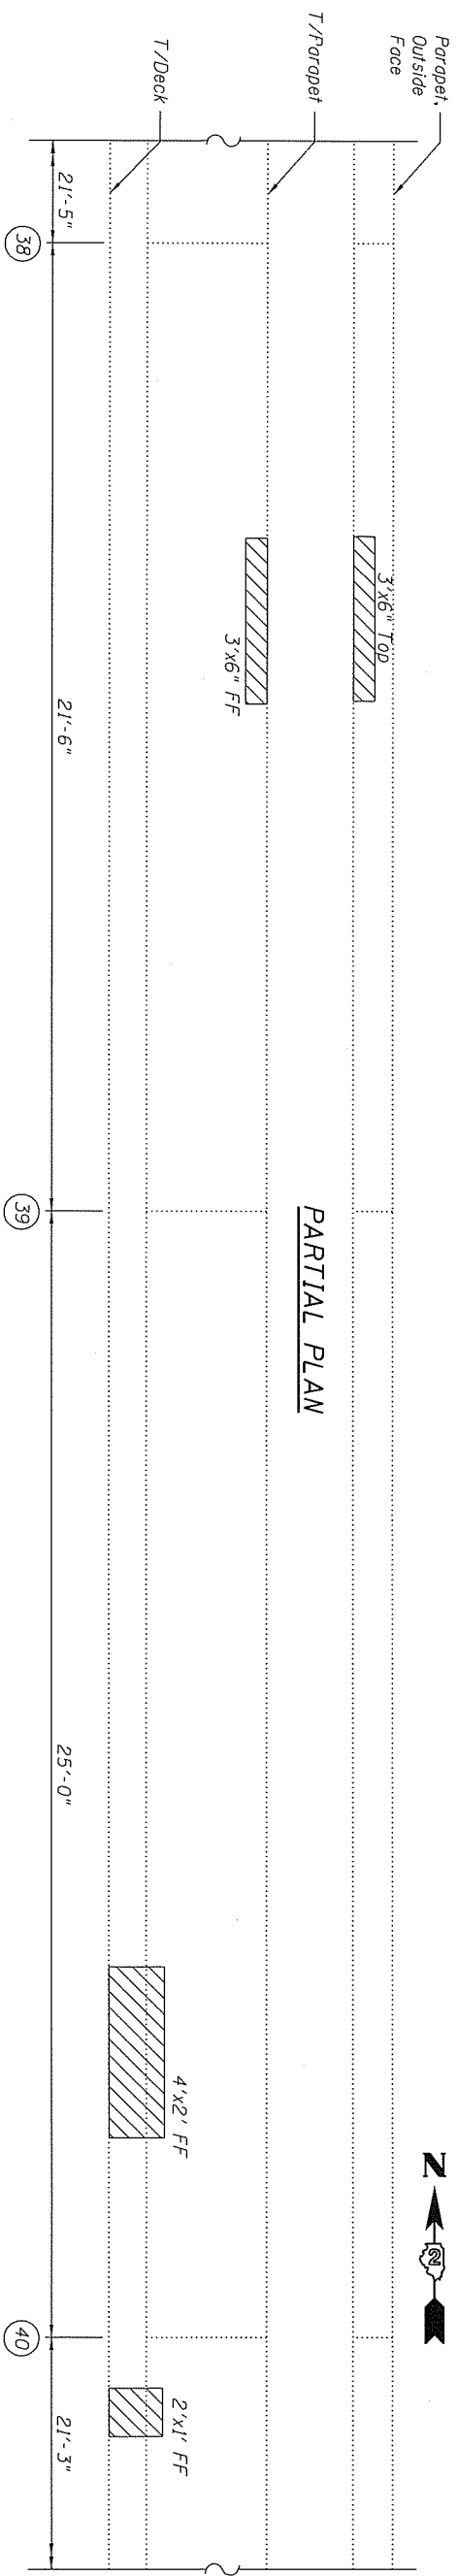
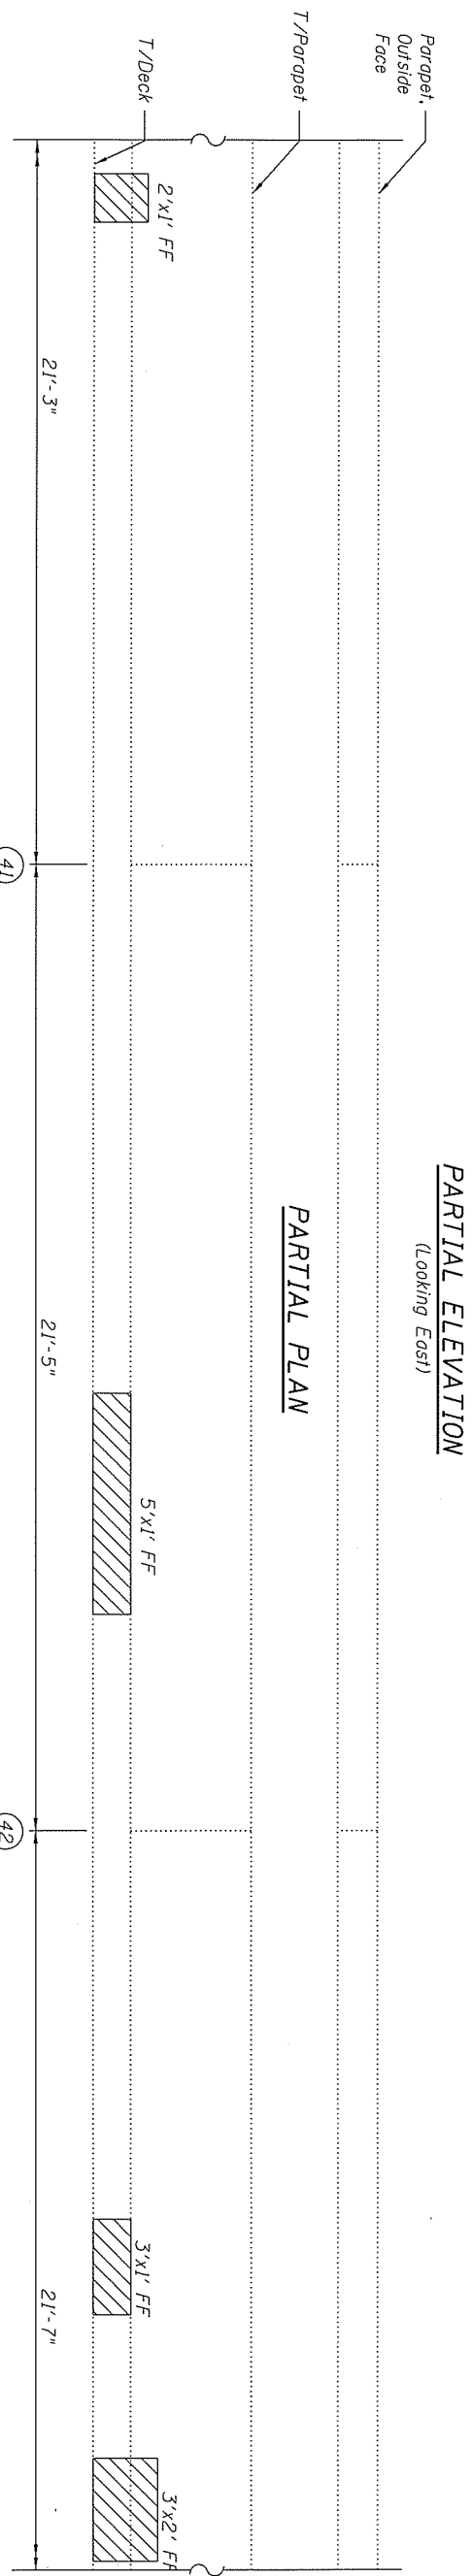
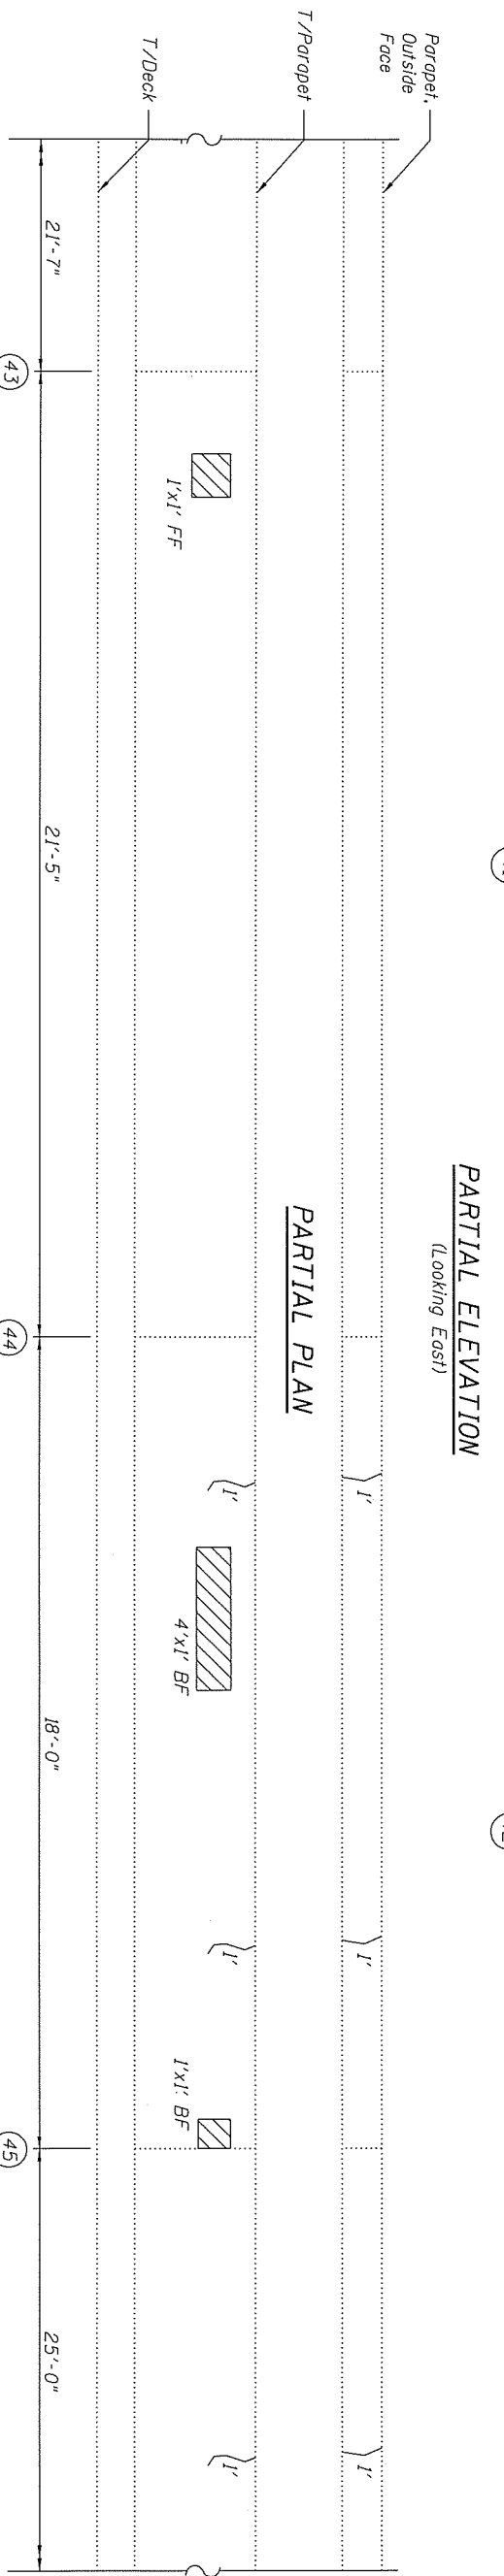
ITEM	UNIT	QUANTITY
Epoxy Crack Injection	Foot	6
Structural Repair of Concrete (Depth Equal to or less than 5 inches)	Sq. Ft.	35

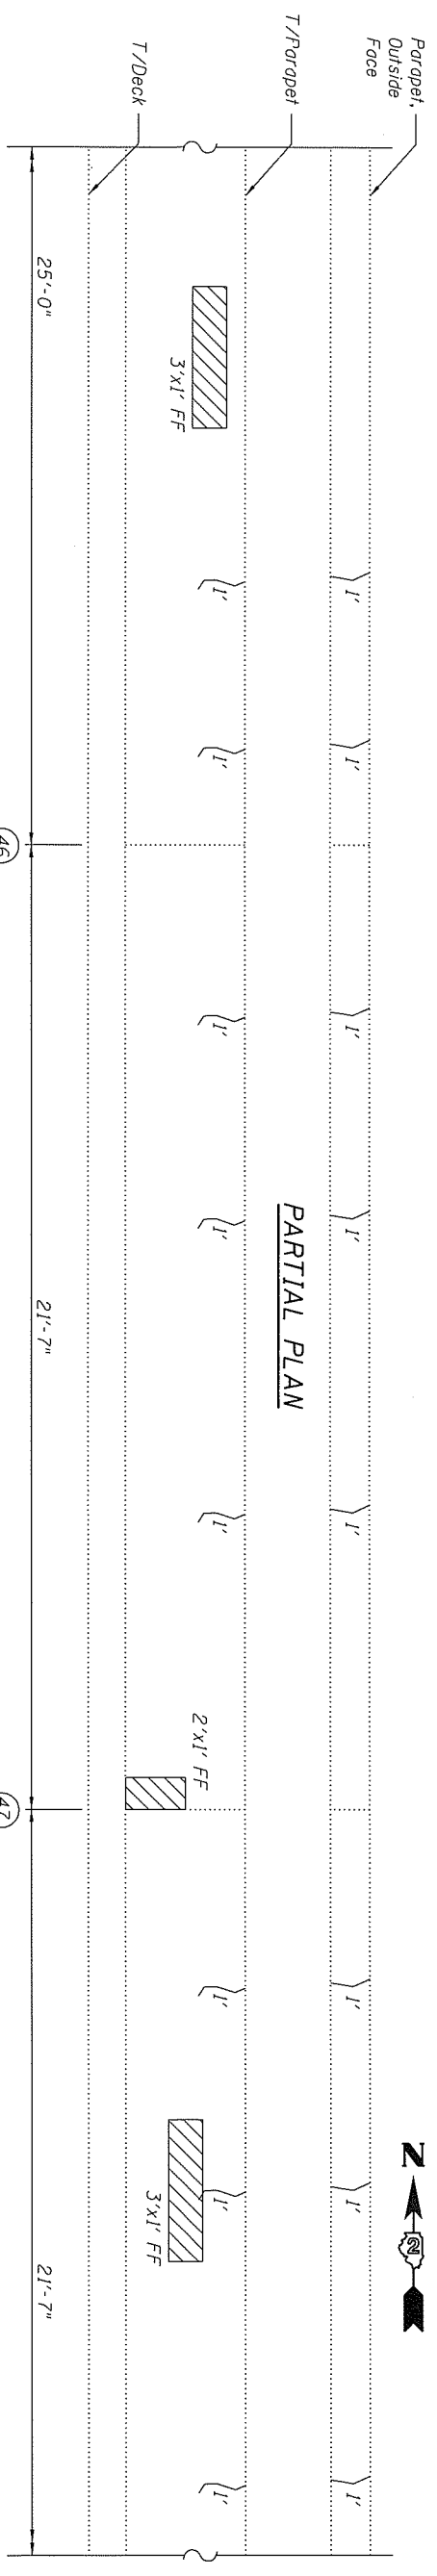
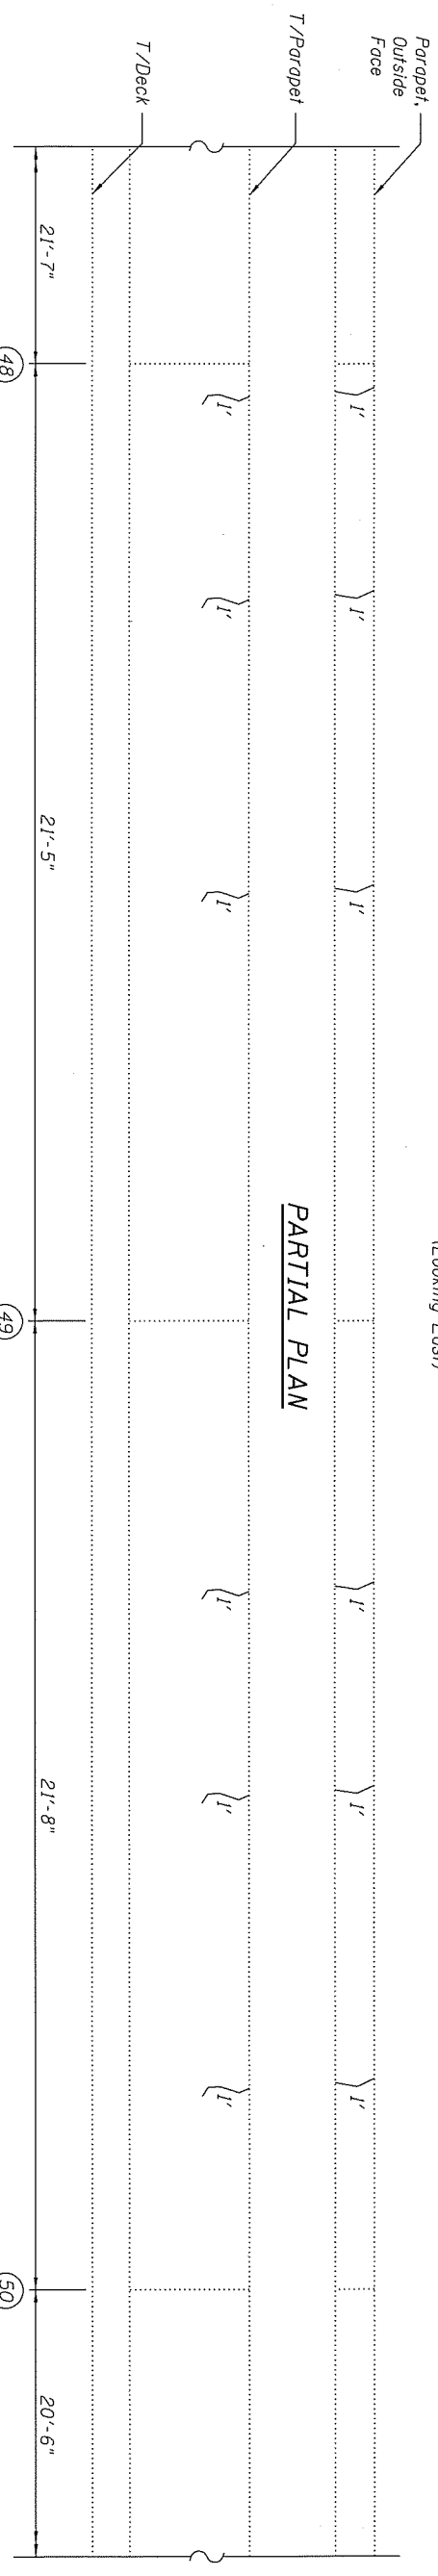
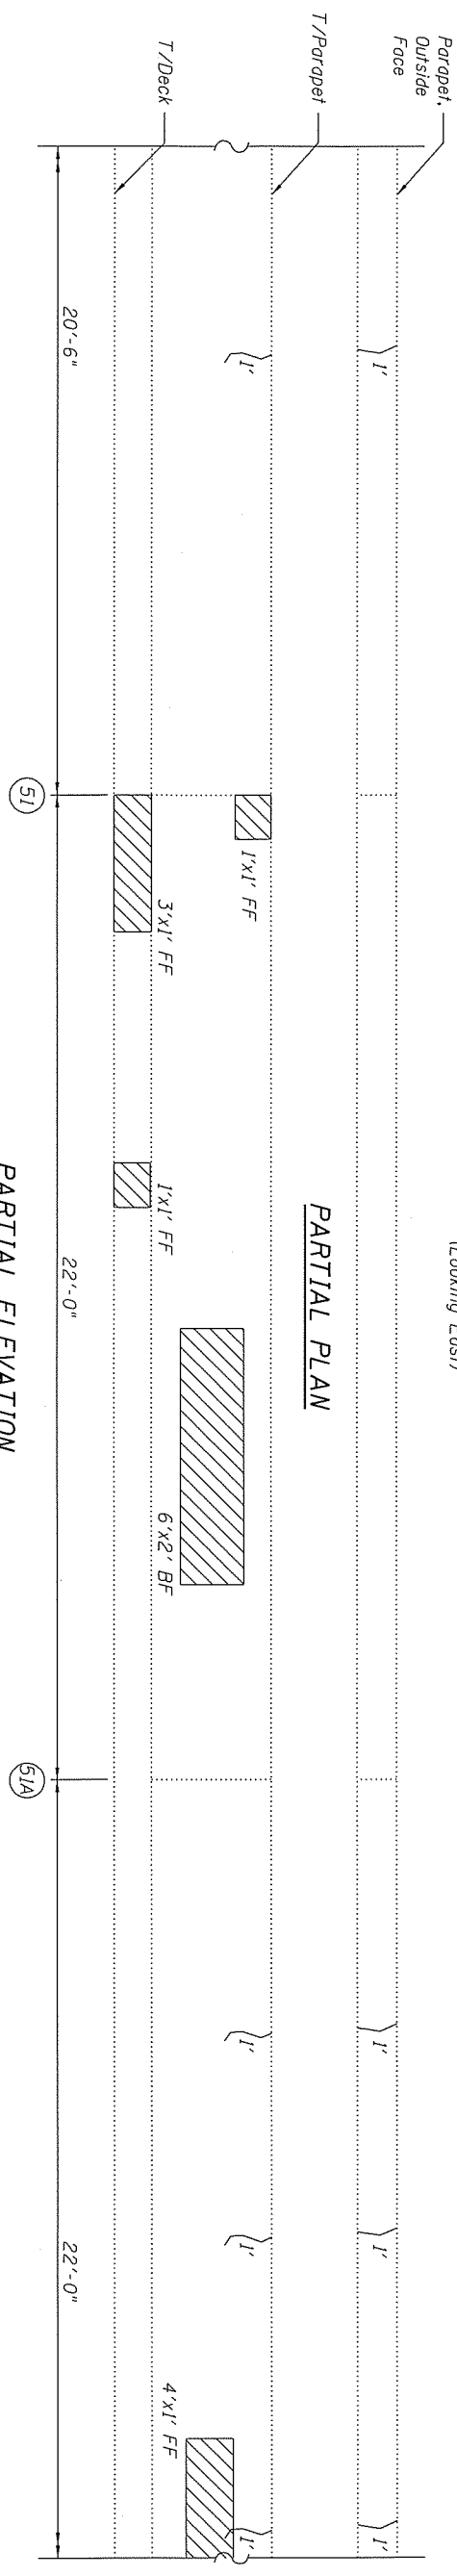
PARTIAL ELEVATION
(Looking East)

ITEM	UNIT	QUANTITY
Epoxy Crack Injection	Foot	36
Structural Repair of Concrete (Depth Equal to or less than 5 inches)	Sq. Ft.	29

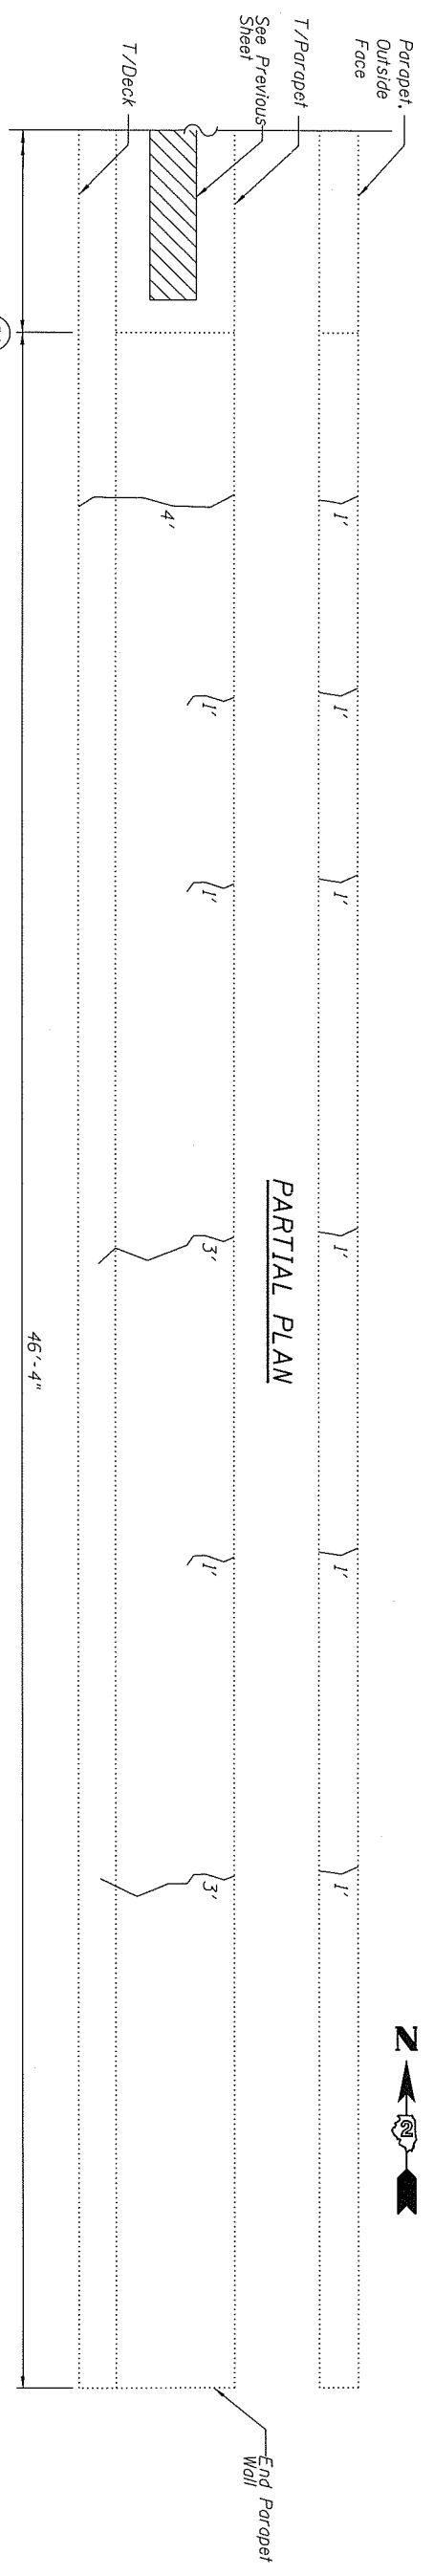
PARTIAL ELEVATION
(Looking East)

ITEM	UNIT	QUANTITY
Epoxy Crack Injection	Foot	19

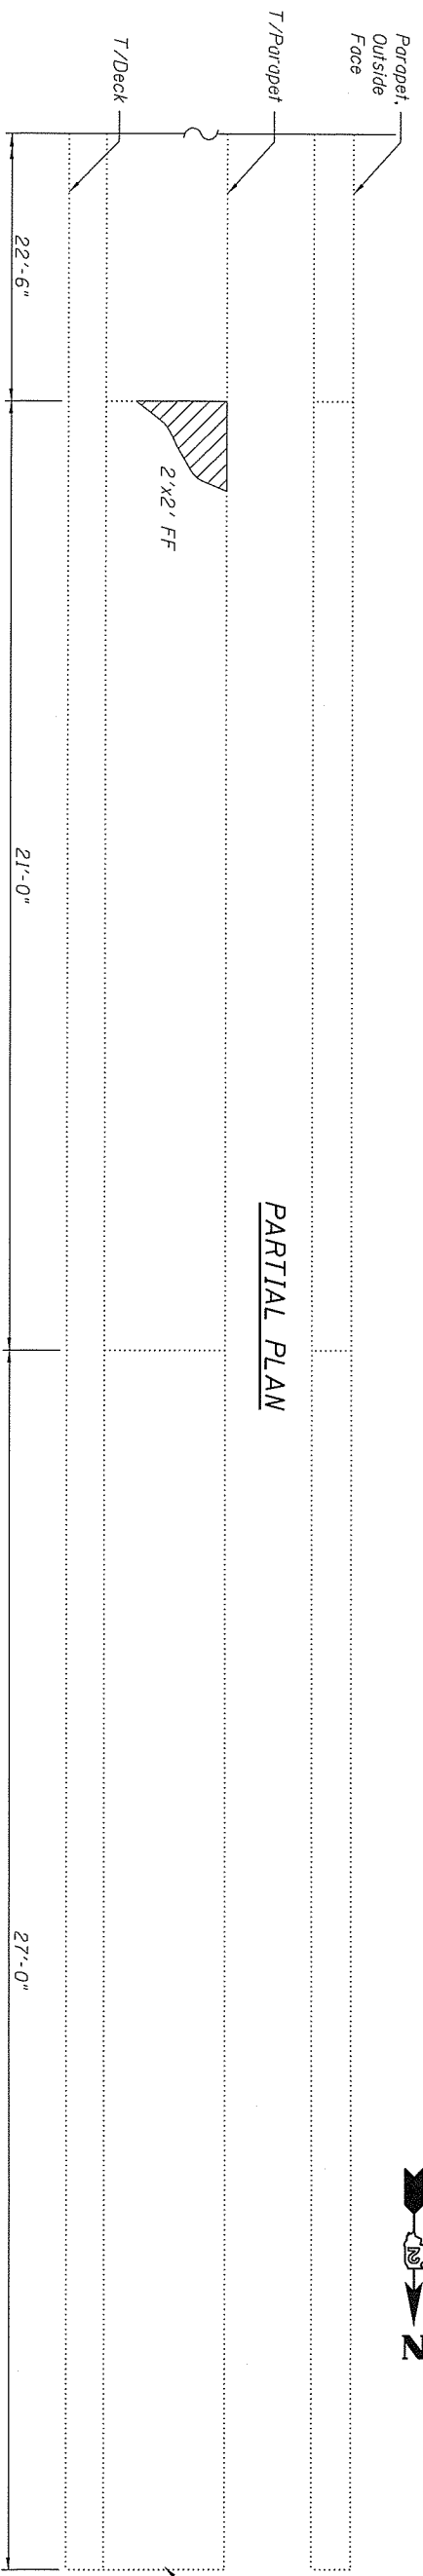
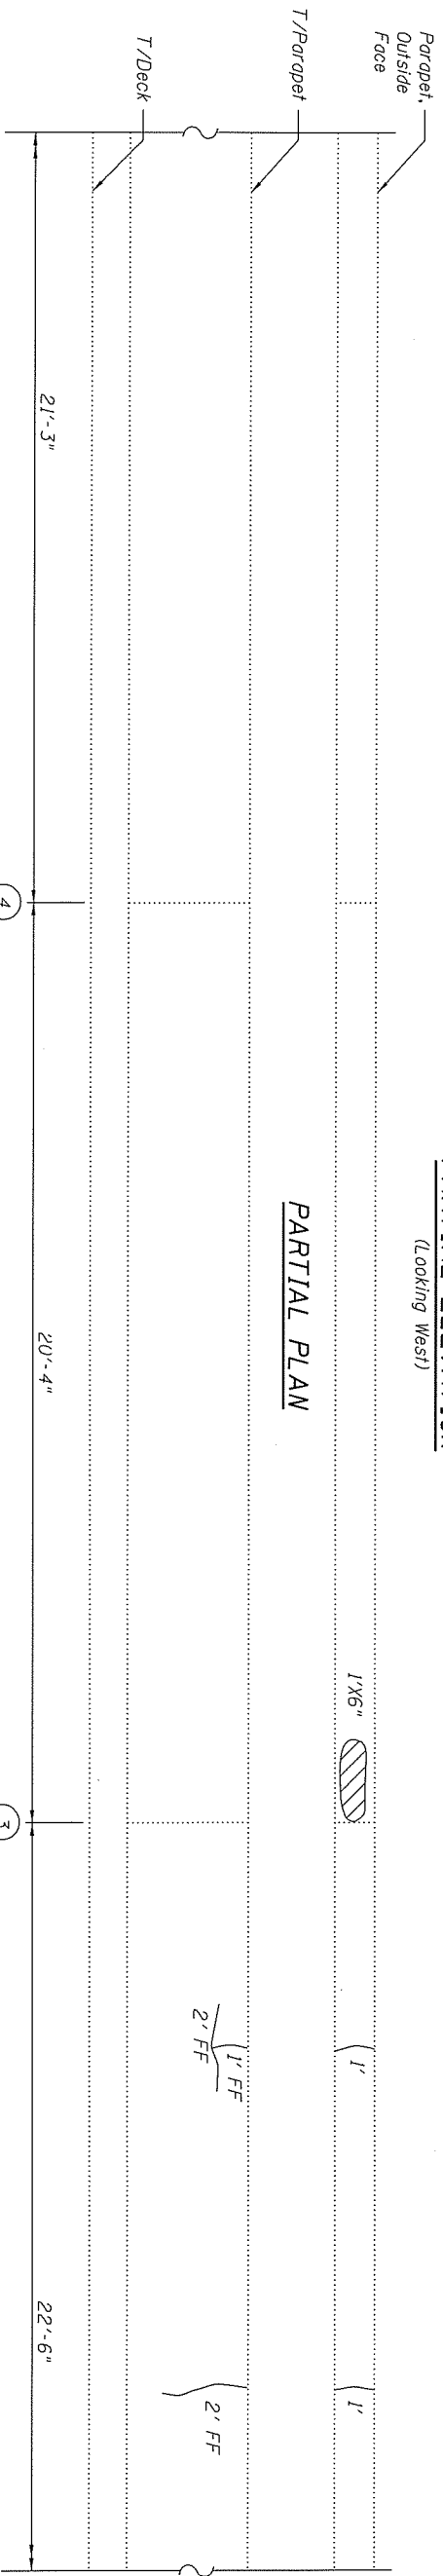
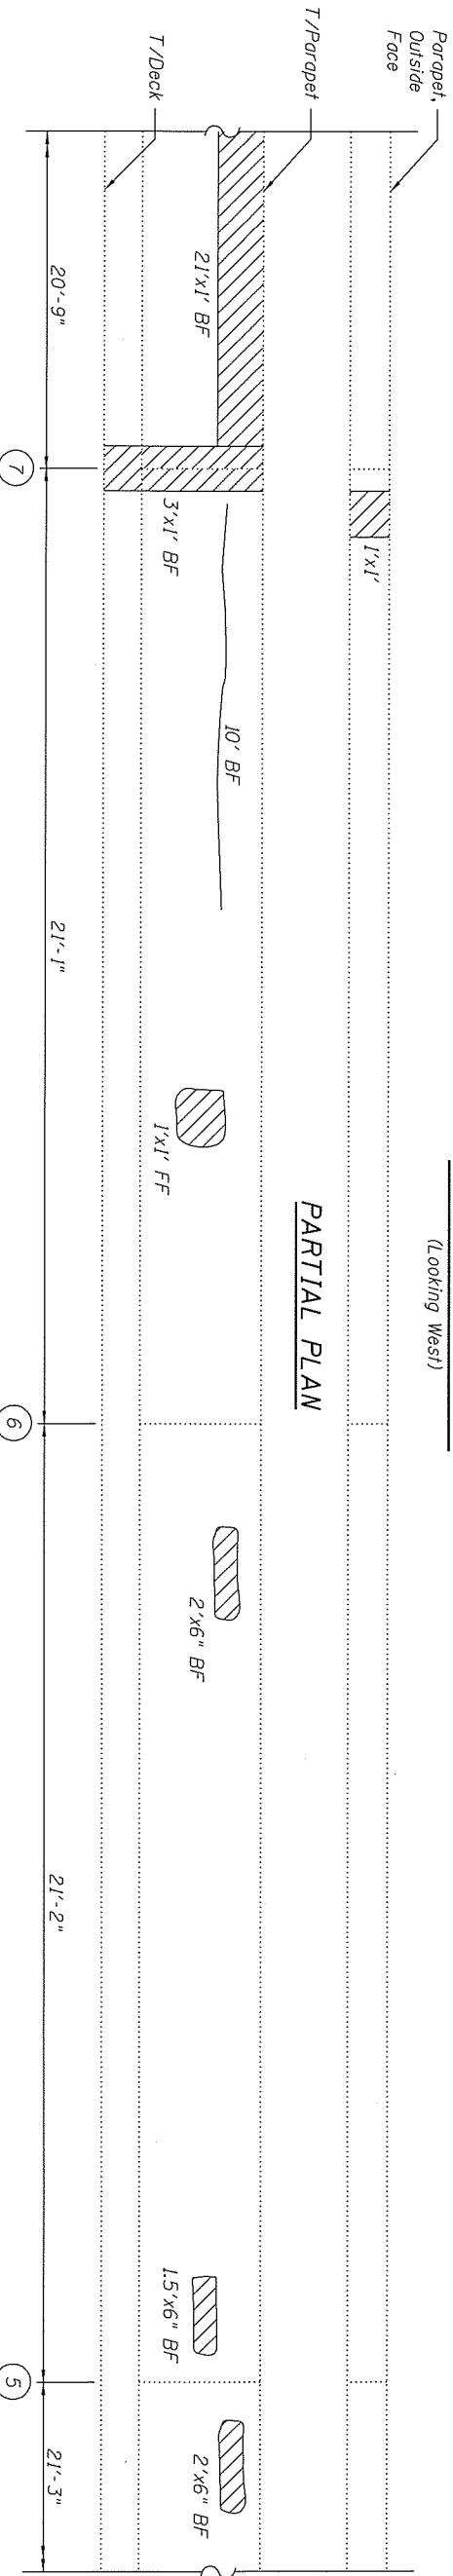
PARTIAL ELEVATION
(Looking West)

ITEM	UNIT	QUANTITY
Epoxy Crack Injection	Foot	17
Structural Repair of Concrete (Depth Equal to or less than 5 inches)	Sq. Ft.	55.3
