CONTRACT NO. 64M74

**PROPOSED
 HIGHWAY PLANS**

PROJECT: NHPP-PEA2(247)
 FAI ROUTE 39 (I-39)
 SECTION (201-1B)BDR
 BRIDGE REHABILITATION
 S.N. 101-0133 SOUTHBOUND
 S.N. 101-0134 NORTHBOUND
 WINNEBAGO COUNTY

PROPOSED SCOPE OF WORK
 EPOXY INJECTION OF CRACKS AND CONCRETE REPAIRS OF PARAPETS

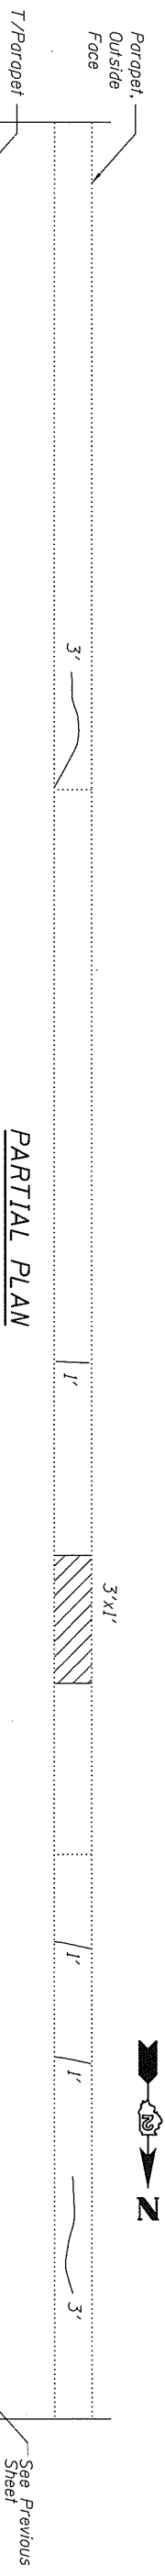
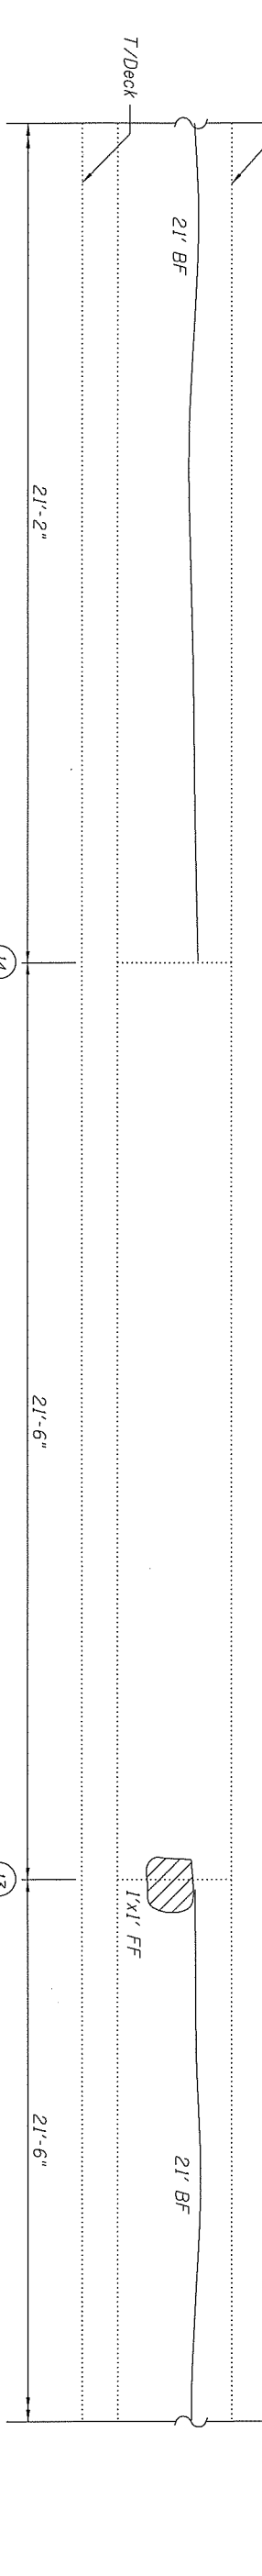
PARTIAL ELEVATION
(Looking West)

ITEM	UNIT	QUANTITY
Epoxy Crack Injection	Foot	57
Structural Repair of Concrete (Depth Equal to or less than 5 inches)	Sq. Ft.	24

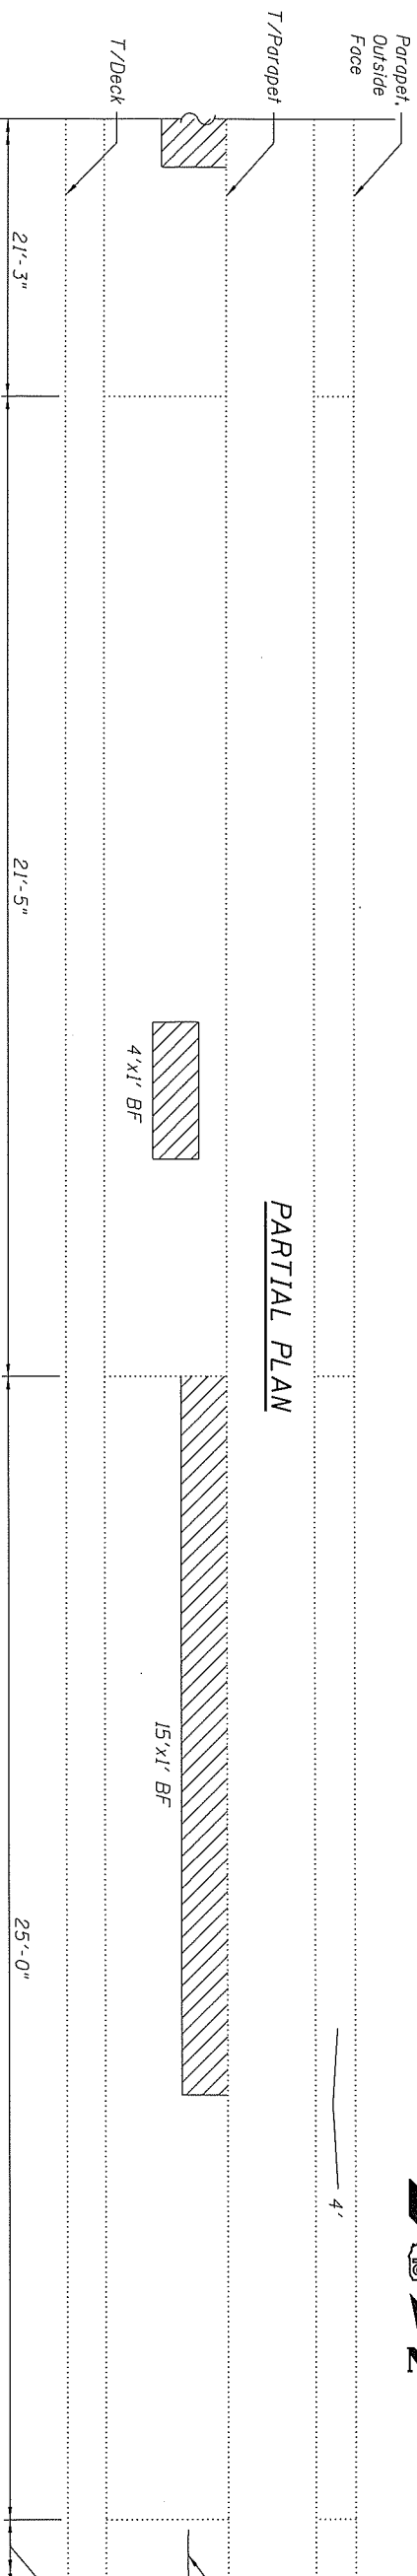
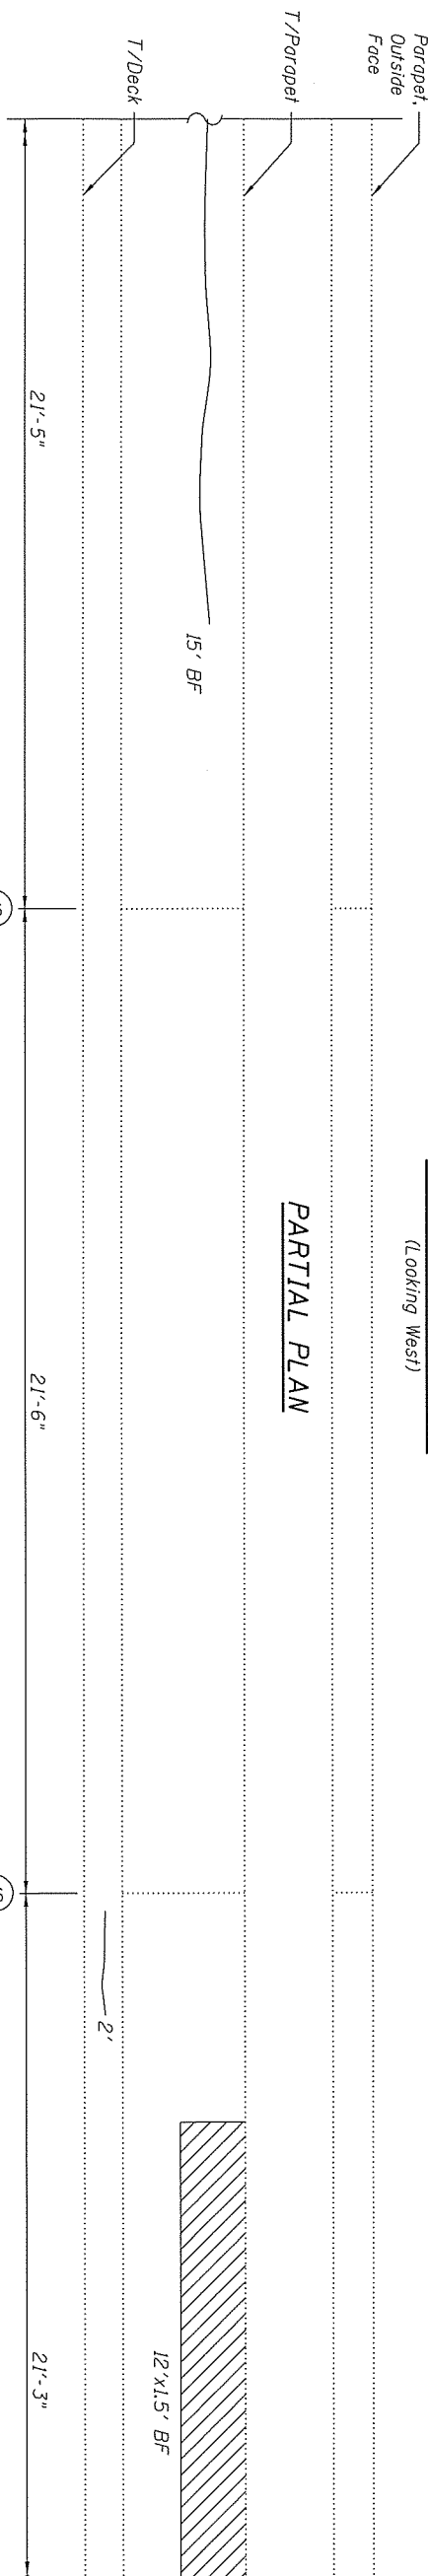
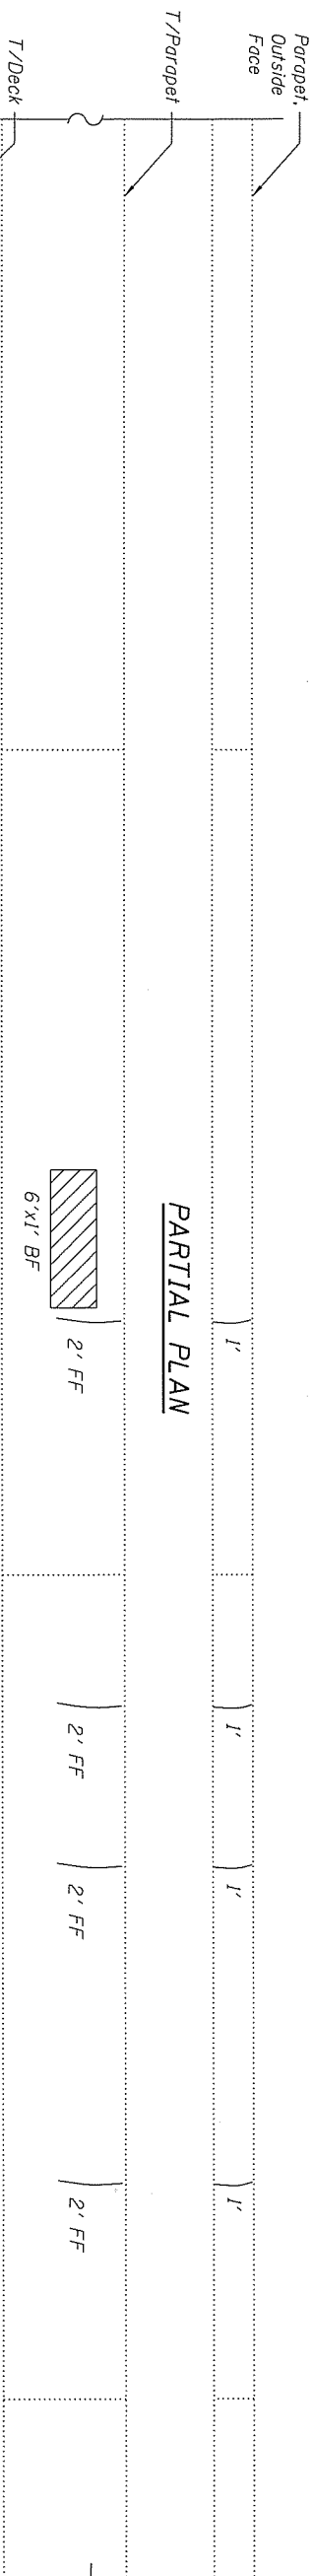
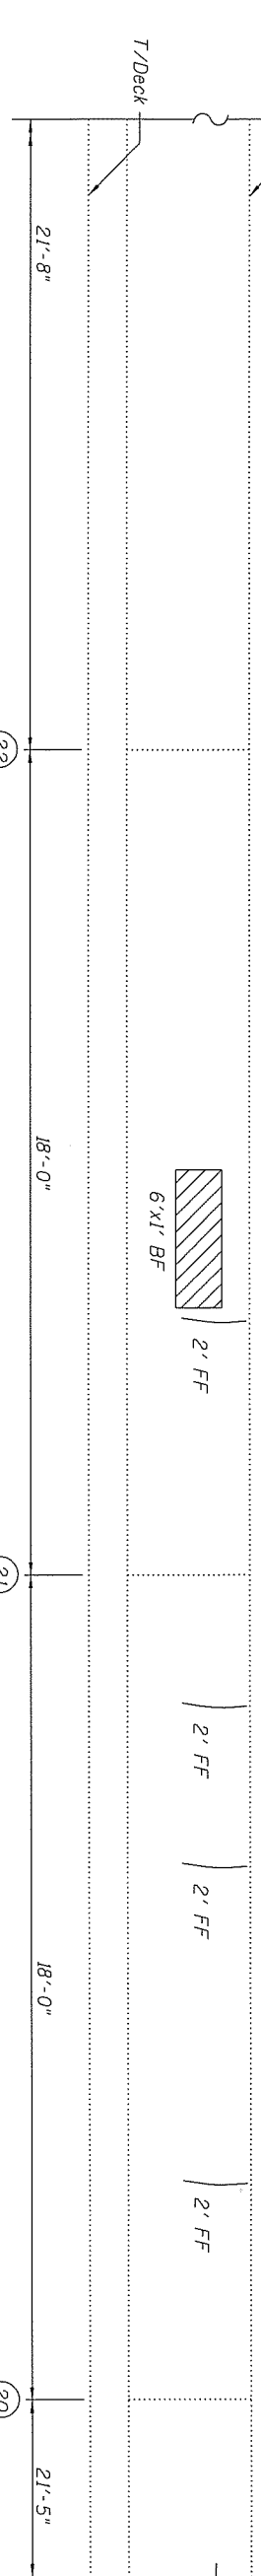
PARTIAL ELEVATION
(Looking West)

ITEM	UNIT	QUANTITY
Epoxy Crack Injection	Foot	33
Structural Repair of Concrete (Depth Equal to or less than 5 inches)	Sq. Ft.	31

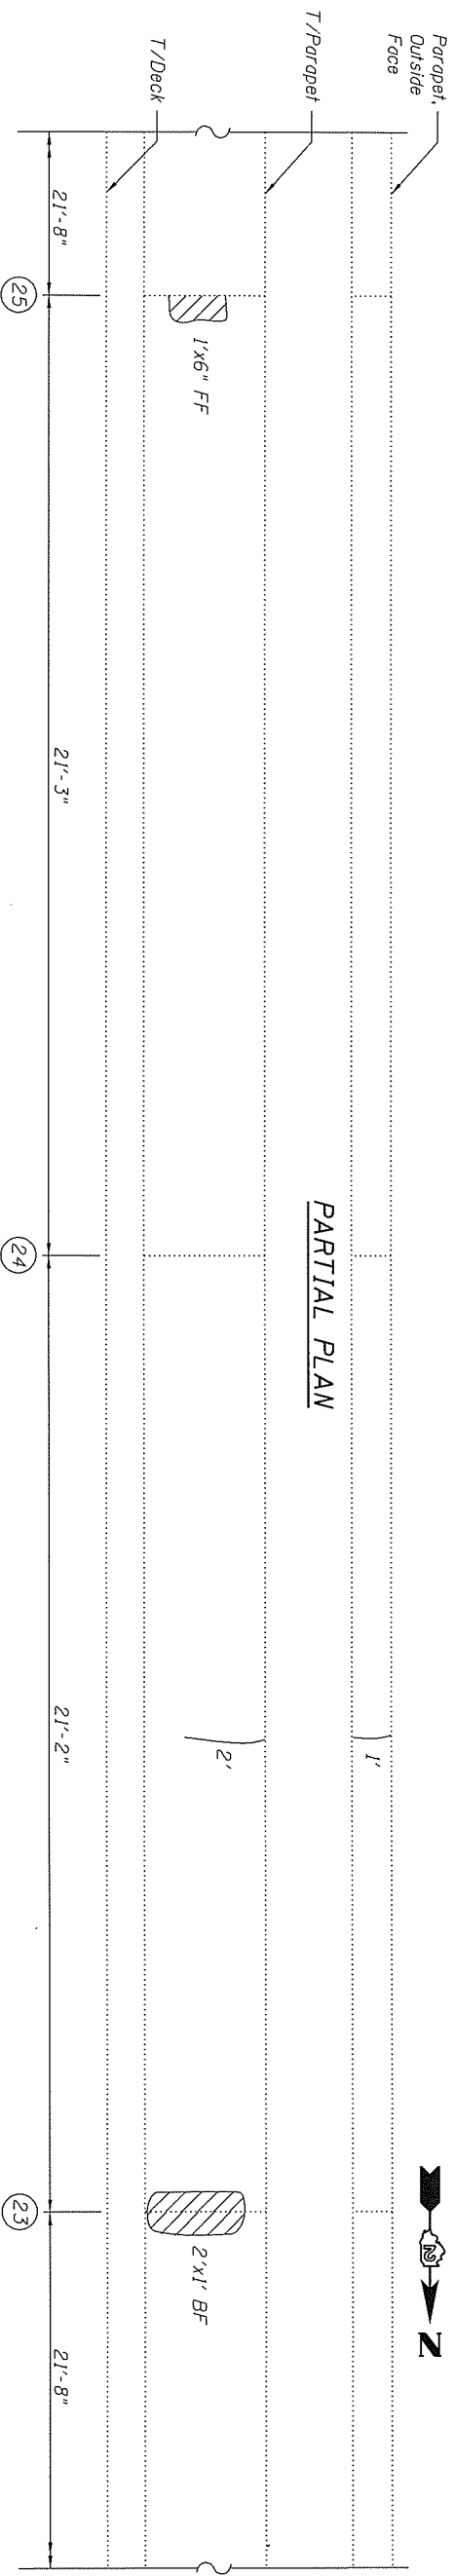
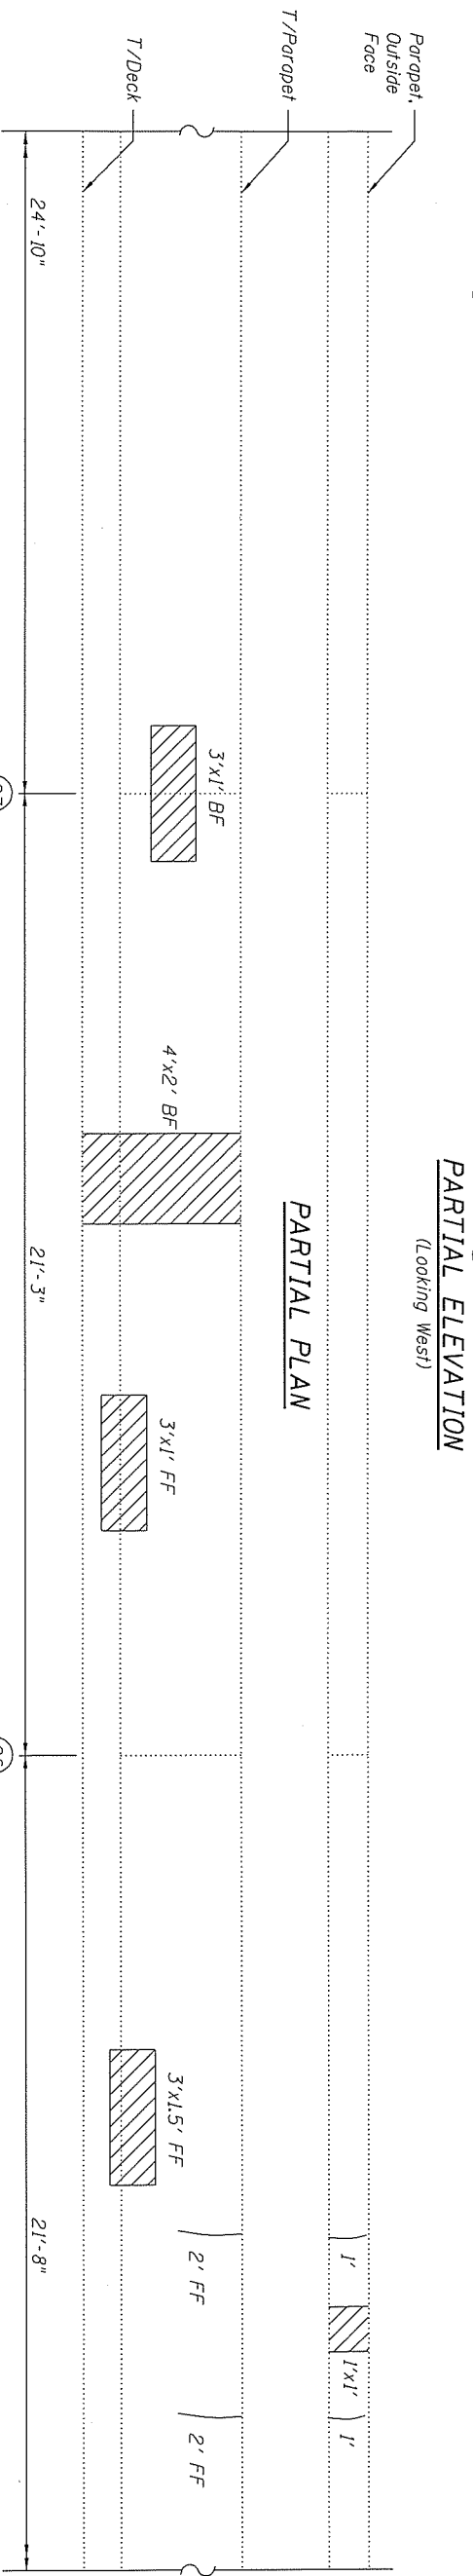
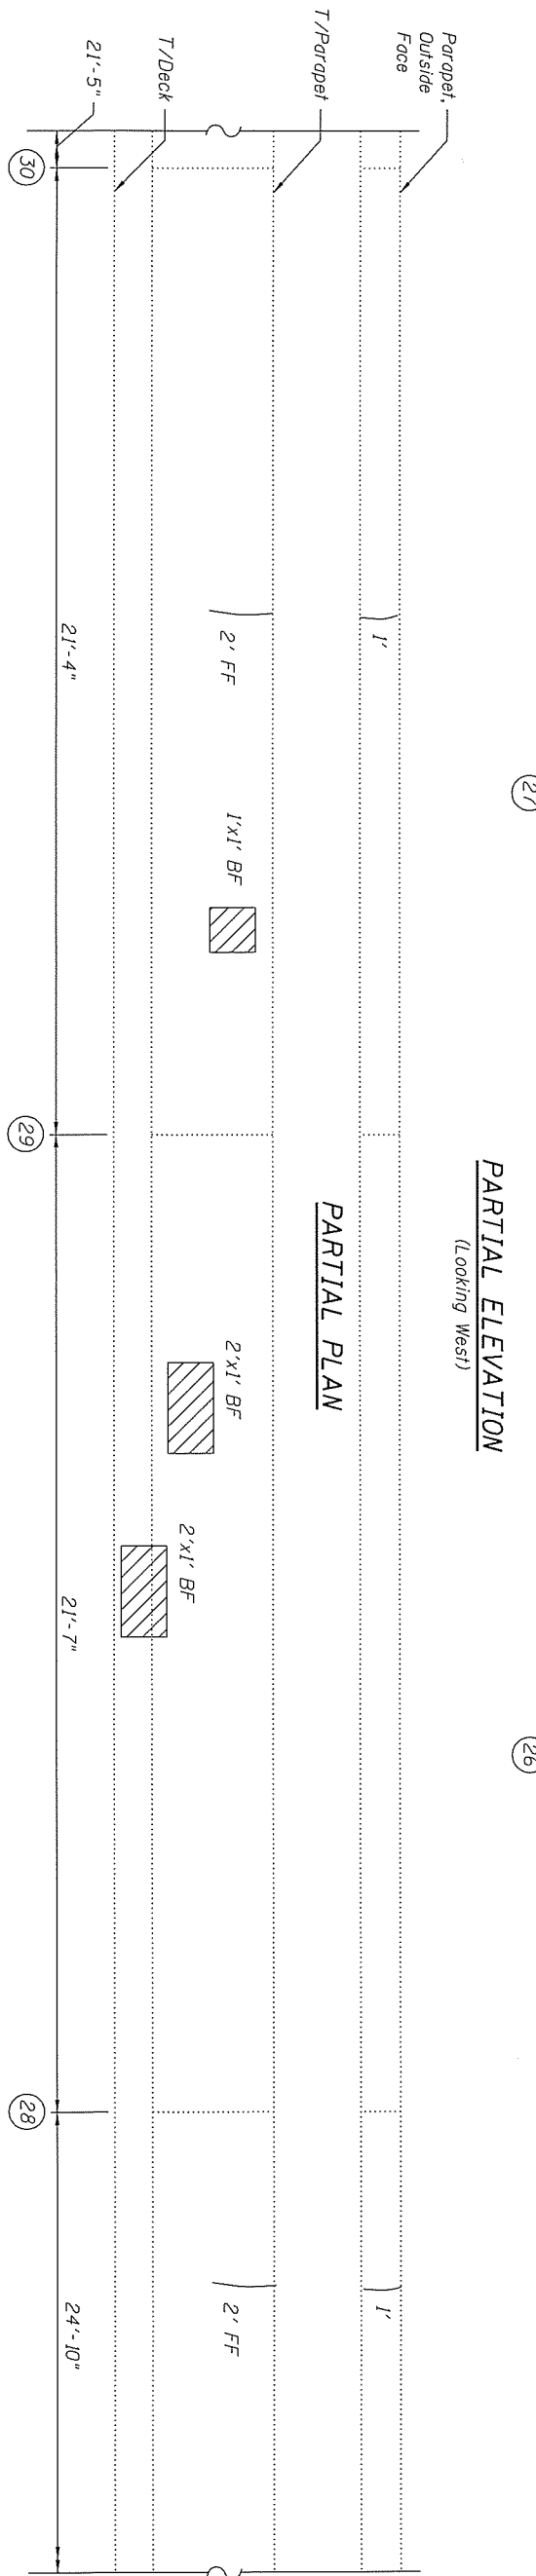
ITEM	UNIT	QUANTITY
Epoxy Crack Injection	Foot	15
Structural Repair of Concrete (Depth Equal to or less than 5 inches)	Sq. Ft.	27

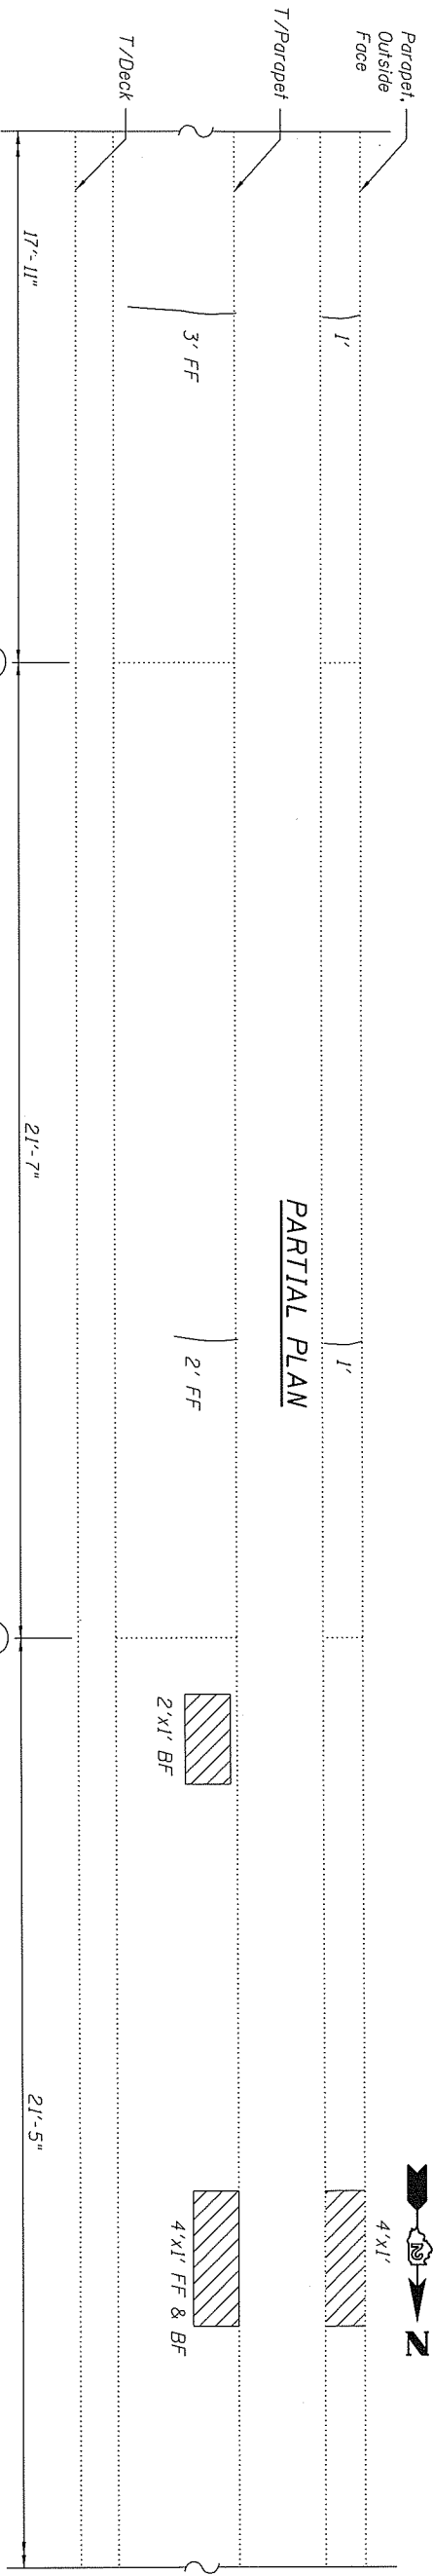
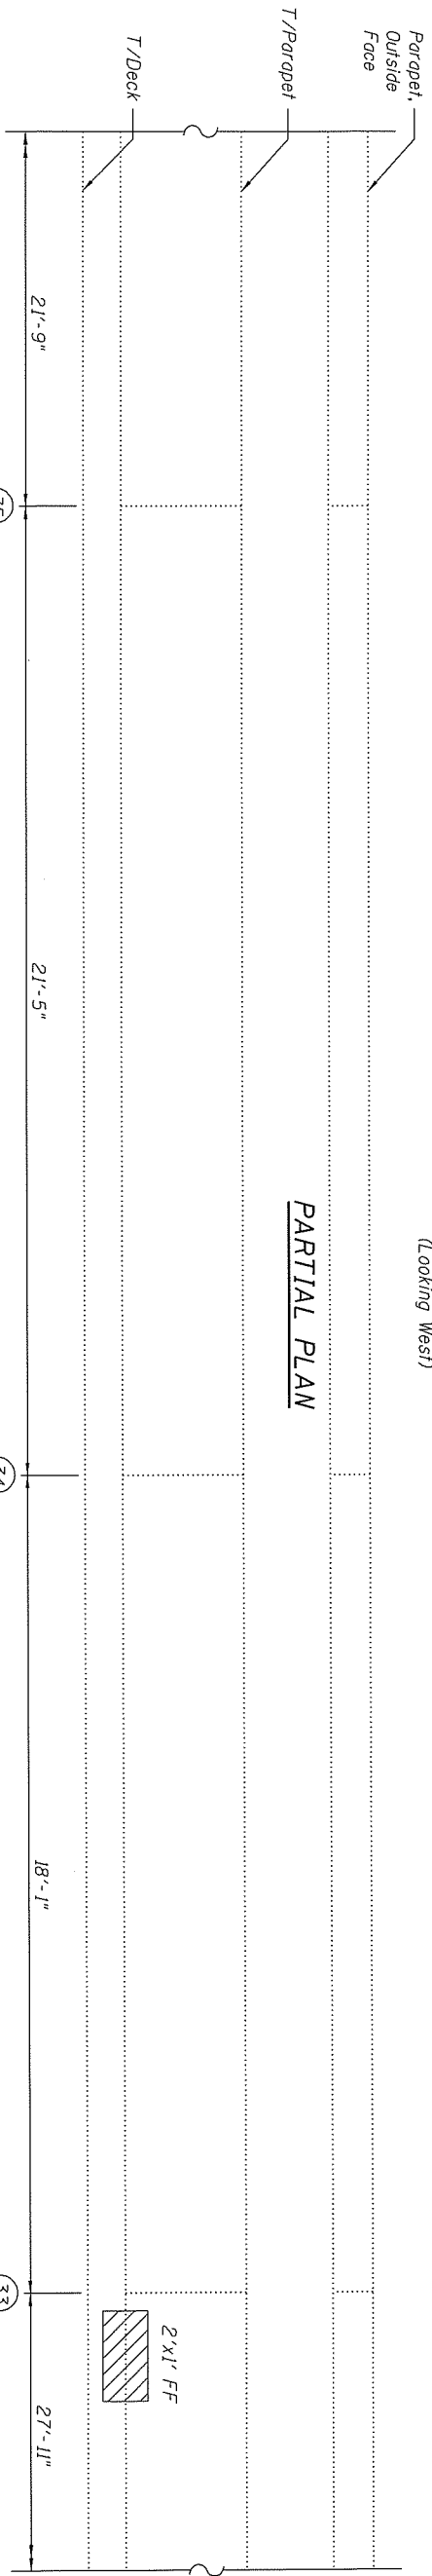
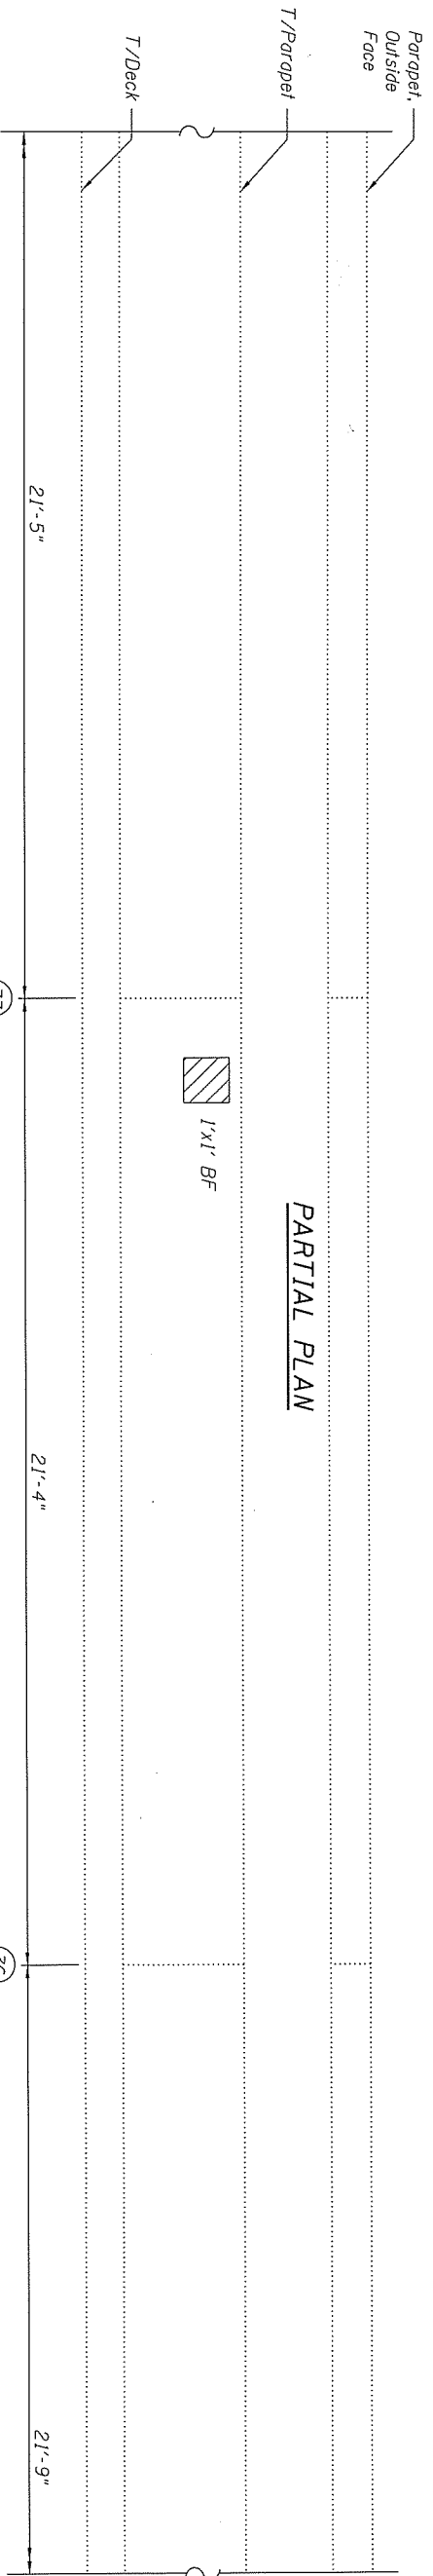
ITEM	UNIT	QUANTITY
Epoxy Crack Injection	Foot	7
Structural Repair of Concrete (Depth Equal to or less than 5 inches)	Sq. Ft.	13

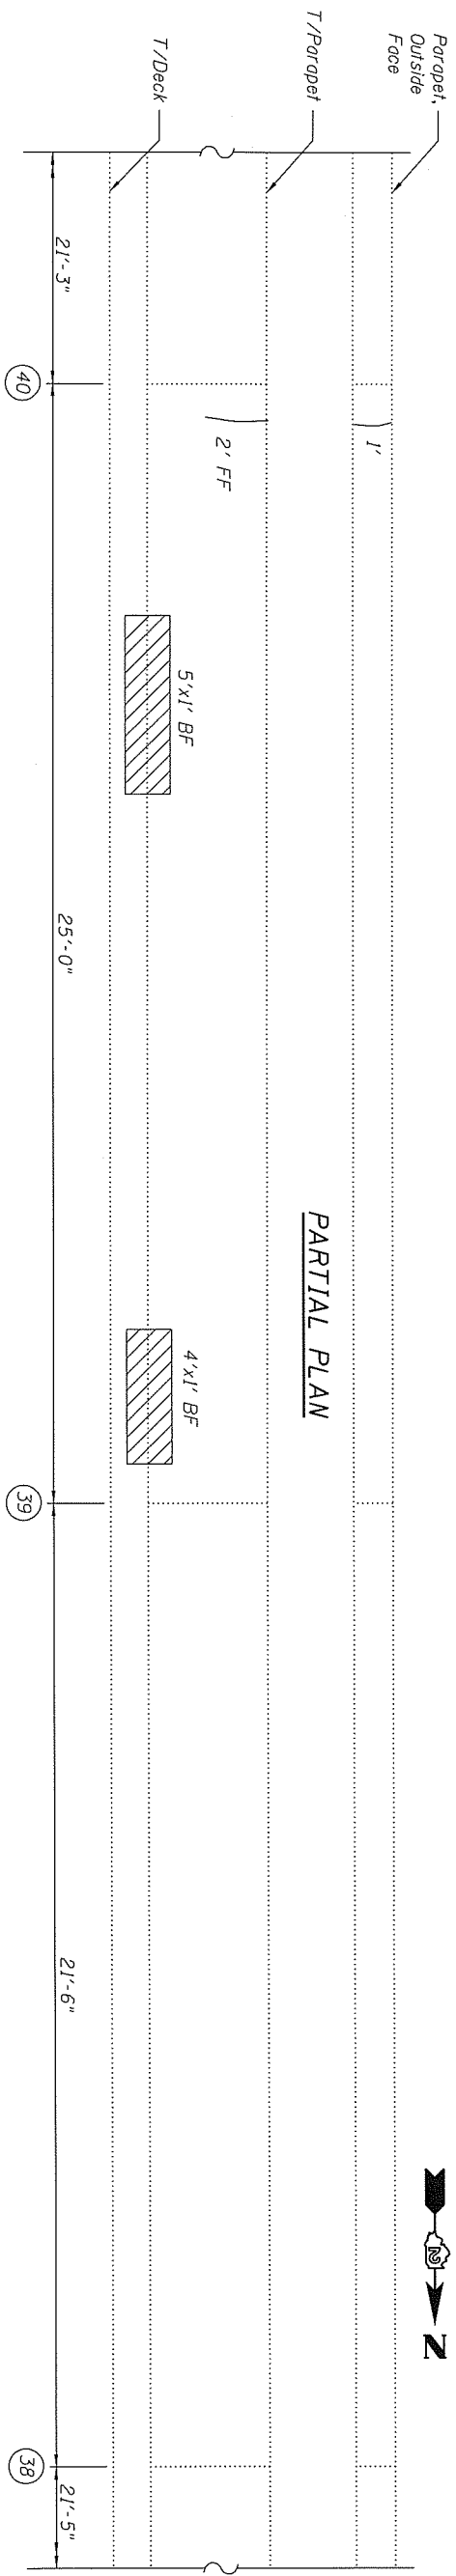
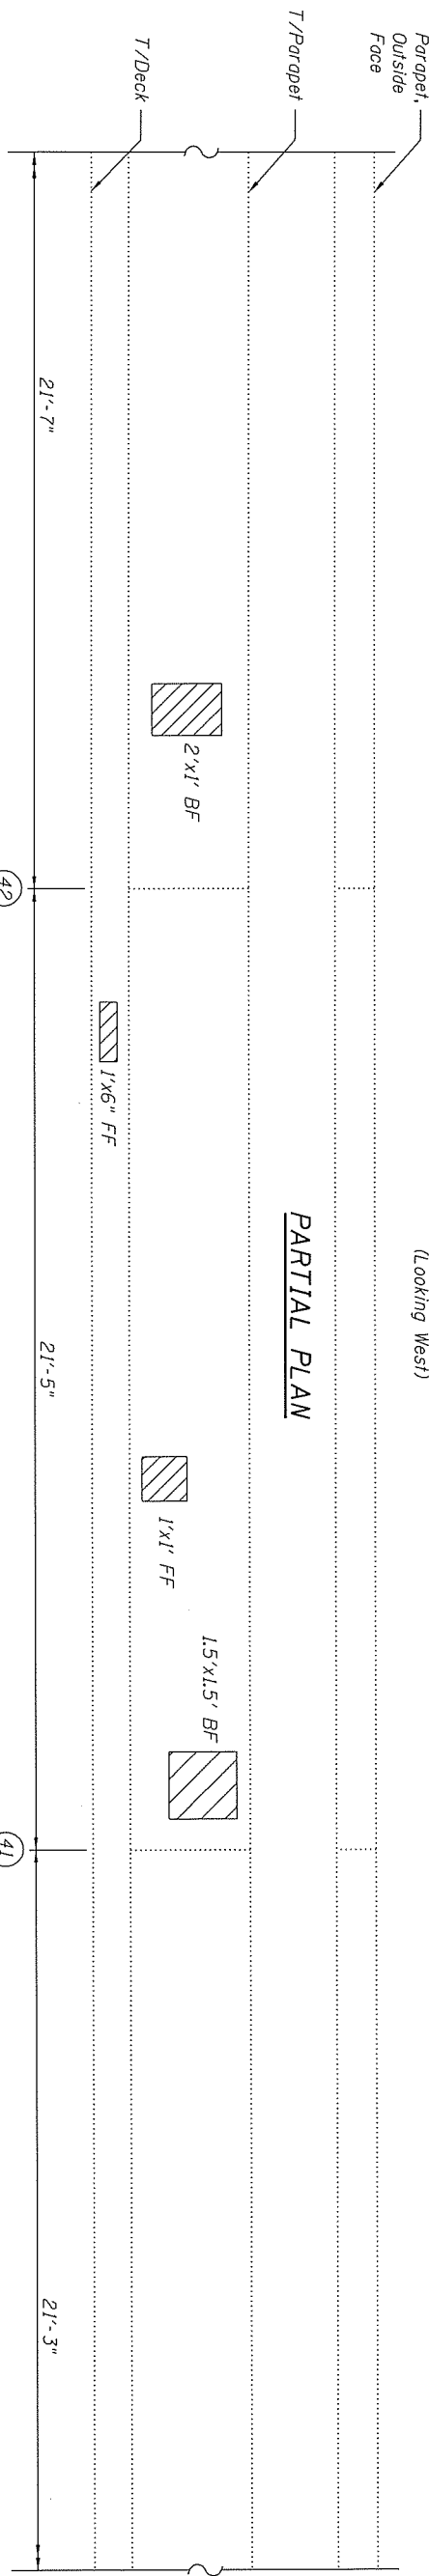
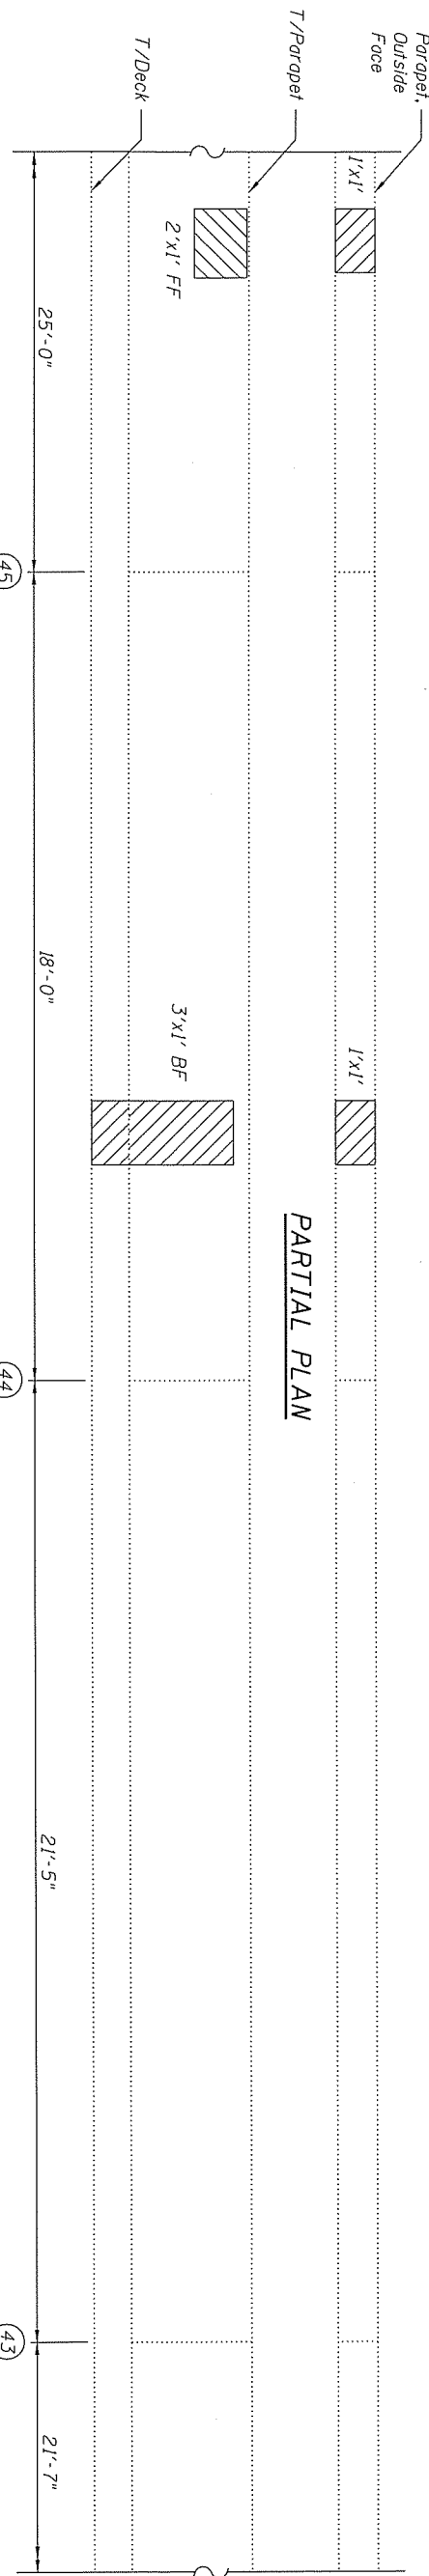
PARTIAL ELEVATION
(Looking West)

ITEM	UNIT	QUANTITY
Epoxy Crack Injection	Foot	3
Structural Repair of Concrete (Depth Equal to or less than 5 inches)	Sq. Ft.	21.8

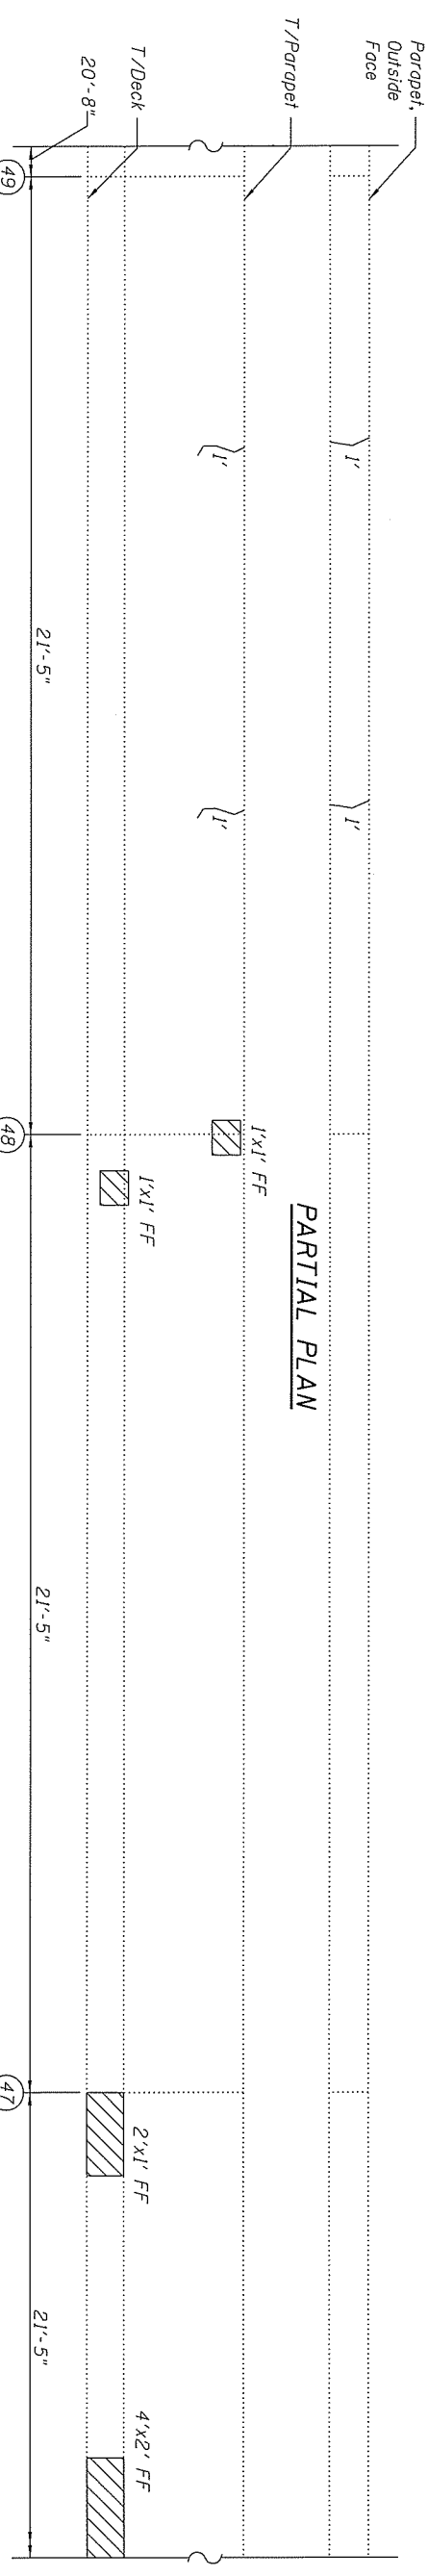
PARTIAL ELEVATION
(Looking West)

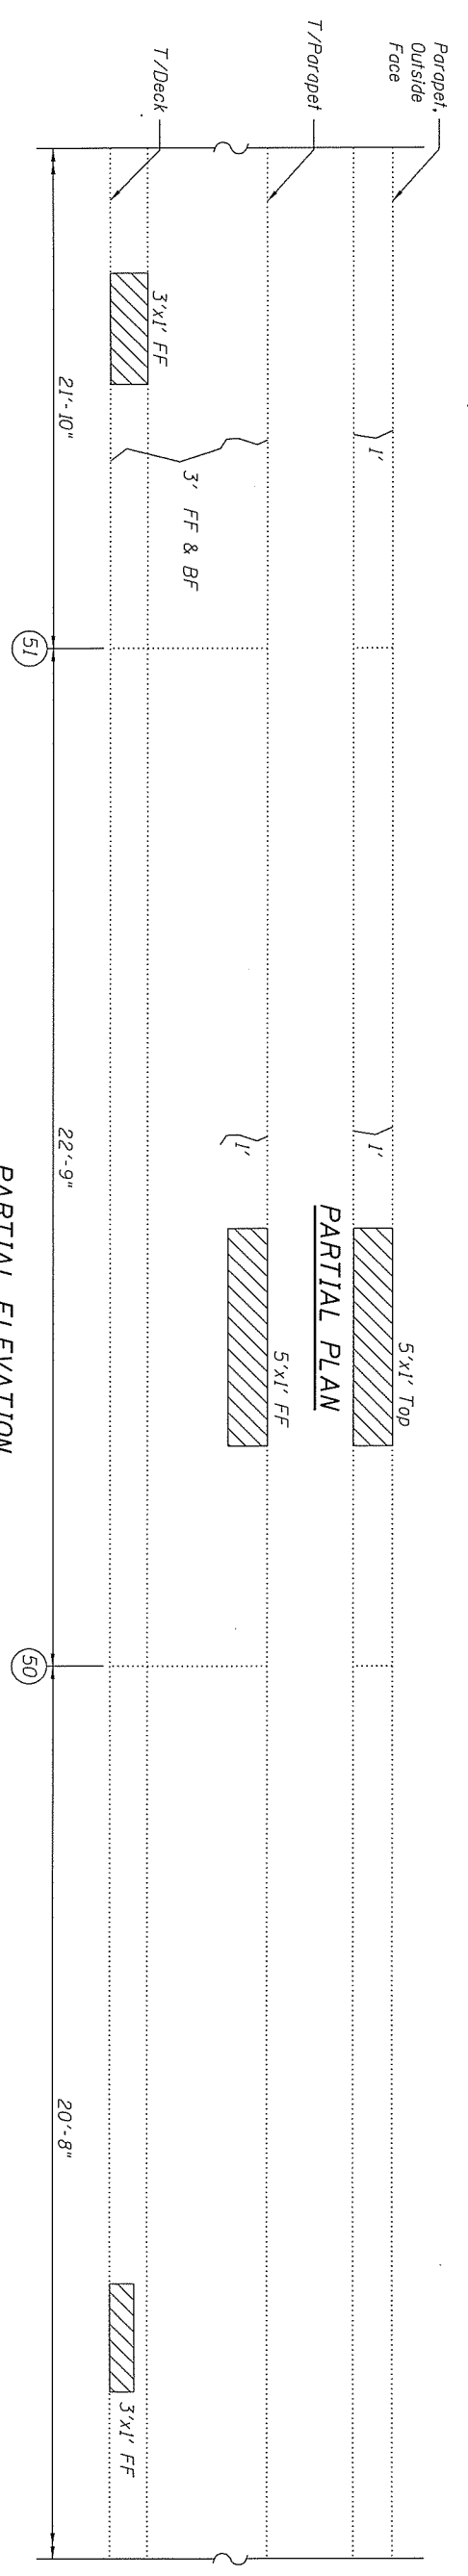
PARTIAL ELEVATION
(Looking West)
