**STRUCTURAL REPAIR OF CONCRETE
IL RTE. 23 OVER OTTER CREEK
FAP 68 (IL 23) SEC. (6B-1)I
LASALLE COUNTY
STA. 142+08
S.N. 050-0160**

**STATE OF ILLINOIS
DEPARTMENT OF TRANSPORTATION**

STRUCTURAL REPAIR OF CONCRETE

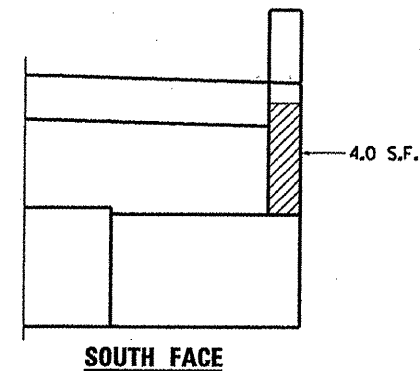
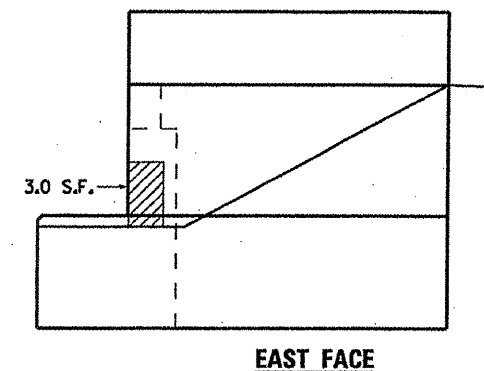
**NORTH ABUTMENT
NORTHEAST CORNER**

SOUTH FACE

EAST FACE

ITEM	UNIT	QUANTITY
STRUCTURAL REPAIR OF CONCRETE (DEPTH EQUAL TO OR LESS THAN 5")	Sq Ft	50
PROTECTIVE COAT	Sq Yd	104

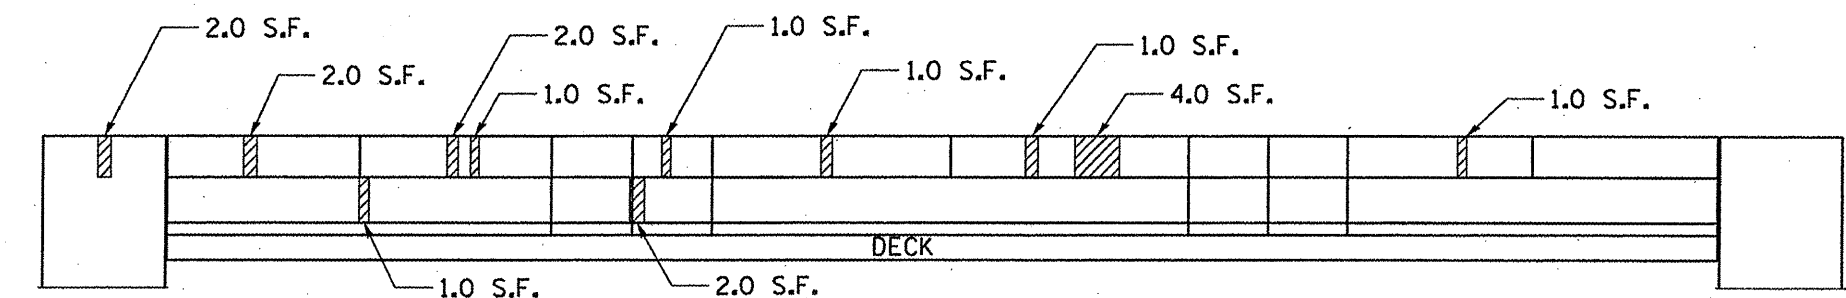
**WEST PARAPET
INSIDE FACE**

**WEST PARAPET SHOWN.
EAST PARAPET SIMILAR.**

**PROTECTIVE COAT
TOP AND INSIDE FACES OF
EAST AND WEST PARAPET**

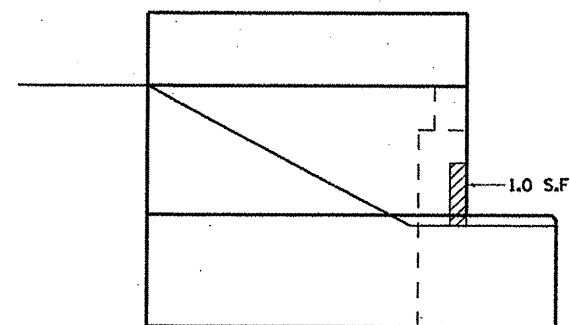
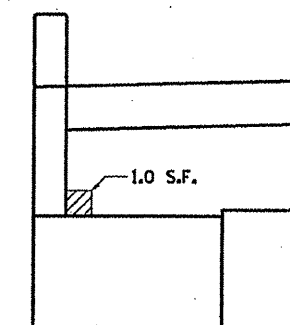
**SOUTH ABUTMENT
SOUTHEAST CORNER**

EAST FACE

NORTH FACE
